TWO YEARS EXPERIENCE WITH THE UPGRADED ELBE RF-SYSTEM DRIVEN BY 20 kW SOLID STATE AMPLIFIER BLOCKS (SSPA)

Abstract

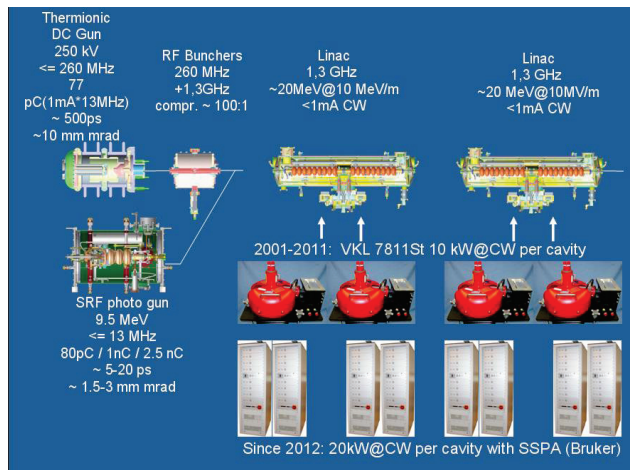
Figure 1: Layout of the upgraded ELBE RF-system.

The replacement of the klystrons by SSPA is illustrated in Fig. 1. 20 kW SSPA modules are used per cavity and one SSPA is used to operate the SRF photo gun. The RF related activities before the upgrade project are described in the papers [2] and [3]. Fig. 2 shows the new SSPA gallery at ELBE. In general the ELBE operation is now much smoother than with klystrons used before.

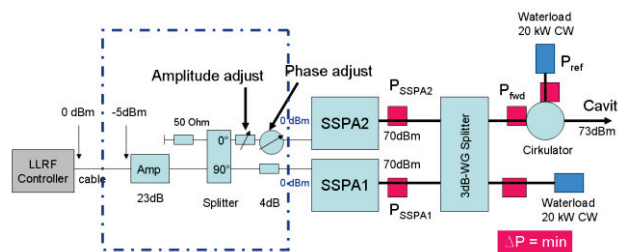
Figure 3: Block diagram of the 20 kW SSPA module.

The block diagram of the driver is shown in Fig. 3. Two 10 kW SSPA are operated in parallel using hybrid waveguide couplers at the output and also 3 dB hybrid couplers (SMA-type) at the input.

Tuning criterion is RF power minimum at the isolated port of the 3 dB-waveguide coupler using the variable amplitude and phase adjusts in the driver box.
