VISUAL INSPECTION OF A COPPER COLLIMATOR IRRADIATED BY 590 MeV PROTONS AT PSI

Å Strinning*, P. Baumann, M. Gandel, D. Kiselev, Y.J. Lee, S. Adam,
Paul Scherrer Institut, 5232 Villigen PSI, Switzerland

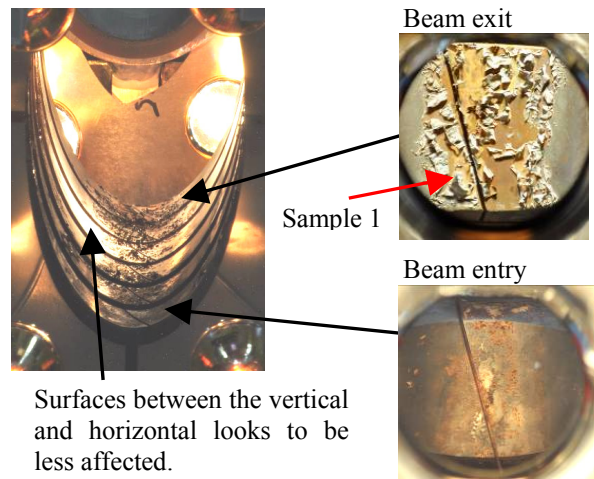
According to Figure 3, the temperatures of the upper and lower inner surfaces of the collimator are about 80 to 100°C at 2 mA. Some photos taken with the inspection tool in mode S1 and S3 are shown in Figure 6. The most important observations are:

- The observed damage seems to be larger at the beam exit.
- Some grey skinlike pieces are peeling off.
- The surfaces between the vertical and horizontal direction (at ~45°) seem not to be affected.

Figure 6: Picture of the lower collimator opening in beam direction. The upper part looks very similar. On the right, the pictures show the surfaces at the beam entry and exit.

Since the stopping range of 590 MeV protons is about 24 cm in a full block of copper, lower energetic protons and more secondary neutrons are hitting the last section of the collimator compared to the first one. It is known that low energetic particles are causing more damage to the bulk material. Further, the main damage seems to be

concentrated at the coldest location. The grey surface and the pieces peeling off might be a result of erosion and dirt. Therefore, a material sample (No 1) was taken from the last section at the bottom using a tissue soaked with alcohol. The analysis and conclusions are presented below.

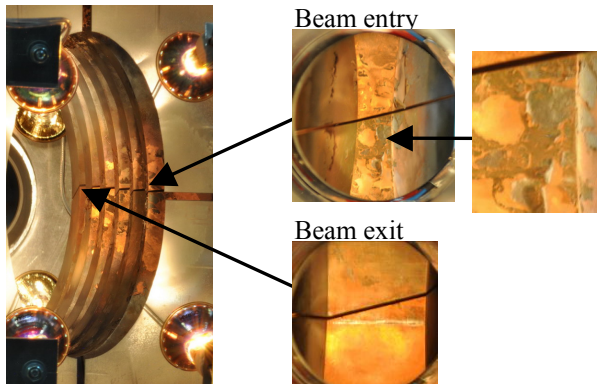
With the same setup, photos were taken from the vertical surfaces on the left and the right hand side (Figure 7), where the temperatures are above 350 °C. The main observations are:

- The main surface modifications seem to be at the beam entry side.
- Grey pieces (about 1 cm in diameter and larger) are peeling off.

Contrary to the vertical direction, the grey pieces are concentrated at the locations with the highest temperatures (left and right). It looks like they peel off along grain boundaries, whose size has grown considerably. The size of the grain boundaries in unirradiated and untreated OFHC copper is of the order of a few hundred microns, but exposed to temperature and irradiation, they are known to grow. Unfortunately, a sample piece could not be taken without the risk of damaging the collimator.

Figure 7: Picture of the right collimator side in beam direction. The left side looks quite similar. Two surface pictures at the beam entry and exit are also shown.

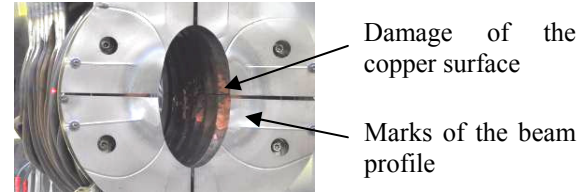
At the beam entry (front side) of the collimator, one can see the aperture diaphragm made out of 127 μm thick Ni foil (Figure 7). It is used for monitoring the beam position online and protecting the collimator and subsequent systems from damage, as it is a device in the run permit system of the accelerator. The Ni foil is in a very good shape and free of dirt. The maximum operating temperature is $\sim 750^\circ\text{C}$ at 2 mA. The slightly darker colour reveals the beam profile. Behind the diaphragm, some damage of the copper can be discerned.

Sample 2
Region of less damage
653 K
= 380°C

Figure 8: Pictures of the back and front side of KHE2. The calculated temperature profile on the back side is shown for comparison.

At the back side the damage to the collimator seems to be larger at the top and the bottom than in the horizontal direction where the temperature ($\sim 380^\circ\text{C}$) is much higher (Figure 7). It seems almost to reveal the temperature profile shown on the right of Figure 8. It is likely that the higher temperatures helped to heal the damage of the bulk material.

At the bottom, a stripe of golden colour can be seen. It is partly covered with black pieces; some of them are peeling off. One of them was taken as sample 2.
