RIKEN RING CYCLOTRON (RRC)

RIKEN Nishina Center, Wako, Saitama, Japan

Abstract

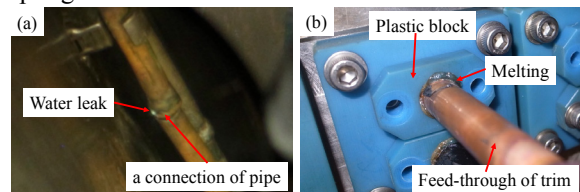
In April 2012, a vacuum leak occurred in the electric power feeder of RF resonator No. 2. This vacuum leak was attributed to a crack in the insulator and to the partial melting of the aluminium gasket. Therefore, the insulator and gasket were replaced with new ones. In the spring of 2013, a vacuum leak occurred in the inner copper cooling-water pipe for the lower dee electrode in the resonator No. 2 cavity. So, the cavity was opened in July, and the inside of the inner conductor was investigated carefully. The water leak occurred at a connection in the inner copper cooling-water pipe, as shown in Figure 3 (a), but it was impossible to repair the leak point due to the narrowness of the space surrounding the pipe. Therefore, because a new bypass line was made for the lower dee electrode, this pipe line was cut at some spot and connected with a new pipe using a sleeve and a silver braze. In October 2013, a vacuum leak occurred in a lower feed-through trim coil in the E-sector sub-chamber [2-3]. So, the E-S valley cavity, which is located next to these lower feed-through trim coils, was opened to perform these repairs in the summer of 2014. Three O-rings and plastic blocks for the feed-through had been melted, as shown in Figure 3 (b). The feed-through was cut at each melted location because there was no coupling to enable desorption of the O-rings and plastic blocks. The melted O-rings and plastic blocks were replaced with new ones, and the feed-through was again connected with coupling.

Figure 3: RRC vacuum leaks: (a) connection of the inner copper cooling-water pipe, (b) O-rings and plastic blocks for feed-through.

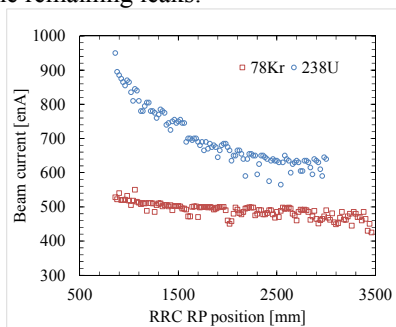
Though a vacuum of about 2×10^{-5} Pa is currently present in the two resonator cavities, beam loss is increasing more than before. Figure 4 shows the circulating beam currents of ^{78}Kr and ^{238}U that were measured by a radial probe (RP) in a 1.6×10^{-5} Pa vacuum in the winter of 2015 [2]. The RP position is defined as the distance from the center of the circulating orbit. Though the ^{78}Kr beam current only decreases by about 9 %, that of the ^{238}U decreases substantially, by more than 30 %. This ^{238}U beam current loss is six times greater than 5 % that measured in 2012, so it is necessary to repair the remaining leaks.

Figure 4: Circulating beam currents of ^{78}Kr and ^{238}U .

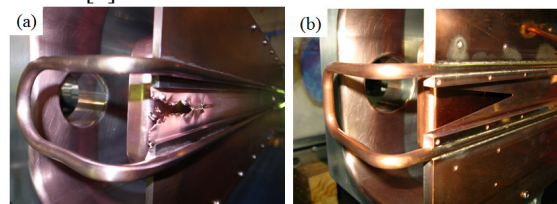
During the U-beam service time in November 2012, a septum electrode of an electrostatic deflection channel (EDC), which deflects the circulating beam to the extraction orbit, was seriously damaged on the injection side by significant beam loss, as shown in Figure 5 [3]. After this issue arose, a beam interlock system was installed to monitor the temperature of the EDC septum electrode of the RRC and to reduce the heat load. Furthermore, a new EDC septum electrode structure was designed, in which the septum electrode forms a V-shape pointing towards the injection side.

Figure 5: EDC: (a) septum electrode damaged by beam loss, (b) new V-shaped septum electrode.
