# CONDITION OF MA CUT CORES IN THE RF CAVITIES OF J-PARC MAIN RING AFTER SEVERAL YEARS OF OPERATION

M. Nomura\*, A. Schnase, T. Shimada, F. Tamura, and Masanobu Yamamoto  
 JAEA/J-PARC, Tokai-mura, Ibaraki, Japan

## Abstract

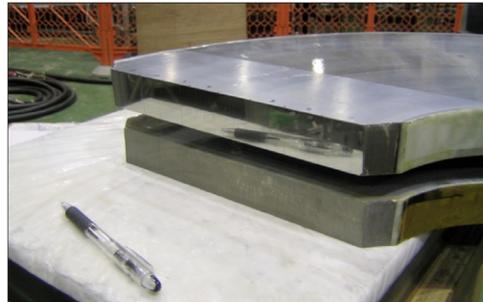
MA cores for J-PARC Synchrotrons are produced by a winding process using amorphous thin ribbons. In order to create enough electrical insulation, a coating of SiO<sub>2</sub> with an average 2 μm thickness was put on one side of the ribbon. The ribbon consists of mainly Fe, Si, B, and a small amount of Cu and Nb. The MA core cutting process has 2 relevant steps. The first step is cutting with water jet. After water jet cutting, the electrical insulations between spiral ribbons on the cutting surface are broken. In the second step, the electrical insulation is recovered by polishing with diamond powder. After polishing, the cutting surface has a mirror quality. The picture of sample cutting surfaces is shown in Fig. 1.

Figure 1: Picture of core cutting surfaces. The lower cutting surface is obtained after water jet cutting and the upper one is after polishing with diamond powder.

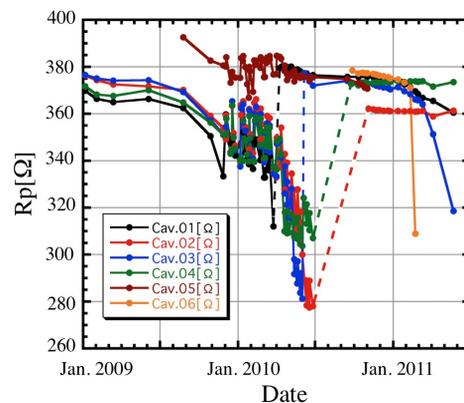
Figure 2: The results of impedance measurements of MR RF cavities. The horizontal axis shows the date and the vertical axis shows the real part of the cavity impedance at the resonance frequency. The broken lines represent the core replacements.

Figure 2 shows that during the first one year half of operation, all 4 RF cavities, RF cavity #1 to #4, show

impedance reductions [3]. We replaced the MA cores of those 4 RF cavities. The impedance fluctuations from December 2009 to July 2010 are caused by draining off the cooling water and exposing to air. The reason why the impedance was recovered to some extent might be an oxidation process.

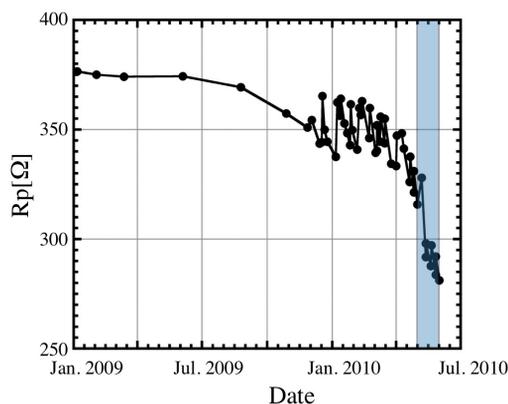
To study the impedance reduction carefully, we pick up the RF cavity #3 that showed typical impedance reduction, and check the RF cavity #3 impedance and each water tank impedance. The RF cavity consists of 6 water tanks. The impedance change of RF cavity #3 and each water tank are shown in Figs. 3 and 4, respectively. Fig. 3 shows that the impedance is declining slowly until Apr. 2010 and in May 2010 the impedance drops largely. From Fig. 4, it is known that this large impedance reduction is caused by the water tank #5.

Figure 3: The results of impedance measurements of RF cavity #3. The blue region represents May 2010.

The slow impedance reduction in Fig. 3 is thought to be caused by the rust on the cutting surface, like in Fig. 6. From X-Ray Diffraction analysis, the rust mainly consists of  $\text{Fe}_3\text{O}_4$ .  $\text{Fe}_3\text{O}_4$  is a typical rust that is generated in water and it has an electrical conductivity. We study the influence of the resistance due to the rust on the cutting surface to the water tank impedance. A circuit diagram of the water tank that stacks three cores is shown in Fig. 8. The capacitances  $C_{\text{in}}$  and  $C_{\text{out}}$  are about ten times larger than  $C_{\text{core}}$ , and hence the resistance  $R$  due to the rust reduces the impedance. In this case the core radial capacitance  $C_{\text{core}}$  is not changed, and hence the resonance frequency is not changed. This thought can explain the impedance reduction of tank #6 in Fig. 5.

On the other hand, the large impedance reduction in Fig. 3 might be caused by the damage of the cutting surface. See Fig. 7. From Fig. 8, it is understood that the radial direction of the core at the accelerating gap side is exposed to the highest RF voltage in the three cores. In the large impedance reduction, at first the cutting surface was rusting, and next the cutting surface at the accelerating gap side core was damaged due to the RF voltage, and then the electrical insulations between ribbon layers on the cutting surfaces were broken. The impedance reduction might be caused by the electrical insulation breaks on the cutting surfaces. These electrical insulation breaks cause the resonance frequency reduction because the core radial capacitance is increased by the electrical insulation breaks. This thought can explain the impedance change of tank #5 in Fig. 5.

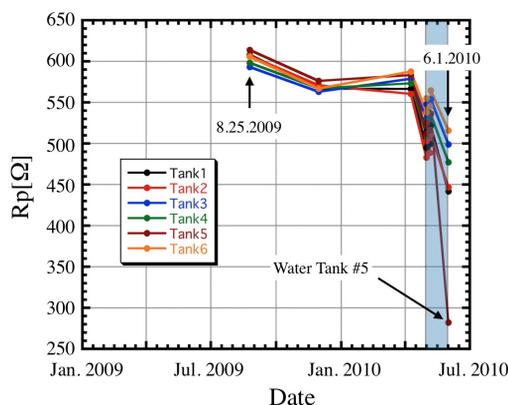
Figure 4: The results of impedance measurements of RF cavity #3 each water tank.

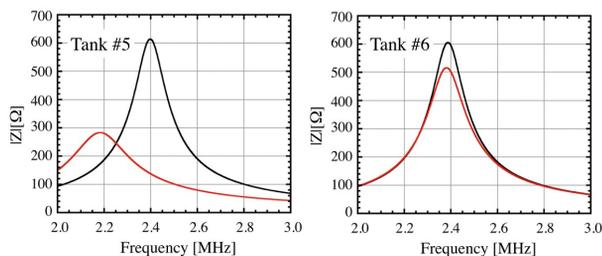
We show the impedance curves of the cavity #3 tank #5 and tank #6 at Aug. 25, 2009 and Jun. 1, 2010 in Fig. 5. Both water tanks show the impedance reductions. The water tank #6 keeps its resonance frequency. On the other hand, the water tank #5 lowered its resonance frequency. The mechanisms of impedance reductions are discussed in next section.

Figure 5: Impedance curve of water tanks #5 and #6. The horizontal axis shows frequency and the vertical axis shows absolute value of tank impedance. The black and red line represents the impedance data at Aug. 25, 2009 and Jun. 1, 2010, respectively.

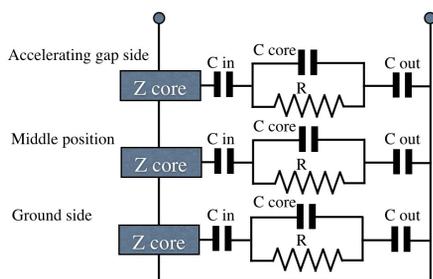
Figure 8: A circuit diagram of the water tank that stacks three MA cores.  $C_{in}$  and  $C_{out}$  represent the capacitances of the inner and outer space between water tank and cores, respectively.  $C_{core}$  represents the capacitance in radial direction of core and is a sum of the capacitances between ribbon layers.  $R$  represents the resistance due to the rust on the core cutting surface.
