STATUS OF J-PARC ACCELERATOR FACILITIES AFTER THE GREAT EAST JAPAN EARTHQUAKE

K. Hasegawa[#], M. Kinsho, H. Oguri, J-PARC/JAEA, Tokai, Japan
 T. Koseki, J-PARC/KEK, Tokai, Japan

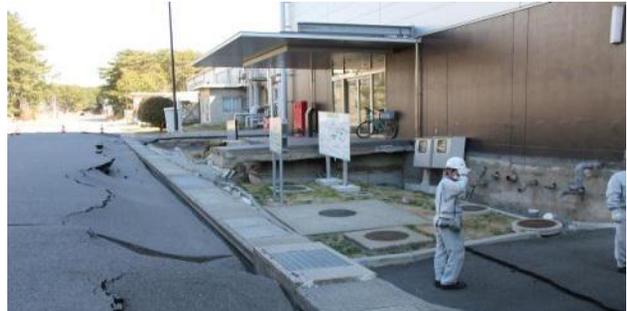
The linac building is approximately 330 m in length, and 44-48 m in width. A wide area at the entrance of the linac building subsided ~1.5 m, and almost all water supply and drainage pipes were broken as shown in Fig. 1.

Figure 1: Subsidence at the entrance of the linac building.

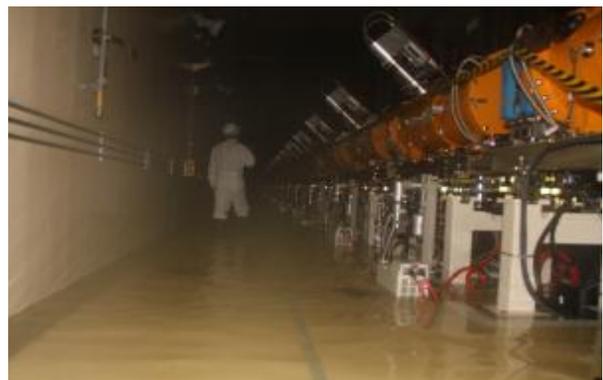
We could not get into the building until March 17 due to many strong aftershocks after the earthquake. It was found that there were no severe damages on the accelerator itself, but that water accumulated 1 cm in deep on a floor of the linac tunnel. When we entered the tunnel again a week later on 24th the water level increased to approximately 10 cm as shown in Fig. 2. It meant the water level increased more than 1 cm per day, and then we decided to pump it out immediately. Since the electricity

had yet not been restored for the building, we used a diesel engine generator. It took two days to drain approximately 150 m³ of water. When the floor exposed, a large number of lateral cracks were recognized on the floor and the walls mainly in the middle of the tunnel.

Figure 2: Flooding in the linac tunnel.

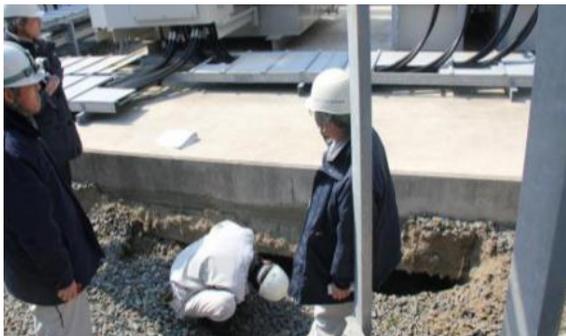
The accelerator components in the yard suffered from serious damages. Many bases for capacitors and transformers for resonant power supplies and rectifiers for RF cavities inclined. There were many hollow spaces

Figure 3: Hollow space underneath of a base for capacitor and transformer racks in the RCS yard.

underneath of bases as shown in Fig. 3. Cable trays installed along the building and all 4 cooling towers for the water system were also damaged.

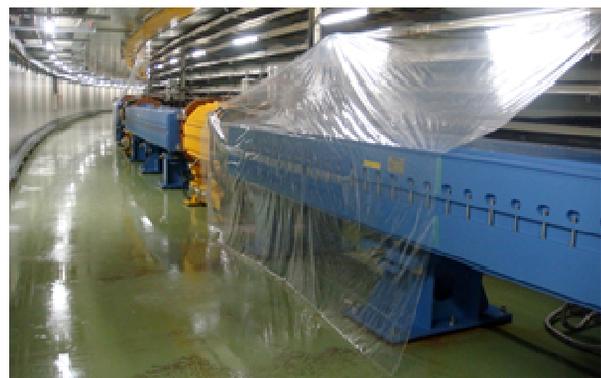
More than 30 cracks were found in the MR main tunnel, and groundwater leaked from these parts. Since the lighting in the tunnel restored on March 25 two weeks after the earthquake, we could investigate the status of MR, finding that some electromagnets were continuously hit by leaked groundwater as in Fig. 4. Fortunately, the tunnels, except a part of the sub-tunnel, did not flood because of the presence of a side ditch. We carried out emergency sealing work at the points of heavy water leaks. An attached building to the main tunnel subsided, and a level difference was approximately 5 cm at the expansion joint part.

Figure 4: Groundwater leakage in the MR tunnel. The magnet is covered with the sheet.
