MALFUNCTION, CAUSE AND RECURRENCE PREVENTION MEASURES OF J-PARC SLOW EXTRACTION

M. Tomizawa*, T. Kimura, H. Nakagawa and K. Okamura,
KEK, Oho 1-1, Tsukuba, Ibaraki, Japan

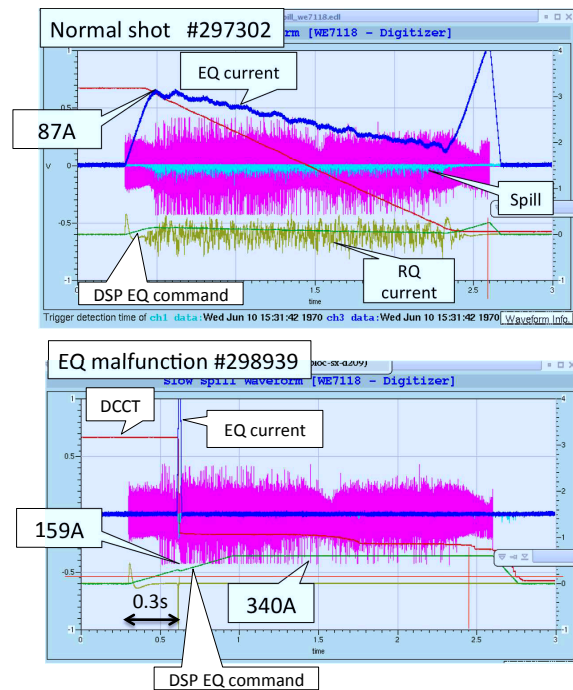
In the ordinary slow extraction operation, a DSP generates the EQ current pattern to obtain an uniform spill shape from the spill monitor signal (see upper part in Fig. 1). Green line shows the DSP current command and blue line is actually flowed EQ current. The DCCT signal (red line) decreases linearly, which indicates that the beam spill shape is flat. Light blue line shows the spill monitor signal. Grass green line shows a RQ current pattern to suppress the spiky spill. Lower part of Fig. 1 shows the malfunction shot. Despite of the DSP command to flow the EQ current (green line) over 0.3 sec., the EQ current did not respond, and the beam is not extracted. The DSP required further to flow the current for the EQ P.S.. At the timing corresponding to 159 A set value, the EQ current suddenly flowed following to the DSP set value. The EQ P.S. was

Figure 1: Spill control patterns of normal and malfunction shots.

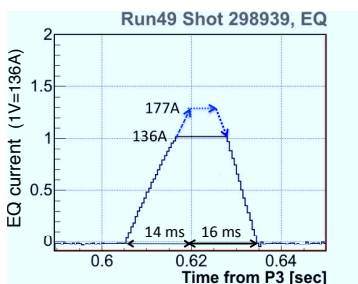
Figure 2: EQ current pattern at malfunction shot. Dotted line shows speculation by the test.

Figure 2 shows the EQ current at the malfunction shot. The recorded current was saturated at 136 A. From the response for a 159 A step command test performed after the accident, the maximum current achieved to 177 A by overshoot and repeating the hunching. A PLC detected the over voltage and dropped the output current after 14 msec. from the start of the current increase. The horizontal tune pattern can be derived from this EQ current pattern including the estimation and a scheduled QFN current pattern. The tune was estimated to be moved from 22.313 to 22.327 by 0.014. The extracted beam time profile is simulated by using the horizontal tune pattern. The circulated beam is assumed to be Gaussian distribution with the emittance of 0.8π mm-mrad cut at 3σ . Upper part of Fig. 3 shows a horizontal tune pattern and lower part shows actual beam spill obtained from time derivative of the recorded DCCT signal and the simulated one. The simulation reproduces an

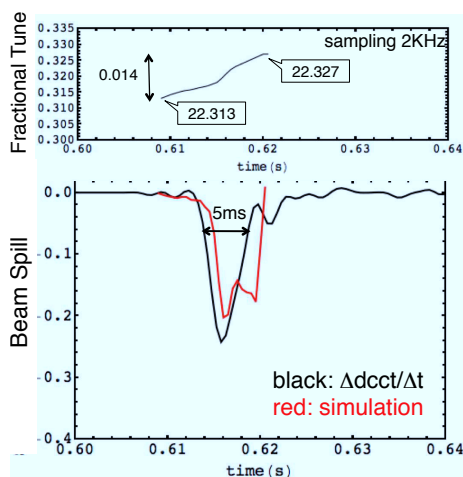
Figure 3: Horizontal tune pattern and beam spill at the malfunction shot.

actual beam spill. An extracted particle fraction can be derived from the simulation as a function of the tune distance from the third integer resonance line. The extracted particle fraction by the simulation is 67%, which is consistent with actually extracted particle fraction at the malfunction shot. A quick stop of the EQ current increase after the trip detection reduces the short-pulsed beam fraction.

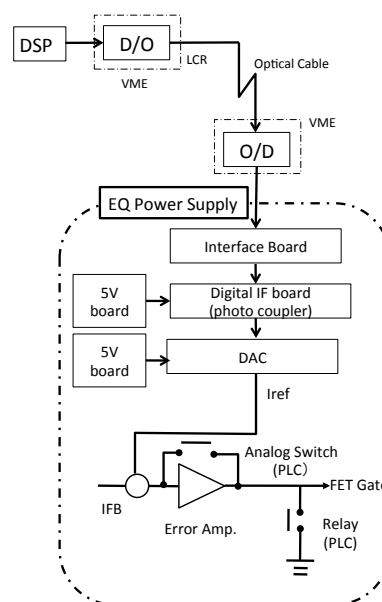
Figure 4 shows a block diagram for the current control of the EQ P.S.. A digital signal from the DSP is converted to an optical signal and the optical signal is converted back to a digital signal by a VME board. The digital signal is transmitted to a digital interface (IF) board with photo-couplers. The digital signal from the photo-couplers is converted to an analog signal by a DAC and fed into FET gates to generate the output current. The 5 V necessary for the digital IF board is supplied from a DC power supply board.

To investigate the cause of the malfunction, the EQ P.S. was continuously operated at a sawtooth current pattern of 6 sec. cycle after the accident over 3 months. The trips of the EQ P.S. rarely happened also in the test. Trips by the over voltage were just 4 times of 774600 cycles. From the rare trip events, we observed an abnormal behavior of the digital signals sent to the DA. The DC power supply board by the maker of the EQ P.S. has two types, low power and high power ones. Though the high power type must be used from the power consumption, the lower power type had been misused. The low power type does not have any heat sink on a voltage regulator and any power transistor supporting the voltage regulator. The voltage regulator was overheated by an excessive power consumption. The surface temperature achieved to $130^{\circ}C$. As a result, The voltage generated by the regulator dropped and fluctuated

Figure 4: Block diagram of the EQ current control.

near 3 V. In this situation, the photo-couplers can not work well. A voltage generator was prepared instead of the DC power supply board for the test. A sawtooth current pattern was sent from the DSP. When the voltage from the voltage generator is set to 3.45 V, the digital signal is normally transmitted to the DA, on the other hand, for 3.18 V, abnormal digital signals makes a step response for the DAC output. This is similar as the behavior at the malfunction shot. The DC power supply board has been replaced to the high power type after this investigation.
