ANALYSIS OF RHIC BEAM DUMP PRE-FIRES*

W. Zhang, L. Ahrens, W. Fischer, H. Hahn, J. Mi, J. Sandberg, Y. Tan
 Brookhaven National Laboratory, Upton, NY 11973-5000

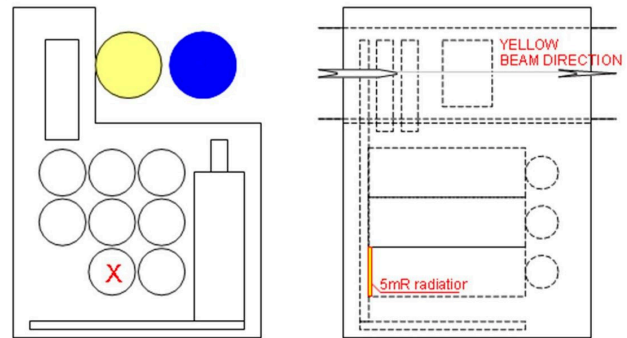
A radiation technician and pulsed power group technicians alerted us of localized radiation phenomena. After replacement of a capacitor during 2009 operation, the radiation survey showed the concentration of radiation at the ground end of the damaged capacitor only, as shown in Figure 1. Coincidentally, the damage, a fine crack line on capacitor case caused a minor oil leak, was at the ground end with abnormal radiation reading. Since the internal arcing of the capacitor happens usually at the high voltage end, this damage at ground end raised alarm of possible radiation damage to capacitors.

Figure 1: The yellow modulator 4 front view and side view and the location of the damaged capacitor.

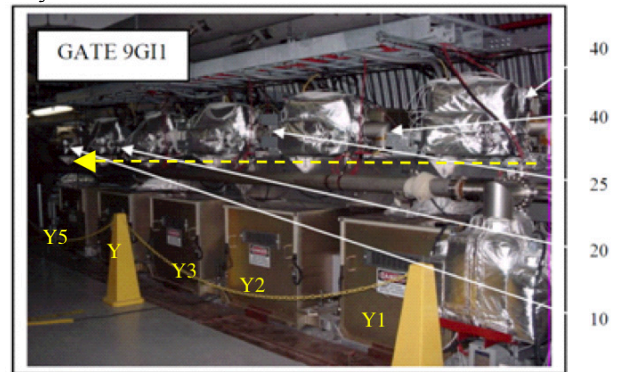
The correlation of the modulator location and the residual radiation in blue seems clear, but not in yellow. The blue module 4 had the highest number of capacitor replacement and the highest residual radiation in survey. However, the yellow module 5 that had a total of 13 capacitors replaced had low reading in radiation survey.

Figure 3: The yellow abort kicker modulators rear view and radiation survey result in μRem . The dashed yellow line is the yellow beam direction.

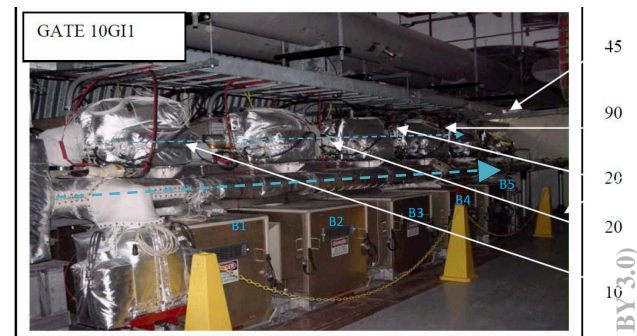
Figure 4: The blue abort kicker modulators rear view and radiation survey result in μRem . The dashed blue line is the blue beam direction.
