# OPTICAL INSPECTION OF SRF CAVITIES AT DESY

S. Aderhold<sup>#</sup>, DESY, Hamburg, Germany

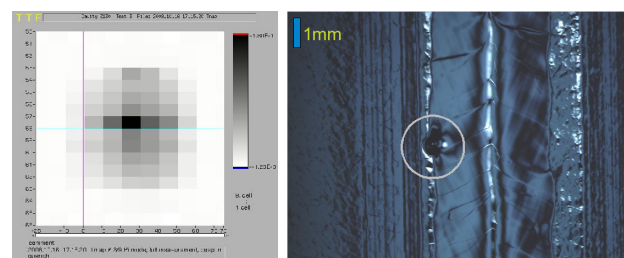
For the 3/9- and 1/9- $\pi$ -mode the heating location was found by T-map on the equator of cell 5 (see left part of Figure 1). Cell 5 was limited by quench at 22 MV/m in the 3/9- $\pi$ -mode.

Optical inspection of Z130 was carried out after the vertical test. At the area corresponding to the heating during quench in 3/9- and 1/9- $\pi$ -mode, a circular pit of about 700  $\mu\text{m}$  diameter is visible on the edge of the equator welding seam (right part of Figure 1).

Samples have been cut from Z130 for a detailed analysis of the surface [2]. The defect in the equator of cell 5 was found to be up to 200  $\mu\text{m}$  deep. No inclusion of foreign material was detected in the defect by EDX.

Figure 1: Quench location found by T-map (left) and optical inspection picture of respective area (right) in Z130.

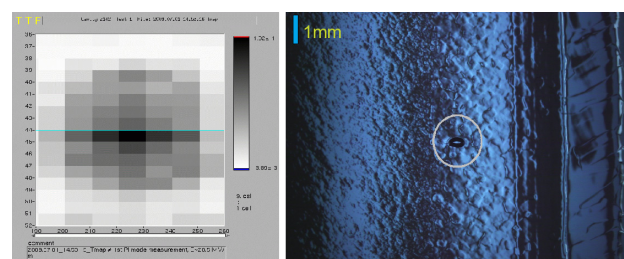
Figure 2 shows another correlation between T-map measurement and optical inspection that was found in Z142. During the vertical RF-measurement heating of the quench was located by T-map near the equator of cell 6 (left part of Figure 2). In the  $\pi$ -mode the cavity was limited at 20.6 MV/m by quench without field emission. Optical inspection of the respective area after the test revealed a defect in the heat affected zone next to the equator welding seam (right part of Figure 2). The defect is a pit of elliptical shape with a semi-minor axis of about 300  $\mu\text{m}$  and a semi-major axis of about 500  $\mu\text{m}$ .

Figure 2: Quench location found by T-map (left) and optical inspection picture of respective area (right) in Z142.

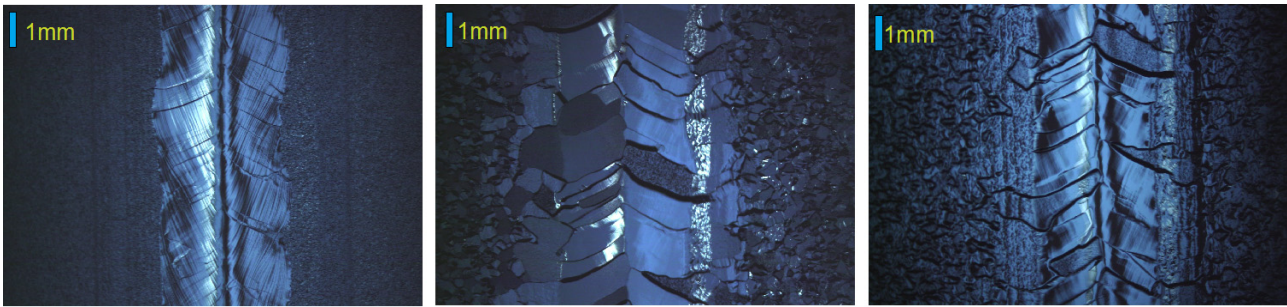
Figure 3: Equator welding seam of cell 1 in Z137: Before chemical treatment (left), after main EP (center) and after final EP (right).

Figure 3 shows a series of three pictures taken at the same spot of the equator welding seam of cell 1 in Z137. The left picture shows the cavity before the surface treatment. The equator welding seam of cell 1 looked normal and similar to the other eight equator welding seams.

After the main surface removal of 108  $\mu\text{m}$  by EP, cell 1 looked different to the other cells (centre picture of Figure 3). Large steps have appeared at the grain boundaries on the welding seam and in the heat affected zone. Complete grains on the welding seam look matte and very rough. This effects are visible along the complete equator of cell 1. None of the other eight cells showed similar effects.

The final EP has smoothed the structures on the equator and the surface is much more shiny (right picture of Figure 3). However the large steps at the grain boundaries remain.

In the vertical test Z137 was limited at 25.2 MV/m by quench. T-map measurement located heating of the quench in the heat affected zone next to the equator of cell 1.

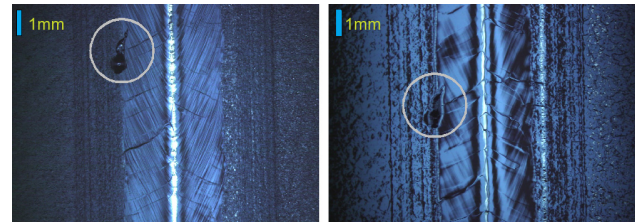
Figure 4: Defect on equator welding seam in cell 1 of Z136: before surface treatment (left) and after main-EP (right).

During the optical inspection of Z136 before surface preparation three defects of up to around 1 mm in size have been found on the equator welding seam of cell 1 and in the heat affected zone next to it. All three defects lie within few cm of the welding seam. An example picture is given in the left part of Figure 4. The defect looks like a circular pit of about 600  $\mu\text{m}$  diameter, accompanied by molten material sitting on the surface.

After the main surface removal of 108  $\mu\text{m}$  by electro-polishing the defects are smoothed but still present (see right part of Figure 4). Final surface treatment of Z136 is scheduled and the subsequent RF-measurement with T-map will reveal, whether the remainder of one of the defects causes a quench or not.

The presence of the defects before any chemical treatment of the cavity indicates that their formation is linked to the welding process itself.
