## UPDATE ON STUDY OF WELDING POROSITY IN NB EBW

Y. Iwashita, Y. Fuwa, H. Tongu, Kyoto ICR, Uji, Kyoto  
H. Hayano, KEK, Ibaraki

We have been developing high-resolution inspection systems and the connected instruments for SRF cavity developments. They include the cavity camera – so-called Kyoto-Camera, eddy current scanner, high-density T-map and X-map system and the local grinding system. They revealed an existence of voids beneath the surface of EBW seam. Study on the welding porosity in the Nb EBW seams is reported.

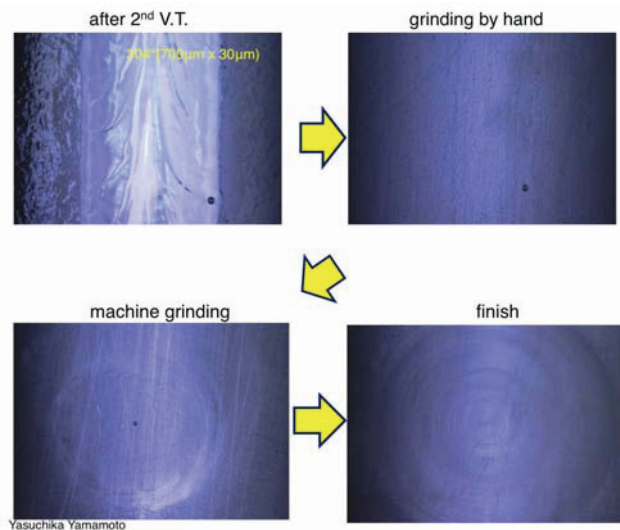
Figure 1 shows the combined cavity camera and the local grinding system. The camera cylinder and the grinder cylinder can be switched quickly for the series of inspection and repair process. Defects found on the surface by the optical inspections have been effectively eliminated for many cases as shown in Figure 2. In spite of this success, it has been found that new defects sometimes appear after the EP on a cavity repaired by the local grinding technique as shown in Figure 3. They grew with the local grindings: the further the ground depth went, the bigger the pit size grew. This alludes that they are voids buried beneath the surfaces. These voids appeared again after the local grinding followed by EP process.

Figure 2: Succeeded example on the local grinding.

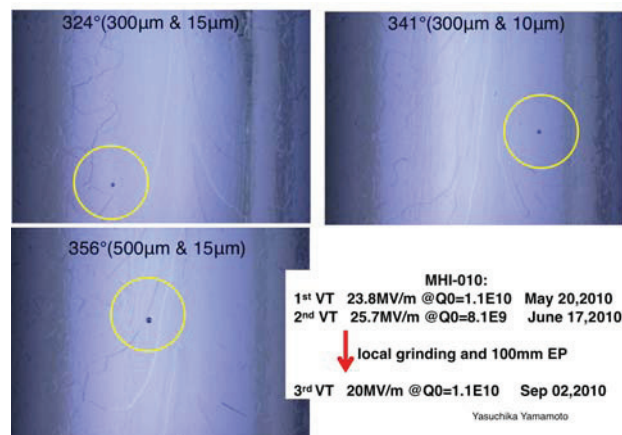
Figure 3: Voids appear after EP on the locally grounded cavity for repair.

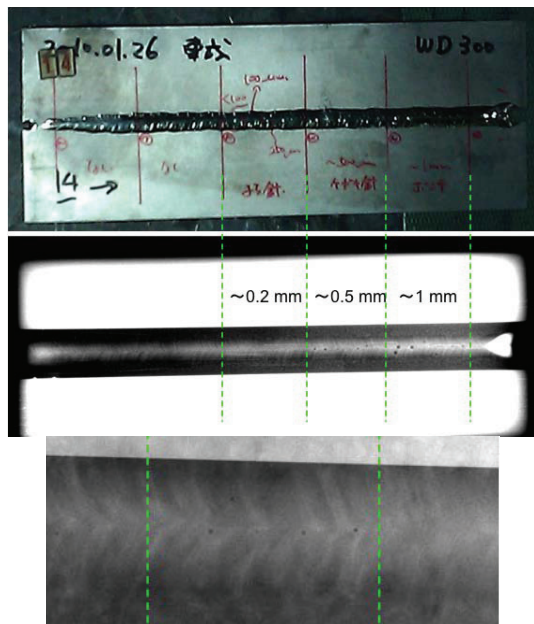
rays usually used for parts made of steel can hardly penetrate the 3mm Nb sheet. Neutron radiography was tried for that reason [5]. Although the results of neutron CT were promising, their availability is somewhat limited and thus is not handy. X-rays, which has a better accessibility, have been also tried at a few facilities with high energy for better penetration depth (see Figure 4). The high energy X-rays, however, was found to be not adequate, since the high penetration power makes the contrast poor and the poor visibility was resulted. Thus we are trying to use conventional X-rays with W target, where the energy of K-X-ray is about 70keV. Figure 5 shows an imaging example currently obtained. Using the magnifying imaging with factor 8.8, 200 μm dents seem to be observed.

Figure 5: Observed EBW seam with artificial dents with 200 μm and 500 μm diameters (top). The 500 μm dents are visible in the right area (middle), while 200 μm dents located in the left area are detected in a magnifying imaging with factor 8.8 (bottom).

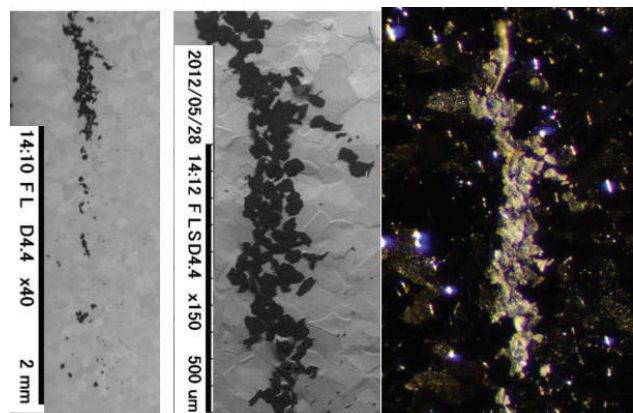
Contaminants found on the Nb surface after BCP as shown in Figure 6. They are firm solids and difficult to come off. According to EDX (Energy Dispersive X-ray spectroscopy) analysis, they seem carbon oxides. This carbon could be a source of the voids. A speculation of defect formation at EBW seam is shown in Figure 7. After BCP on the trimmed edge, this kind of carbon contaminants may be resulted on the edges. When the contaminants were buried in the joints between the dumbbells, they might form the voids during the EBW process.

Figure 6: Contaminants found on the Nb surface after BCP. Left to right: camera image, SEM and optical microscope. (by Dr. M. Sawabe)

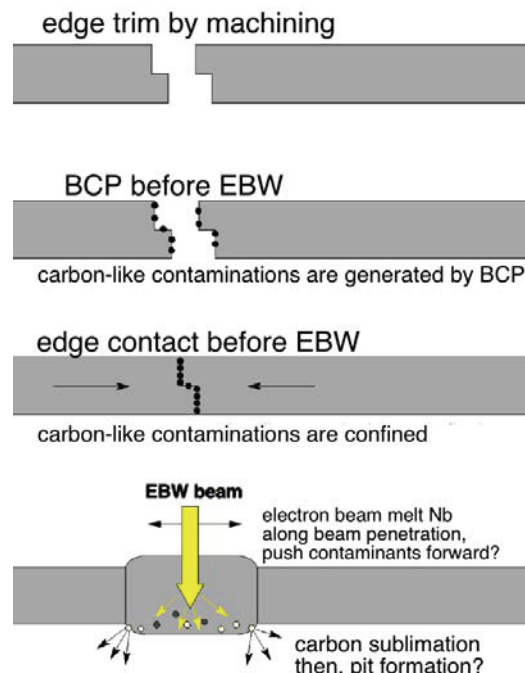
Figure 7: A speculation on defect formation at EBW seam

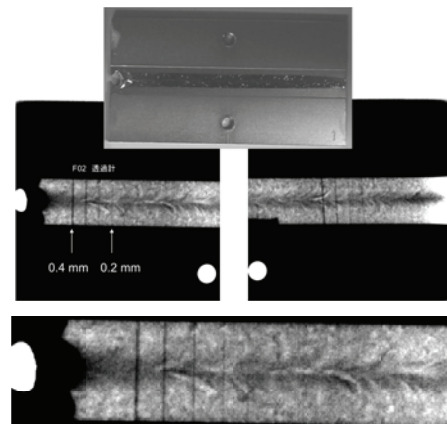
coated with carbon material before fixed with a jig for EBW (see Figure 9 and 10). Seven pairs including an initial pair for parameter setup were prepared, while four of them have the carbon coats. The EBW rise time was 0.1 s and the speed was at 0.2 m/s, which went down with 0.5 s. The voltage of the electron beam was 60 kV where the currents of 30 mA and 33 mA were supplied for a first half and a last half of EBW. Figures 11 and 12 show the images of the EBW samples. The top figures show the surfaces of the samples without and with thick carbon coating on the edges. Transmission images are shown in the middles. In these measurements, the whole areas were divided into two images because of the limited detector size. The bottom images were taken with the geometrically magnified method (x8.8). We could not observe any void in the seams on this trial. The total length of the EBW seams with the artificial carbon contaminants is less than 40cm. This short length may be a reason why no evidence of a void. Further investigation will be followed on this subject.

Figure 11: Images of the EBW seam without carbon coat at the edge. Vertical black lines are thin wires from 0.2 to 0.4 mm for resolution check.

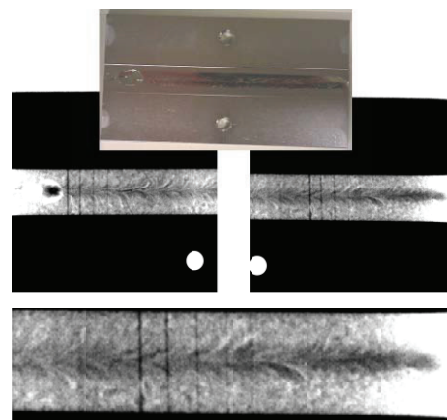
Figure 12: Images of the EBW seam with carbon coat.
