ANALYSIS OF DEGRADED CAVITIES IN PROTOTYPE MODULES FOR THE EUROPEAN XFEL

S. Aderhold*^{1,2}, D. Kostin¹, A. Matheisen¹, A. Navitski¹, D. Reschke¹

¹Deutsches Elektronen Synchrotron DESY, Hamburg, Germany

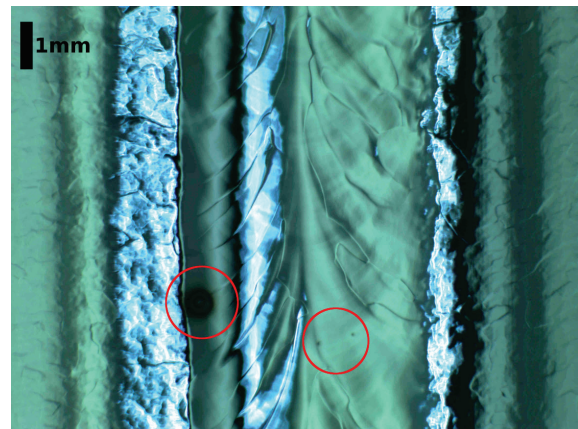
In the vertical test number 8 the Second Sound set-up at DESY was used to locate the quench spot [6]. For the π -mode the quench location was found in the second cell close to the equator at 269 degrees (details about the coordinate system can be found in [7]). This is consistent with the mode measurement in previous vertical tests that pointed to cells 2 or 8 as the limiting ones.

welding seam area close to the determined quench location is shown in Figure 1. On the edge of the equatorial welding seam a dark spot with a concentric ring pattern and a total diameter of about 700 μm is visible. In addition two small dark spots can be seen on the middle of the welding seam. The cavity had been optically inspected during its initial surface preparation cycle. It is worth noting that nothing special was visible at the respective location back then.

Figure 1: Optical inspection picture of AC127, taken at equator 2, 260 degrees. A big stain is visible on the edge of the equator and two mores spots in the middle of the welding seam.

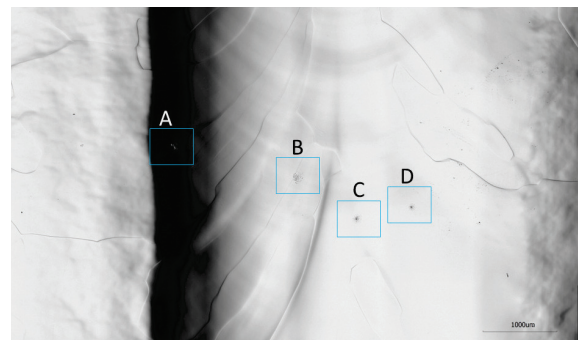
In order to investigate details of the defect with higher resolution and gather information about the surface topology a replica of the respective area was taken [9]. An overview over the defects found by examination of the replica is shown in Figure 2. A total of four individual defects is visible. One in the center of the big circular stain (labelled A), one that is not easily visible in the optical inspection picture (labelled B) and the two small black spots (labelled C and D).

Figure 2: Overview over the defects found by examination of the replica of AC127. The defect in the center of the big stain is labelled A, the two small dark spots C and D. An additional defect that is not easily visible in the optical inspection picture is labelled B.

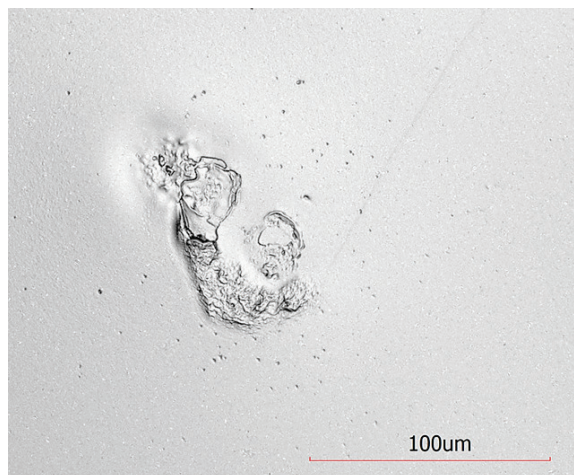
Figure 3 shows a closer look of defect A. It's size is about 100 μm x 70 μm . The structure resembles material that is

Figure 3: Optical microscope image obtained from the replica of the structure in the center of the big circular stain in AC127 (defect A). It resembles molten material on the surface.

Mode measurement, second sound measurement and optical inspection consistently identify the defect in cell 2 at 260 degrees as the limiting location. The high resolution pictures obtained from the examination of the replica reveal structures that look like molten material on the surface. A likely hypothesis is that a particle (presumably metallic) was introduced into the cavity during string assembly. The location is compatible with that assumption. Cell 2 is still close to the end of the cavity and the angular position is at

Once RF power is applied the metal would melt (defect A) and spatters form the other defects (B, C and D). Non-superconducting material on the inner surface of the cavity would also explain the high dynamic cryogenic losses that were observed during the module test.

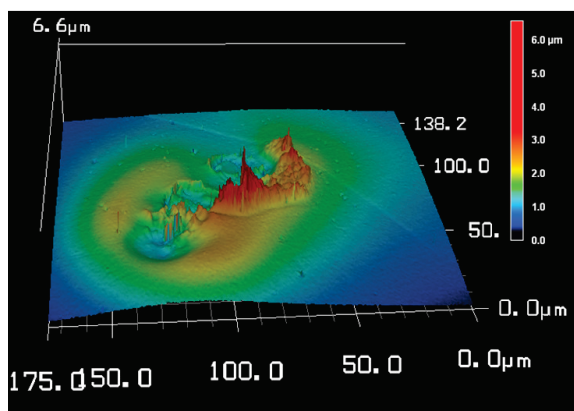
molten in and onto the surface. This assumption is backed by the surface profile in Figure 4. Some areas stick out of the surface, some are slightly recessed. The overall difference in height is only few micrometers.

Figure 4: Surface profile obtained from the replica of the structure in the center of the big circular stain in AC127 (defect A).

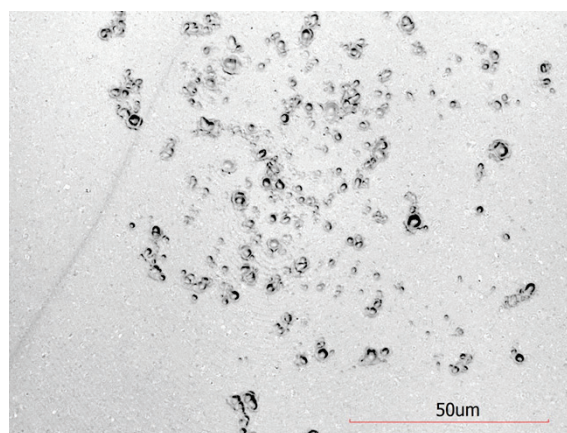
An image of defect B is shown in Figure 5. This is a group of dozens of small molten craters. Pictures of defects C and D are not shown but look very similar.

Figure 5: Optical microscope image obtained from the replica of defect B in cavity AC127. Many small molten craters are visible.
