Performance Recovery of the TRISTAN Superconducting RF Cavities

K. Asano, T. Furuya, S. Mitsunobu, T. Tajima and T. Takahashi

KEK, National Laboratory for High Energy Physics

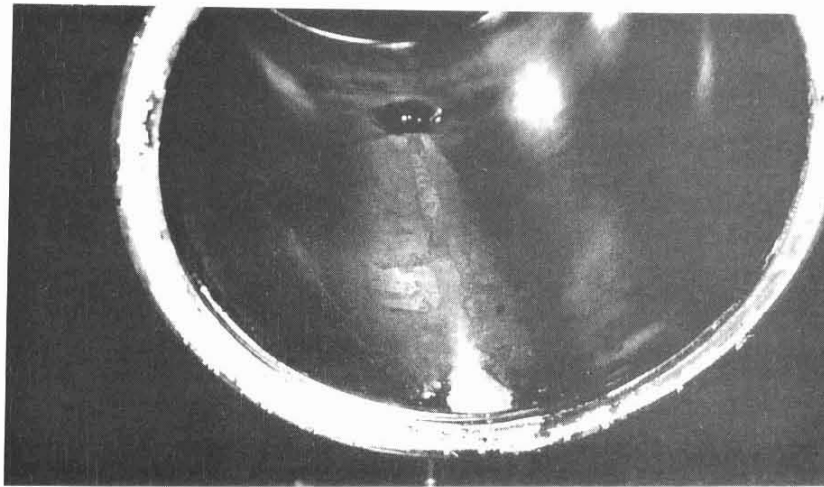
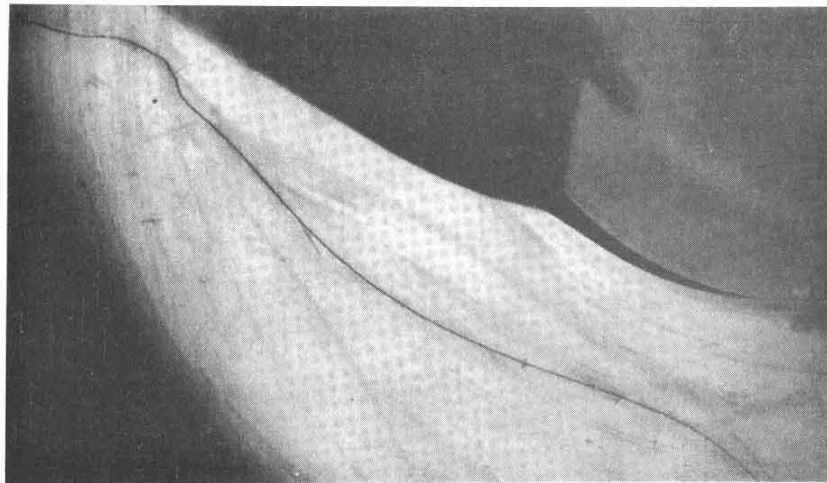
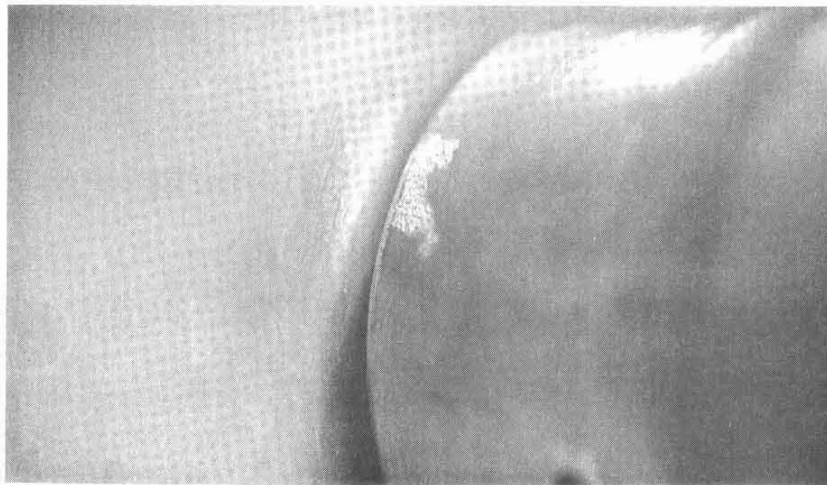
In this early stage of the operation (January 1989), the teflon backup disk on the atmospheric side of the ceramic window for the MR-6b input coupler was burnt down seriously, and the ceramic window was also broken during aging at beam-off at 4.4 K in TRISTAN MR³). A lump of green powder consisting of Cu and Nb oxides was observed inside the nearest cavity-cell to the broken input coupler. Inside the beam pipe of the broken input coupler side, a lot of white powder whose composition is mainly Nb oxide including small amount of Cu oxide was also observed. Many traces of discharge were found out inside the Nb input port and the outer conductor of the input coupler. Fluorine of the teflon backup disk was detected from the surface to 500 Å depth of the Cu plated inner conductor by Auger electron spectroscopy (AES). Annealing in addition to electropolishing the contaminated cavities was necessary to decompose the C-F bonding of the evaporated teflon on the Nb surfaces. **Fig. 1** shows the photographs of the contaminated area and discharge traces.

Fig. 1 Photographs of contaminated cavities, broken input coupler ceramic windows, and discharge traces.

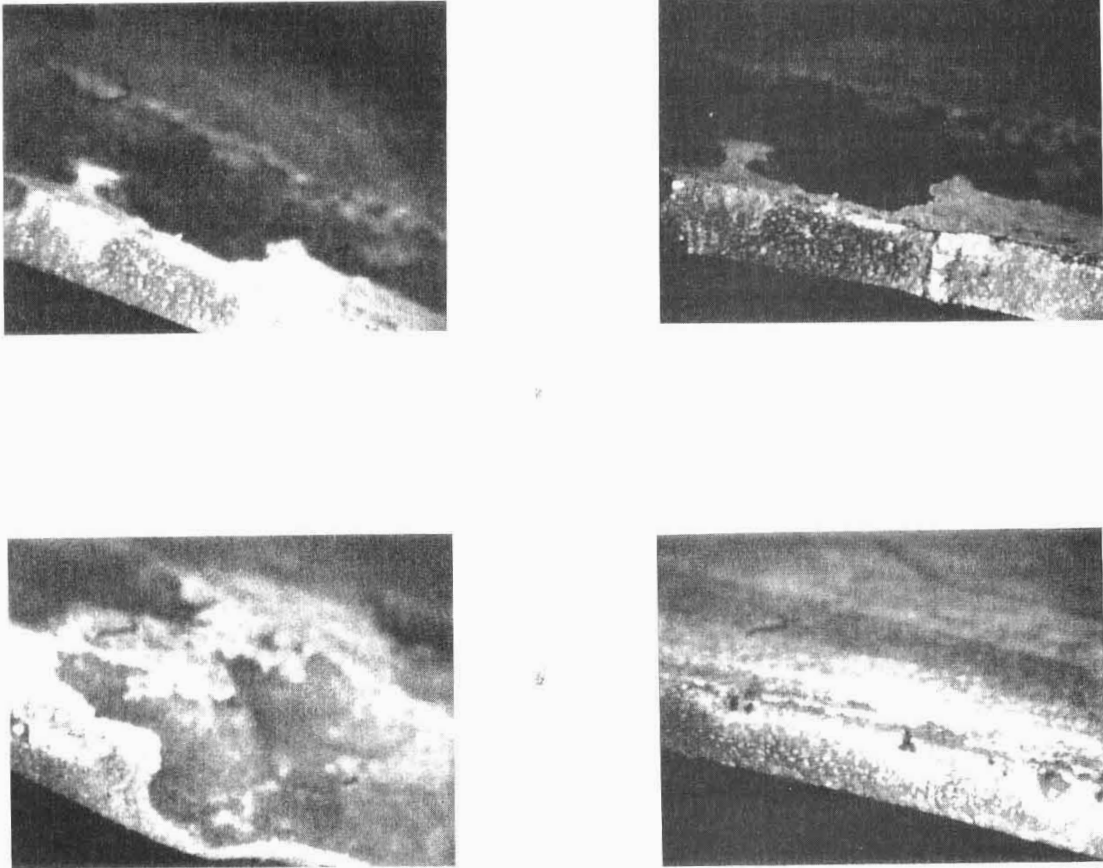
The corrosion resistant oxide films of Cu are easily peeled off by impingement of air cavitation bubbles in cooling water. The pitting corrosion is generated at the locally peeled off area (Erosion-Corrosion or Impingement Attack). This impingement attack happens at the water inlet (Inlet Attack or Inlet-Tube Corrosion). **Fig. 2** shows the mechanism and photographs of erosion-corrosion of outer water Cu jackets (Inlet-Attack) for input coupler ceramic windows. This trouble will be simply solved by using filters and decreasing the water flow rate and air bubbles in cooling water. But water cooling of outer cylinders was stopped for the moment⁴).

Inlet - attack (inlet - tube corrosion)

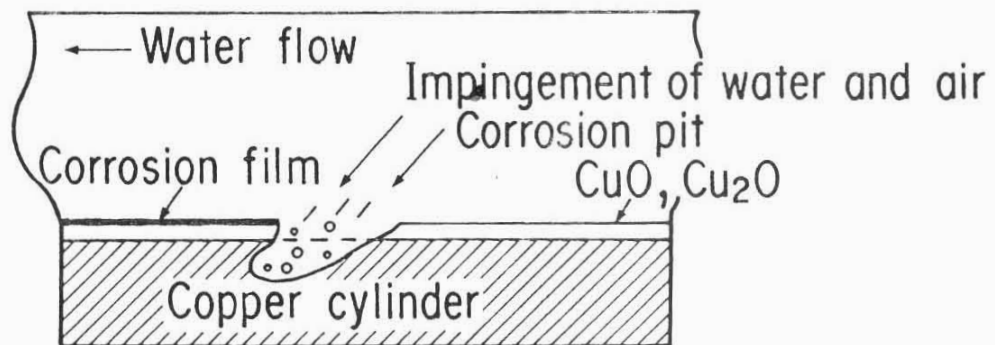
Table 2 shows the analysis results for leaked water in cavities from input couplers, cooling water (used and not used), and final rinsed water after cavity retreatments. A large amount of Mo and Cu contents were included in the leaked water and cooling water for input couplers. Many local erosion-corrosion pits were observed on 1 mm thick Cu cylinders which were brazed to ceramic disks with Mo wires wound.

The corrosion starts at the defect points of the stable protecting films on Cu surfaces and becomes to pitting corrosion. Mo wires are easily corroded by water including air. Mo ions in cooling water accelerate the generation and growth of pitting corrosion on Cu water jackets. The precipitation of molybdate leads to local corrosion of Cu (Deposit Attack).

Erosion - corrosion of Cu outer water jacket at the water inlet

Fig. 2 Photographs and mechanism of erosion-corrosion of outer water Cu jackets for input coupler ceramic windows.

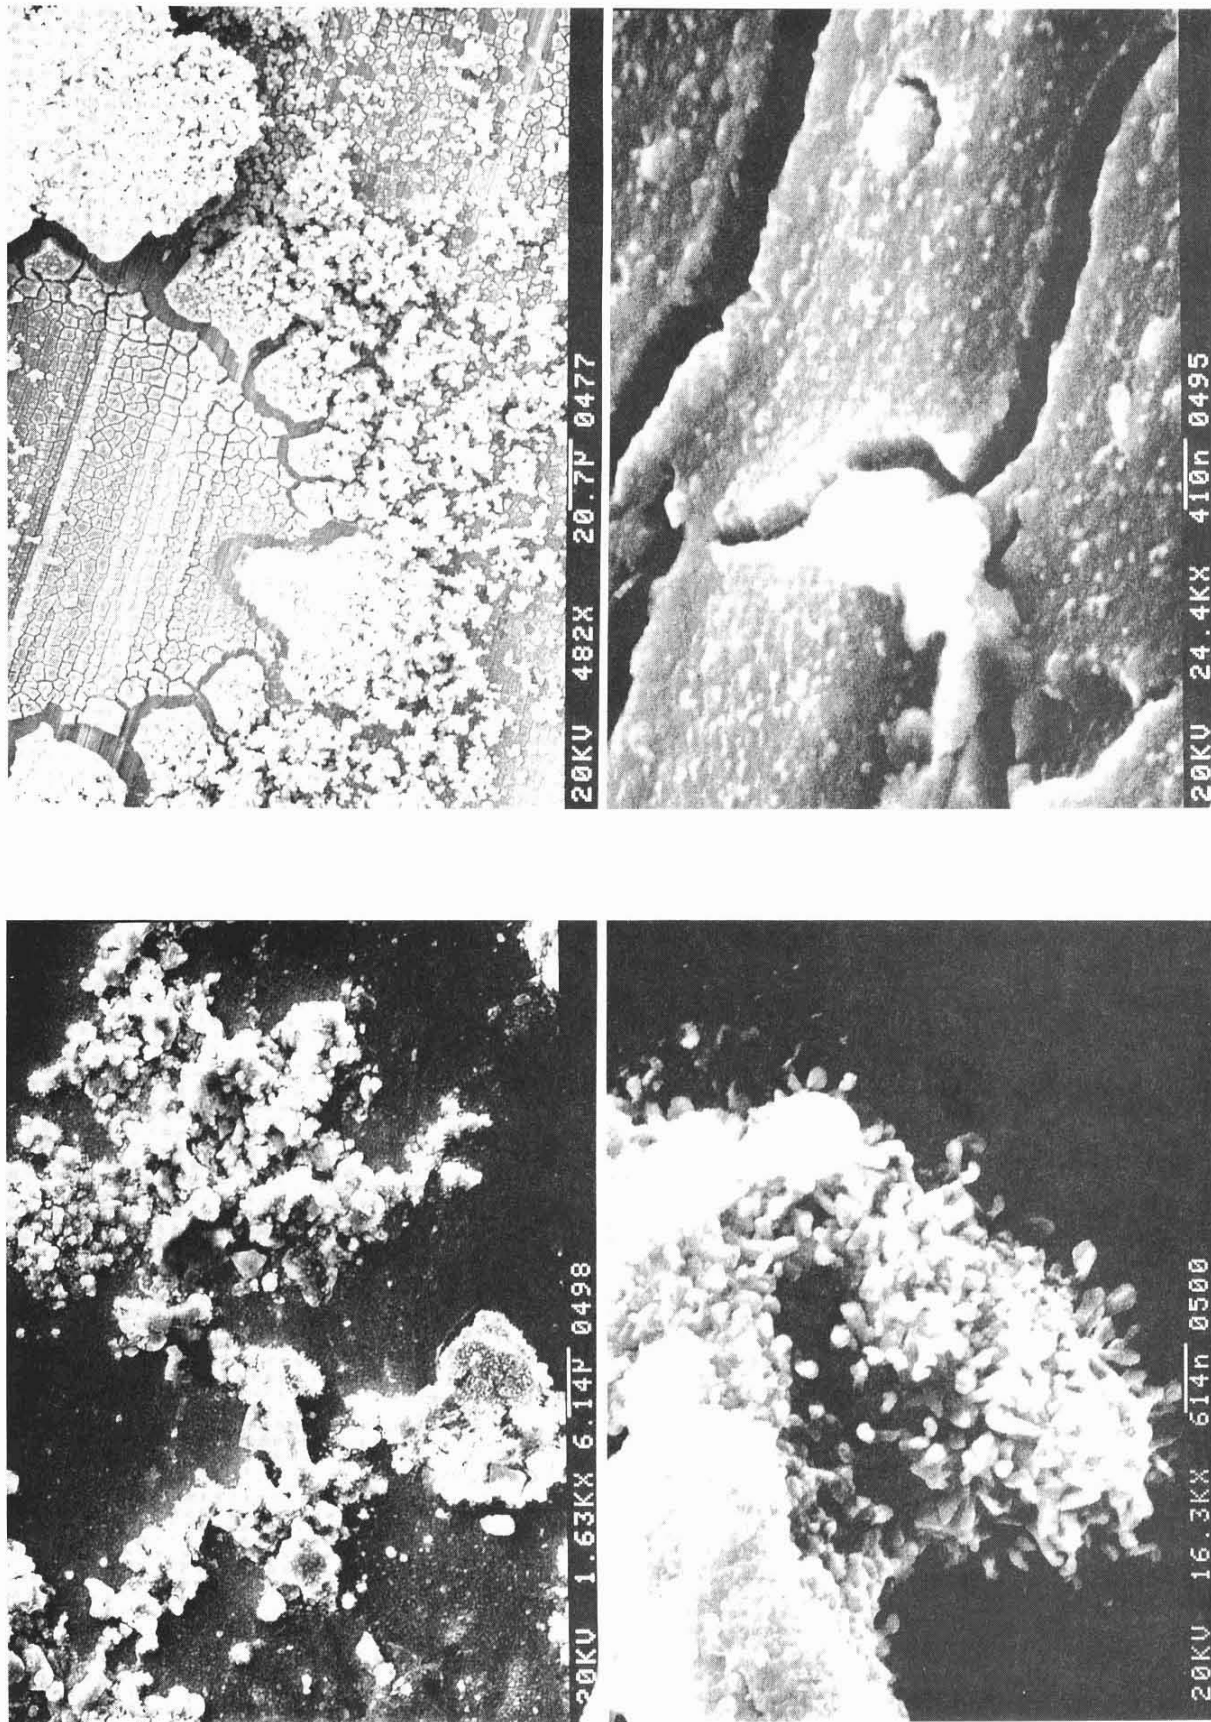
TRISTAN superconducting two 5-cell cavities in one cryostat are connected by a SUS 316L center ring and indium ribbon. We found out the brown color corrosion area on the bottom surface of the SUS 316L center connecting ring for water leaked cavities. One of authors observed the corrosion area using Scanning electron microscope (SEM) at KEK. Fig. 3 shows the typical SEM photographs for the inner and outer surfaces of the SUS 316L ring for water leaked cavities. A large number of pitting corrosion ($1 \sim 30 \mu\text{m}$) was also observed on the outer surface of a new electropolished ring. The stress corrosion cracking and hydrogen embrittlement were observed only for outer surfaces and inner surfaces, respectively, of the rings for water leaked cavities.

(b) outer surfaces – stress corrosion cracking

(a) inner surfaces – embrittlement

Fig. 3 Typical SEM photographs of SUS 316L center connecting ring for water leaked cavities.

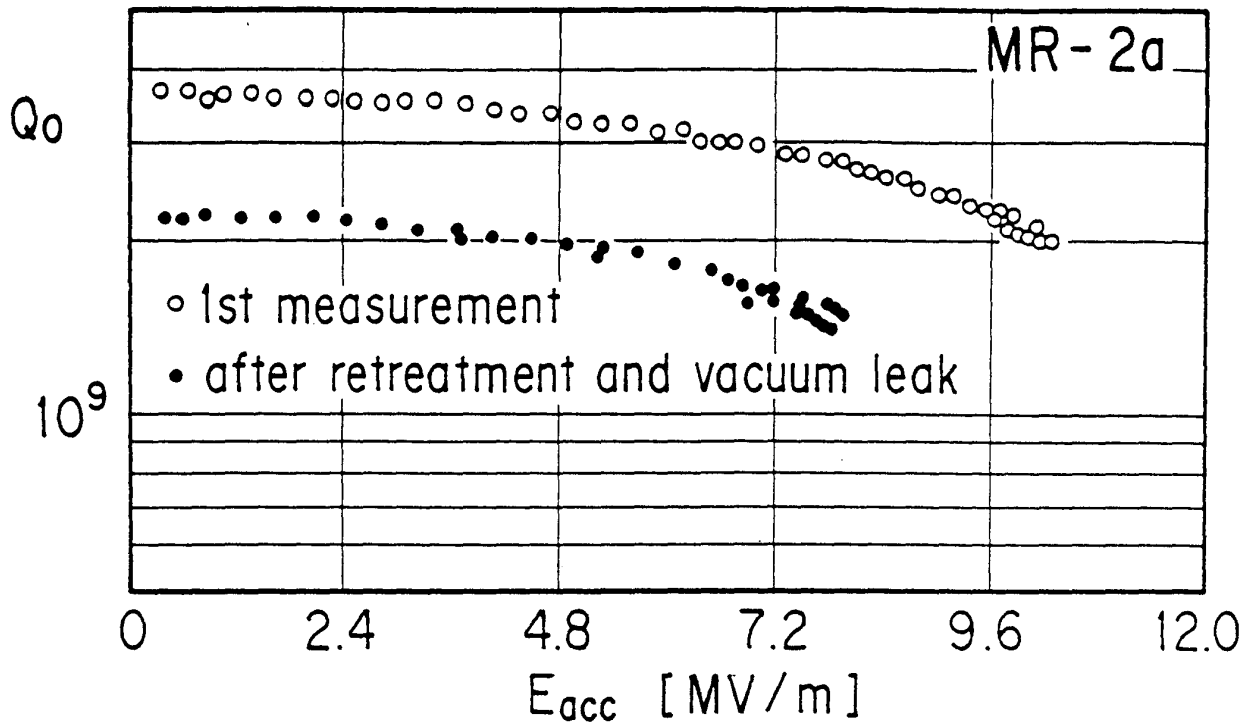
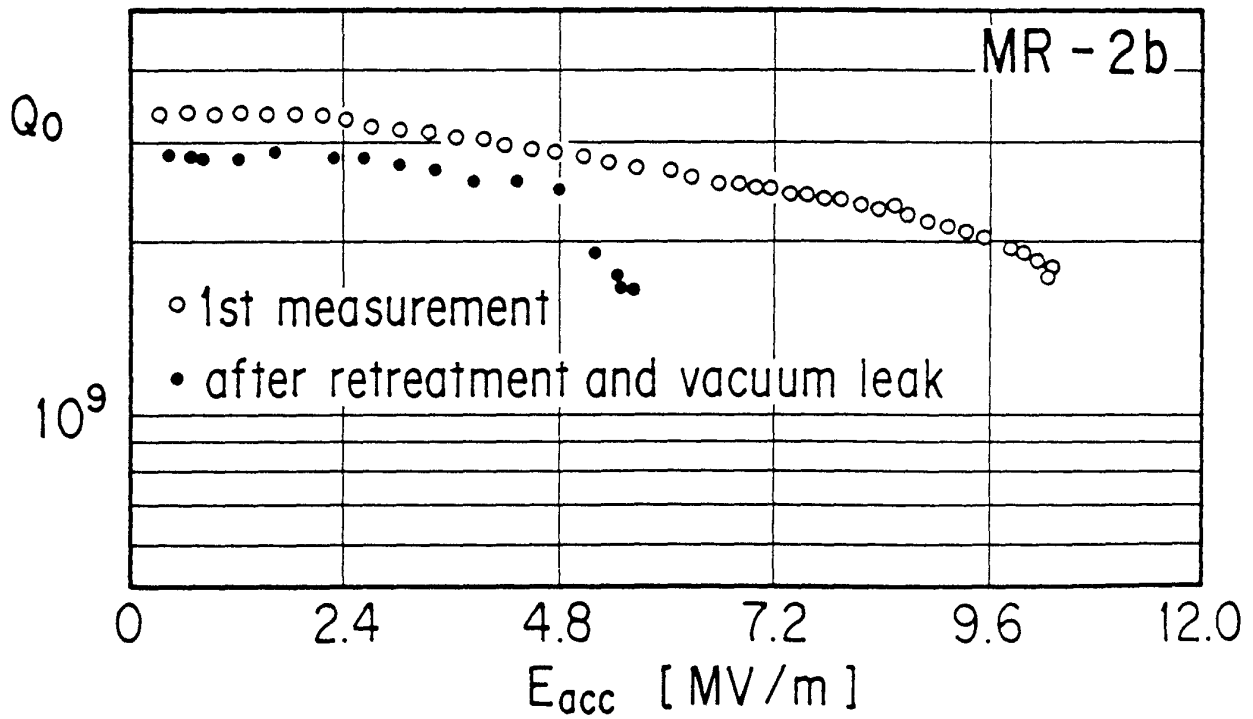
Fig. 4 Q_0 - E_{acc} curves for MR-2 (a,b) cavities.

The MR-2 (a,b) cavities leaked to about 10^{-3} Torr in precooling by liquid N_2 for vertical tests after surface retreatments due to water trouble. Both cavities showed the break down at 7.9 and 5.6 MV/m in vertical tests respectively. The Q_0 values for both cavities were also lower than those for the 1st measurement. After assembling, MR-2 (a,b) cavities showed $E_{\text{acc}}^{\text{max}} = 7.1$ and 4.9 MV/m respectively in the horizontal test⁷⁾. These cavities are set in the test stand outside the tunnel.

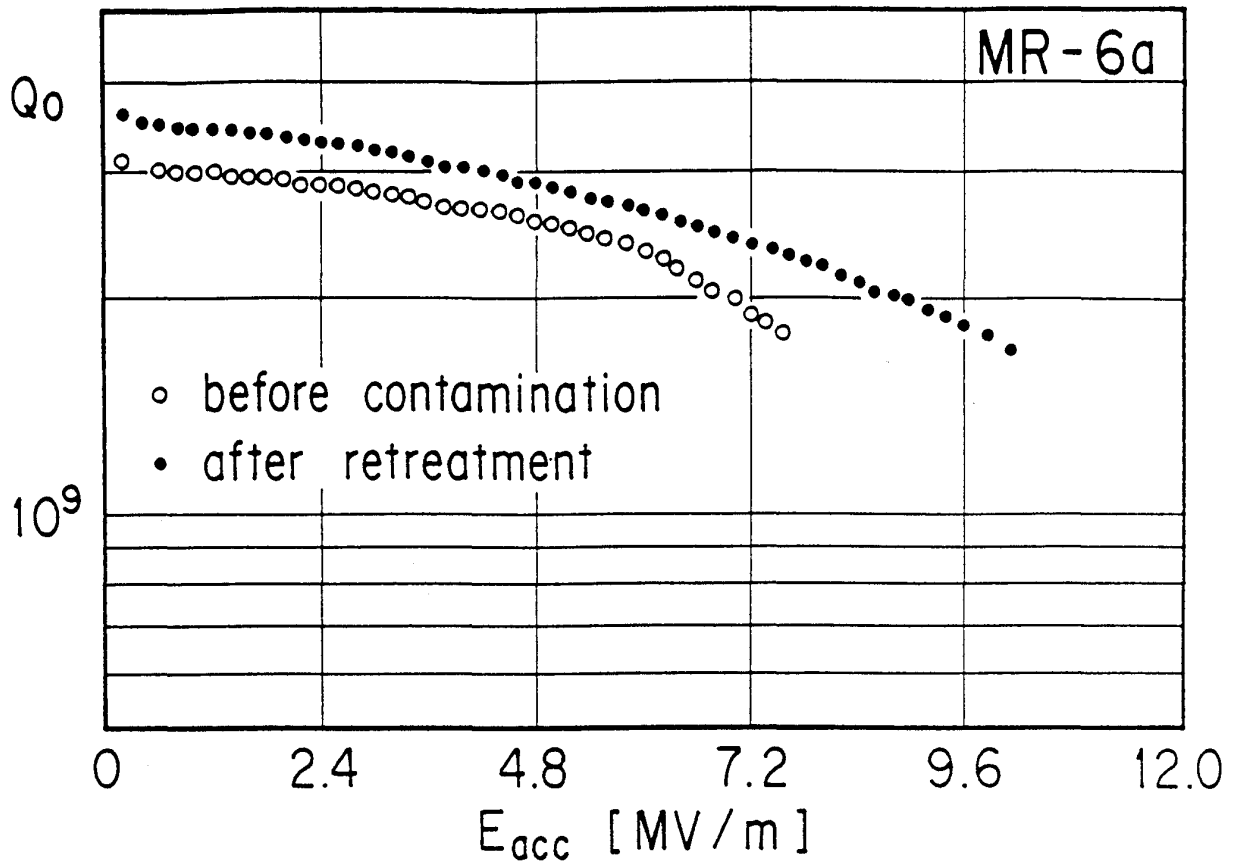
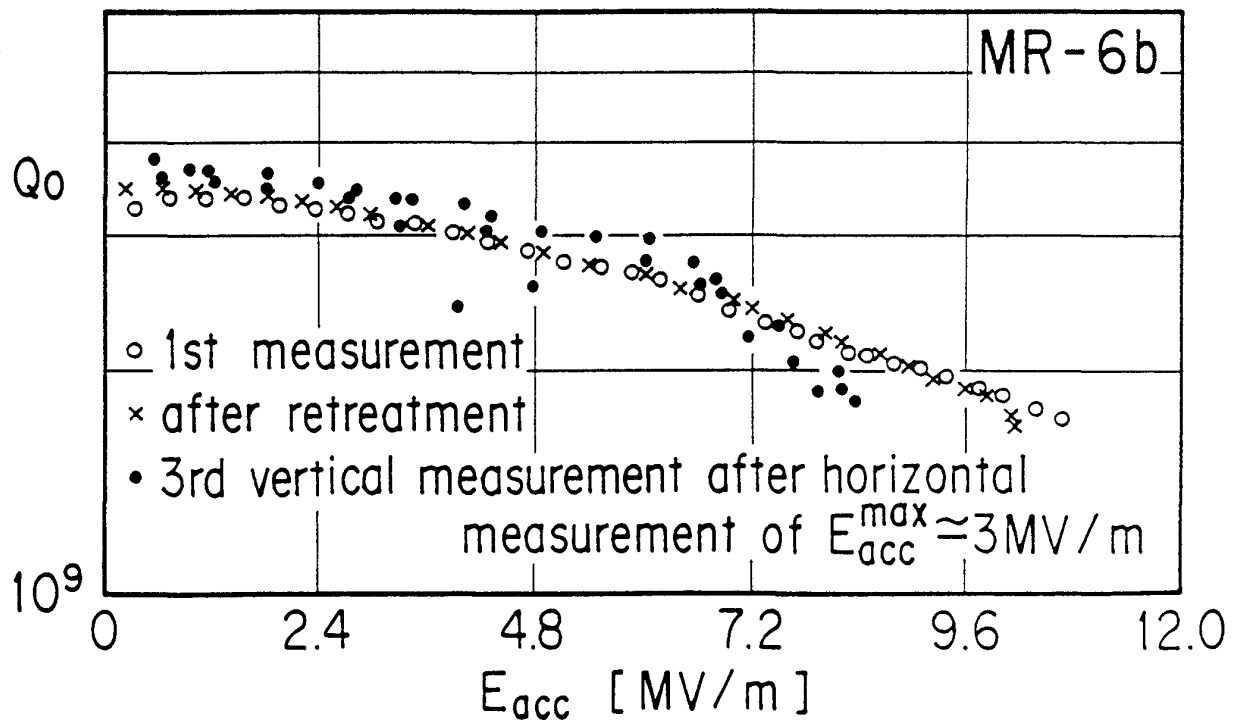
Fig. 5 Q_0 -Eacc curves for MR-6 (a,b) cavities.

A pair of MR-6 cavities showed $E_{\text{acc}}^{\text{max}}$ higher than 10 MV/m after surface retreatments. $E_{\text{acc}}^{\text{max}} > 10.2$ MV/m for the MR-6a cavity was higher than that before the retreatment. The performances for these two cavities were recovered completely in vertical tests. But in horizontal tests, $E_{\text{acc}}^{\text{max}}$ for the MR-6b cavity was limited to 3.0 MV/m⁷⁾. In TRISTAN MR, this MR-6b cavity was detuned because of low $E_{\text{acc}}^{\text{max}}$ ³⁾. We obtained again the high $E_{\text{acc}}^{\text{max}}$ of 8.4 MV/m in the vertical test for this MR-6b cavity without any surface treatment except for RF processing. We suppose that some dust or micro-particles are introduced into the cavity cells during assembling in a clean room. On the other hand, the MR-6a cavity in TRISTAN MR showed the highest record of $E_{\text{acc}}^{\text{max}} = 9.1$ MV/m limited by klystron power⁷⁾.

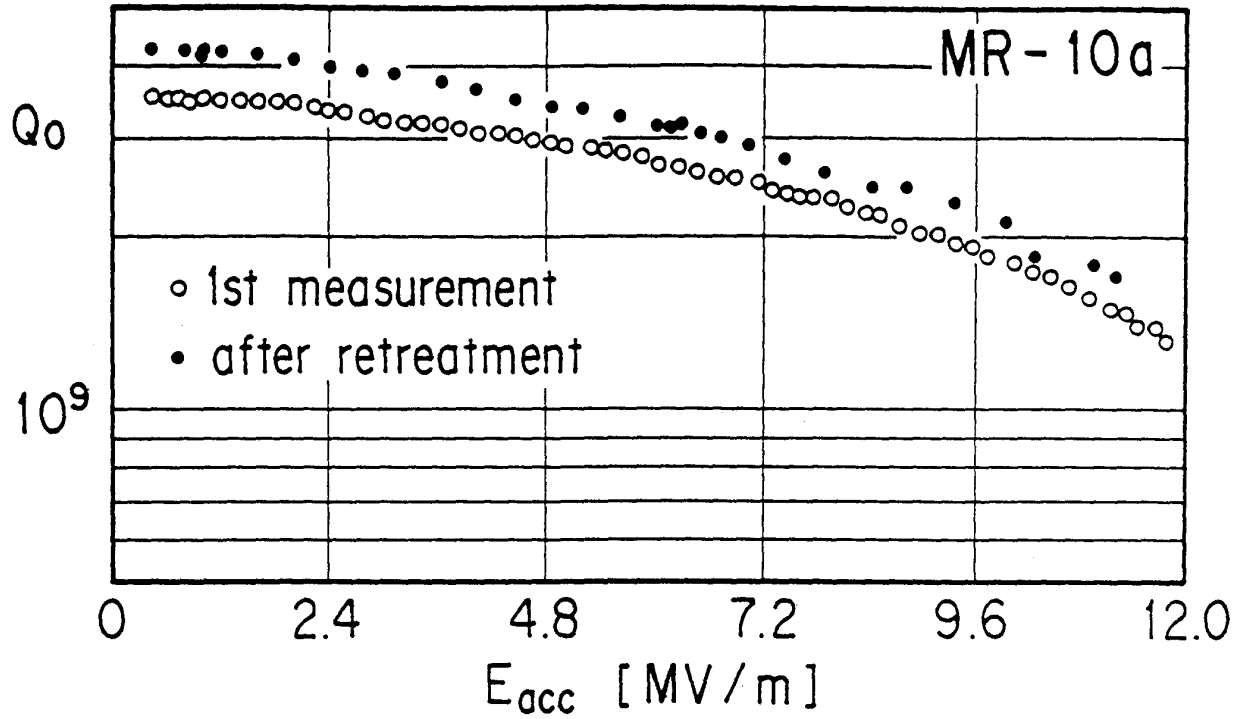
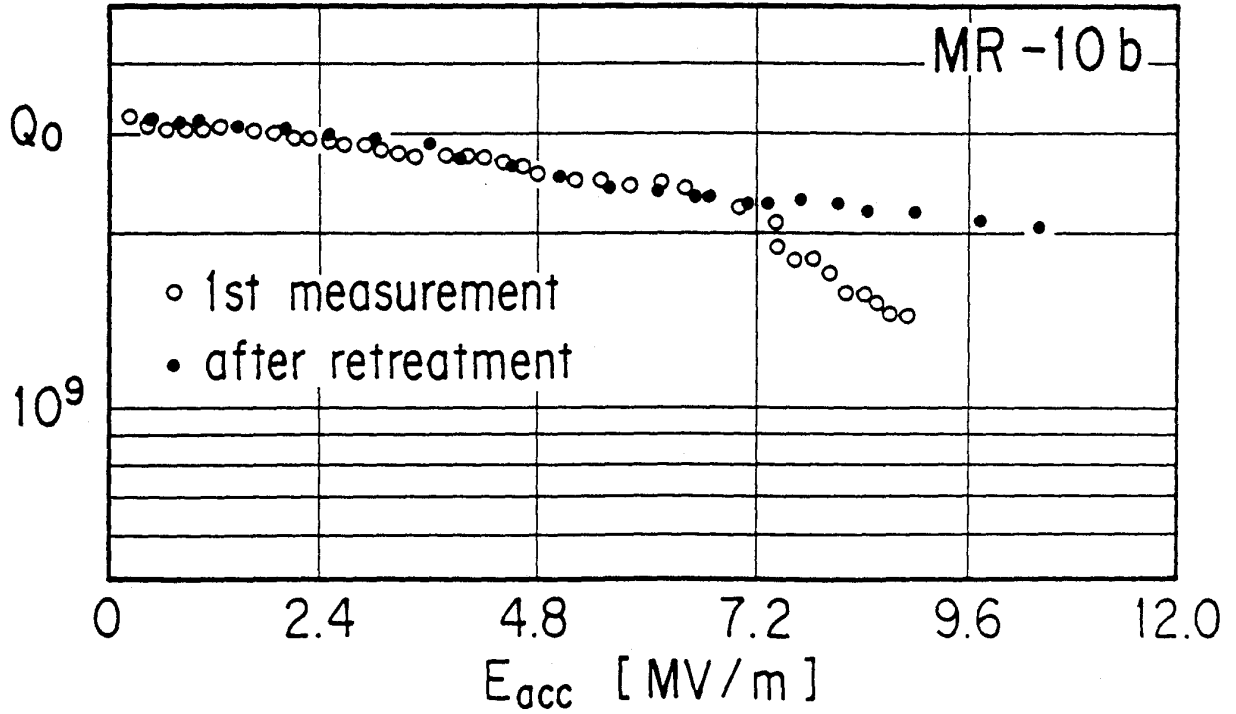
Fig. 6 Q_0 - E_{acc} curves for MR-10 (a,b) cavities.

The MR-10 cavities also showed $E_{\text{acc}}^{\text{max}}$ higher than 10 MV/m in vertical tests after surface retreatments. After installation in TRISTAN MR, $E_{\text{acc}}^{\text{max}} = 6.6$ (10a) and 6.2 MV/m (10b) were obtained in October 1992⁷⁾. After one year operation, these MR-10 cavities showed $E_{\text{acc}}^{\text{max}} = 7.2$ (10a) and 6.5 MV/m (10b) in TRISTAN MR⁷⁾, which were a little higher than before by RF aging.

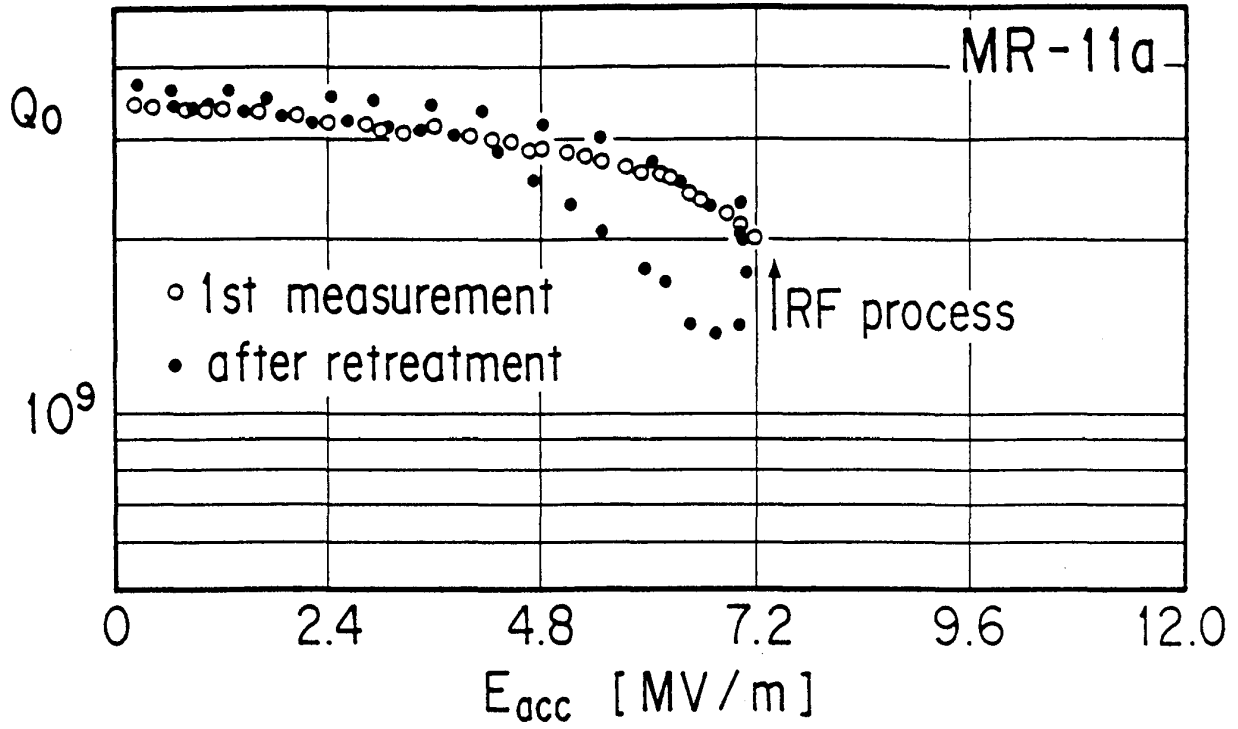
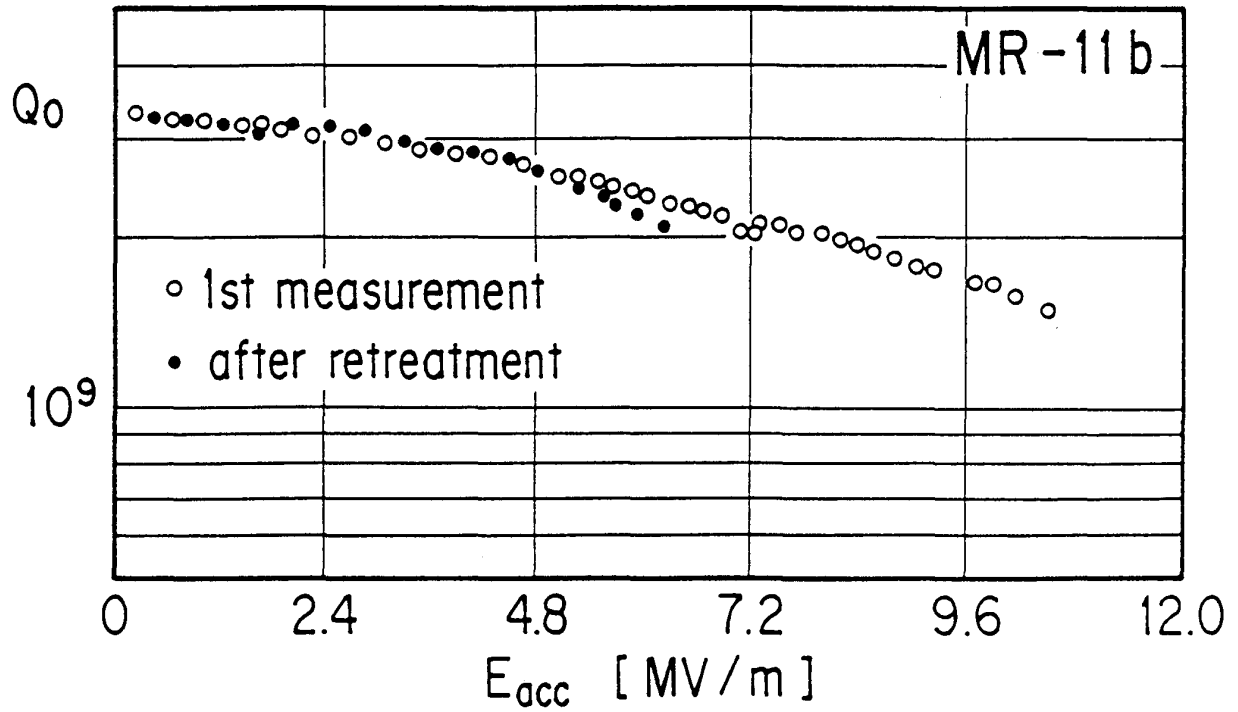
Fig. 7 Q_0 - E_{acc} curves for MR-11 (a,b) cavities.

The MR-11 (a,b) cavities showed the breakdown at 7.0 and 6.2 MV/m respectively in vertical tests after surface retreatments. After installation in TRISTAN MR, $E_{\text{acc}}^{\text{max}} = 6.3$ (11a) and 5.0 MV/m (11b) were obtained in October 1992⁷⁾. After one year operation, these cavities showed $E_{\text{acc}}^{\text{max}} = 6.6$ (11a) and 7.6 MV/m (11b) in TRISTAN MR⁷⁾. One year operation in TRISTAN MR upgraded both MR-10 and 11 cavities after surface retreatments.
