ANALYSIS OF THE COATING SUCCESS RATE IN THE SERIES PRODUCTION OF Nb/Cu SUPERCONDUCTING RF CAVITIES FOR LEP2

K.M. Schirm, E. Chiaveri, B. Thony and W. Weingarten

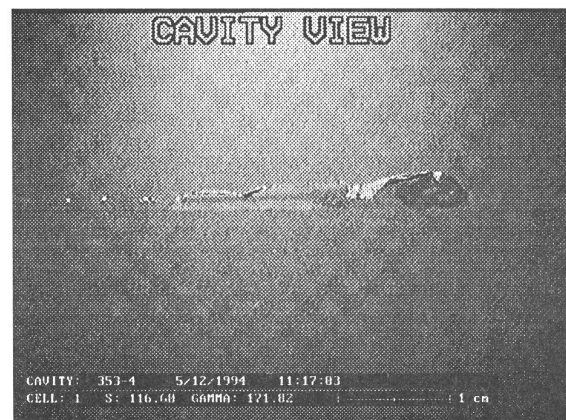
fig. 3.1: detachment with detrimental effect on the cavity performance. (oriented along the cavity axis)

eventually the denudation of the copper substrate. In fig. 3.1 we show one characteristic example. We can clearly observe a copper oxide trace caused by a liquid running from a zone of non-uniform Cu chemical polish downwards (the cavity is in a vertical position during chemical processing and baking).

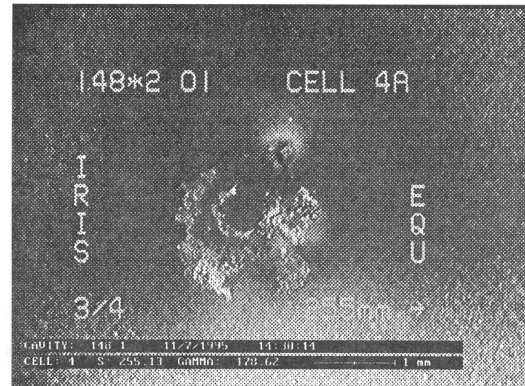
fixed, they can provoke thermal quenching due to a reduced thermal conductivity towards the substrate (see fig. 3.2). Defects of this type can be cured by the video controlled removal of the foreign particle, grinding of the melted zone (fig.3.3) and additional high pressure/low pressure water rinsing. After such a treatment of the defect shown in fig. 3.2 the "quench" was shifted to electric field gradients much higher then the design value, the cavity was therefore recovered without stripping of the Nb layer/new coating.

fig. 3.2: surface defect related to a thermal quench.

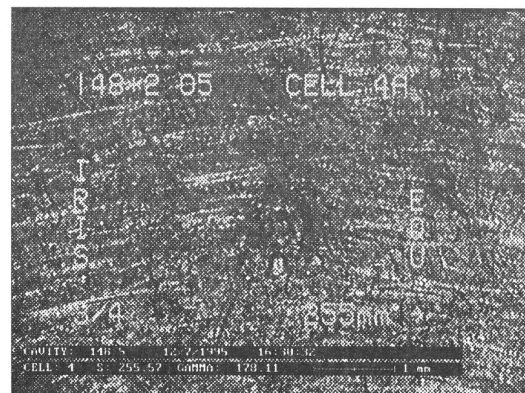
fig. 3.3: same area after grinding before the high pressure water rinsing.

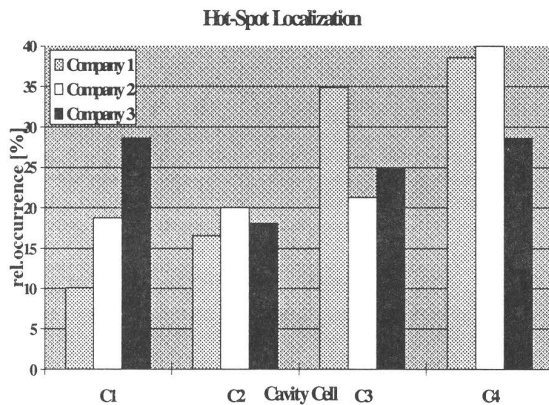
Fig. 3.4: Rel. occurrence of observed hot-spots (>100 mK) in different cells of the cavity. C4 is the upper cell (B-side) in the vertical chemical processing.

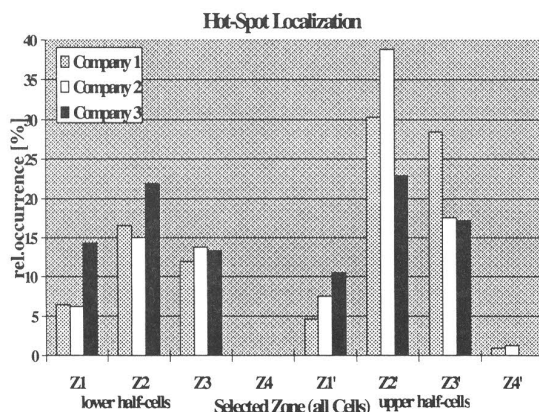
Fig. 3.5: Rel. occurrence of observed hot-spots (>100 mK) in specific zones of the active layer, distinguished between upper and lower half cell in the vertical position.

- almost no hot-spots in the iris region due to the low magnetic fields in that zone and a difficult resistor contact;
- upper zones are more affected than the corresponding lower zones, especially if combined with the result on different cells (s. above);
- company 3 has an increased defect probability in the areas closed to the equatorial welding may be due to the insufficient treatment of welding projections or the handling of the half-shells before and after welding.

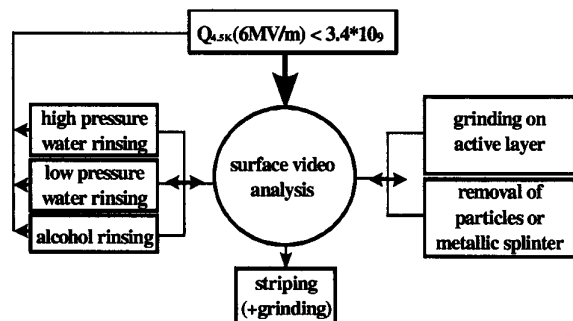
Fig. 4.1: possible recovery action depending on the specific inspection result

for cavity/module recovery. A stripping and new coating should be done only when the Nb layer is detached on areas summing up to more than 1mm^2 . Strong profiles in the copper substrate have to be treated mechanically before the following chemistry/coating. In the other cases we first try to locally work on the defects and combine this effort with local/global high pressure water rinsing and water/alcohol rinsing for cleaning and drying.
