## Microscopic Examination and Elemental Analysis of Surface Defects in LEP Superconducting Cavities

C. Benvenuti, R. Cosso, M. Hauer, N. Hellgren, D. Lacarrère  
*CERN, 1211 Geneva 23, Switzerland*

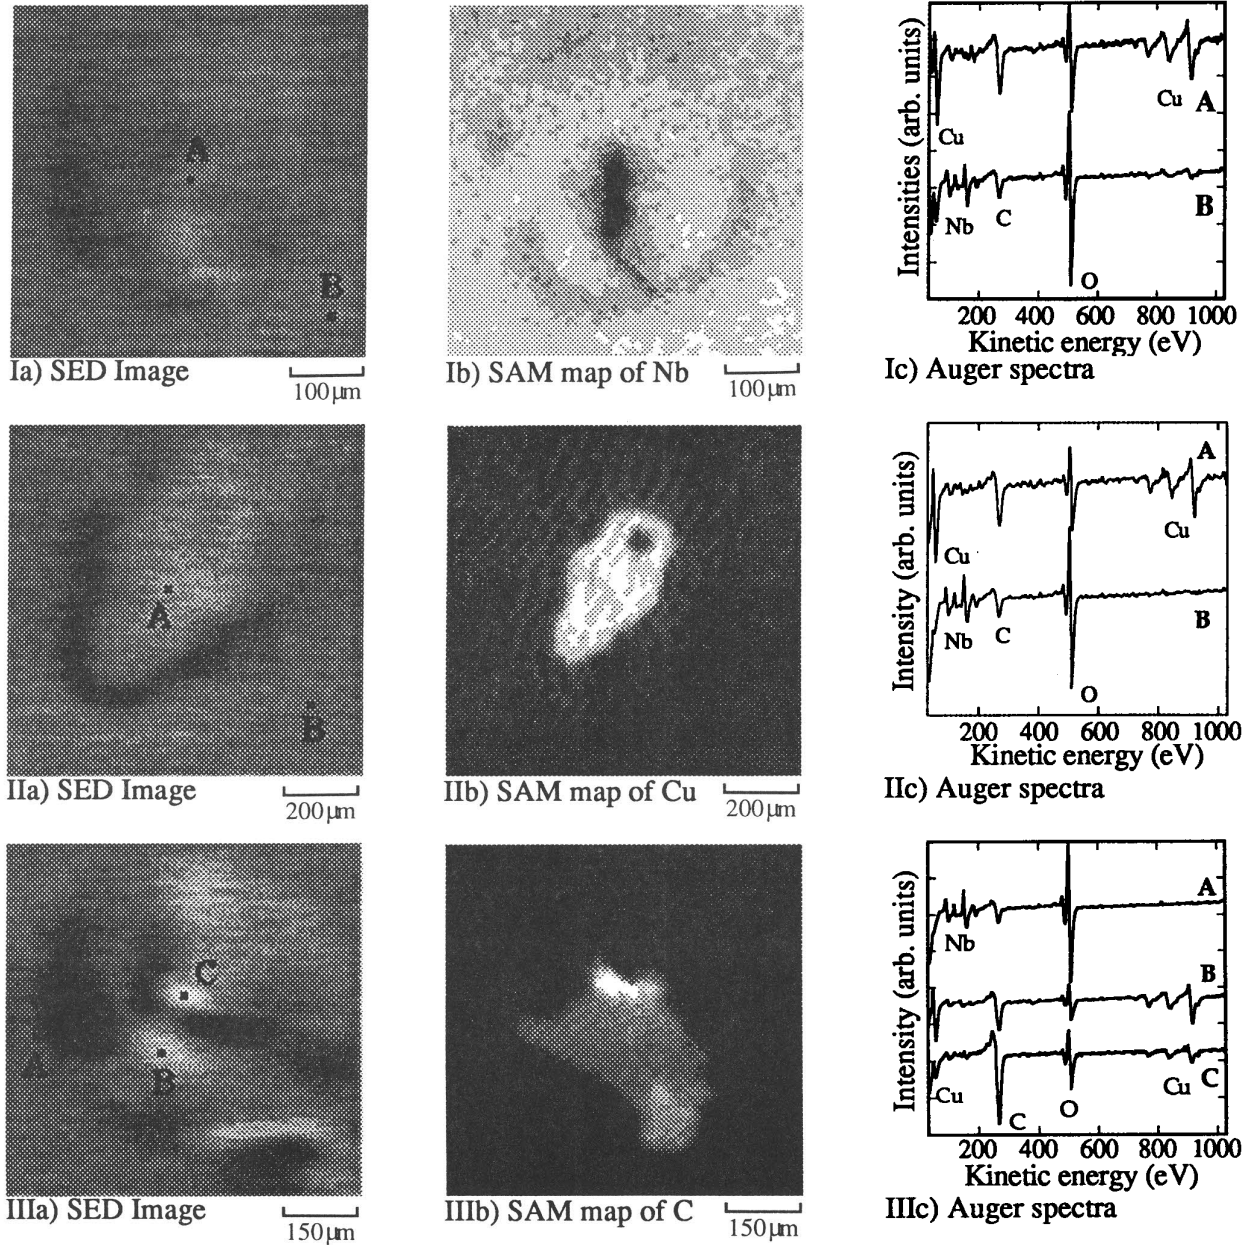
**Fig. 3: Examples of typical defects in Nb/Cu LEP superconducting cavities:**  
 (In the SAM maps, lighter areas correspond to higher concentration of the analysed element)

The most characteristic defects (etching pits, C granules, stains) are illustrated in Fig. 3. In general, it has been possible to correlate the total surface area of these normal conducting defects with the unsatisfactory RF performance of the corresponding cavity.

- I) "Blister"; the film is no longer in contact with the substrate and the Cu is visible at central point.
- II) One of the largest defects detected with Nb-film peel-off.
- III) Film peel-off with C granules.

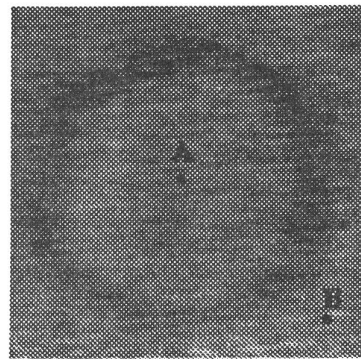
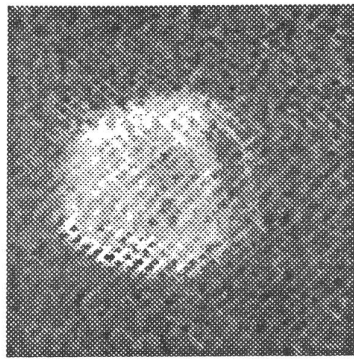
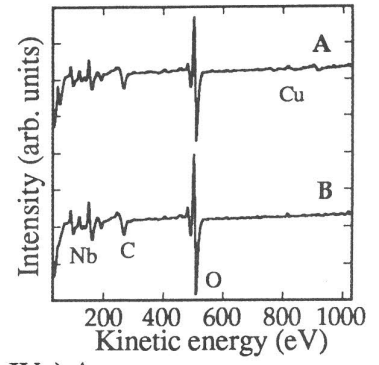
IVa) SED Image 150 $\mu$ m

IVb) SAM map of Cu 150 $\mu$ m

IVc) Auger spectra

IV) "Stain"; the Nb film is still present but some Cu is detected.

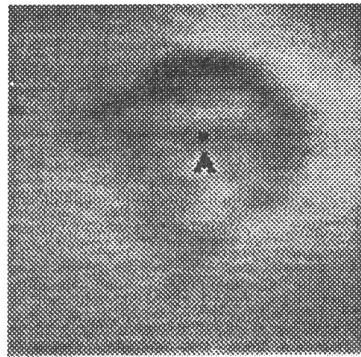
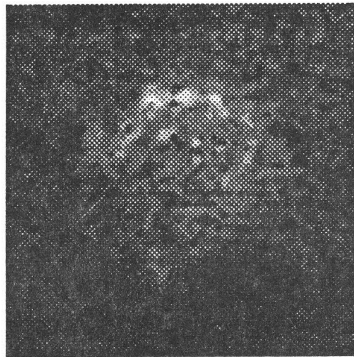
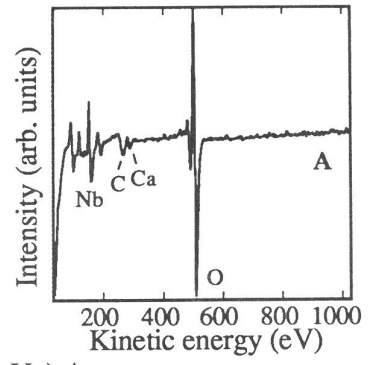
Va) SED Image 150 $\mu$ m

Vb) SAM map of Ca 150 $\mu$ m

Vc) Auger spectra

V) Surface defect with Ca contamination.

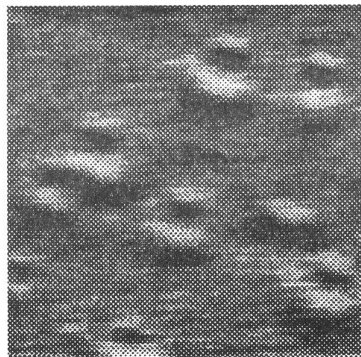
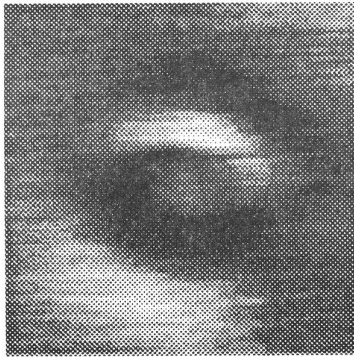
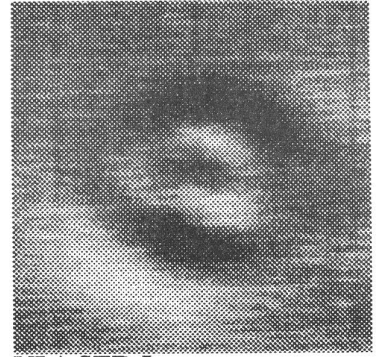
VIa) SED Image 400 $\mu$ m

VIb) SED Image 100 $\mu$ m

VIc) SED Image 100 $\mu$ m

VI) "Etching pits", covered with the Nb film.
