TRIUMF RF SYSTEM - INITIAL OPERATING PROBLEMS AND THEIR SOLUTIONS

R.H.M. Gummer, R.L. Poirier and M. Zach  
 TRIUMF, Vancouver, Canada

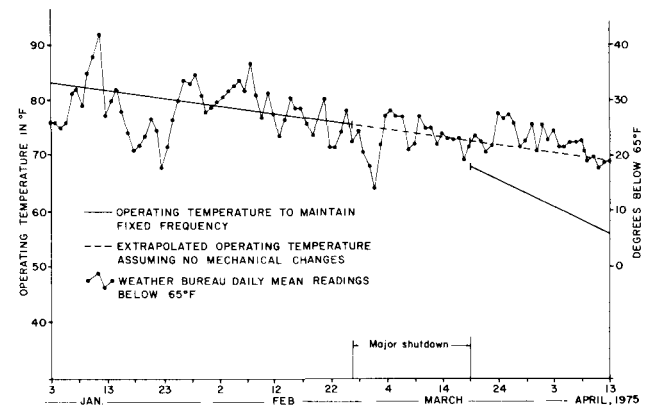
Towards the end of April the cooling water had been reduced to the minimum attainable, so it became impossible to operate the RF system at the correct frequency. During a cyclotron shutdown in May the resonator segments were realigned and adjusted to give 23.05 MHz with the cooling water at 80°F. Since then the correct frequency has always been attainable with small adjustments to either the water temperature or pressure. A pressure adjustment has the advantage of almost immediate response, without the 2 min delay and initial reverse effect which occurs on a temperature change.

Fig. 3. Resonator operating temperature and air temperature as a function of time.
