SUPERCONDUCTING CYCLOTRON MAGNET COIL SHORT\*

M.L. Mallory, H.G. Blosser, D.J. Clark, H. Laumer, D. Lawton, P. Miller and F. Resmini

National Superconducting Cyclotron Laboratory, Michigan State University, East Lansing, MI 48824, USA

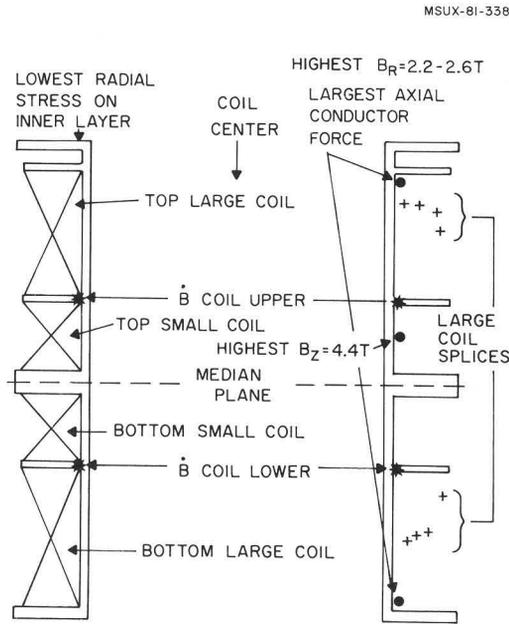
Fig. 1: A schematic drawing of the K500 cyclotron superconducting coil is shown. The complete coil has two large and small coils placed symmetric to the cyclotron median plane. The + denote wire splices within the large coils. The positions of the small coil splices were not recorded. The position of the flux sensing loops are shown. The maximum axial conductor force occurs in the large coils at the inside corner furthest from the median plane. The lowest radial pressure occurs for the inner layer of both small and large coils.

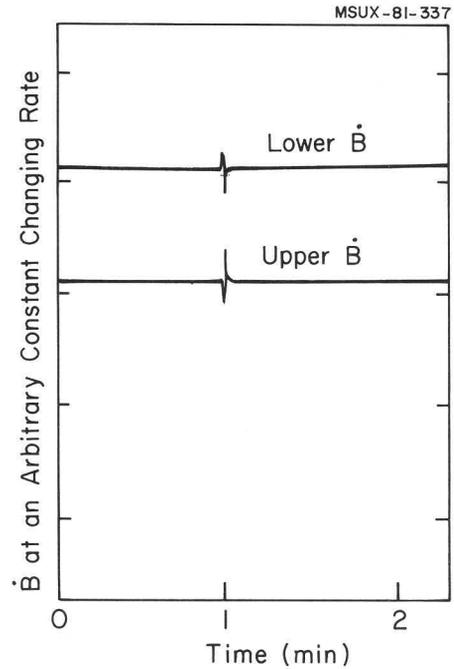
Fig. 3: The recorded signals of the  $\dot{B}$  coils, position indicated in Fig. 1, are shown. The magnet is charging at a constant rate, (the power supply can be adjusted to produce a constant current ramp of up to 10 amp/sec. in the large and small coils subject to voltage limitation at low fields). A transient short event is detected and gives an opposite sign in the flux rate of change between the bottom and top B coils.

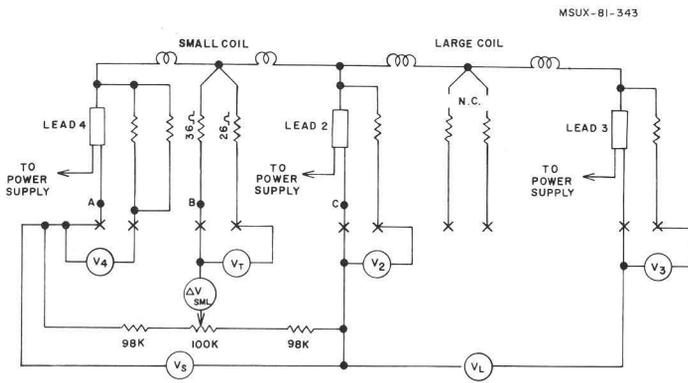
Fig. 2: The voltmeter connections are the following:  
 $V_S$  = small coil total voltage  
 $V_L$  = large coil total voltage  
 $\Delta_{SML}$  = small coil, upper/lower difference  
 $V_2$  = current lead 2 voltage drop  
 $V_3$  = current lead 3 voltage drop  
 $V_4$  = current lead 4 voltage drop  
 $V_T$  = center tap short test meter  
 Points A, B, C, are the positions where intentional shorts across the coil were made. (The center taps of the large coil (N.C.) were burned out in a very early failure of the magnet current lead (1); at that time the magnet coils were connected to a common center lead (2)).

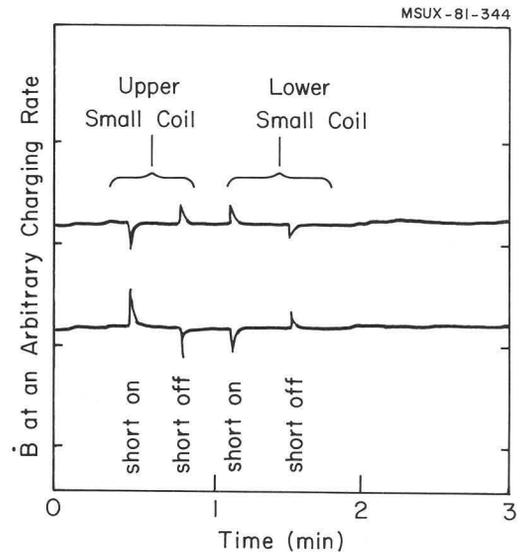
Fig. 4: The upper and lower  $\dot{B}$  coils are shown for a constant magnet charging rate. The detected  $\dot{B}$  signals occurred when a deliberate short was made across the upper and lower small coils. The polarity direction of the upper coil simulated short has the same sign as the transient short events observed in the magnet.

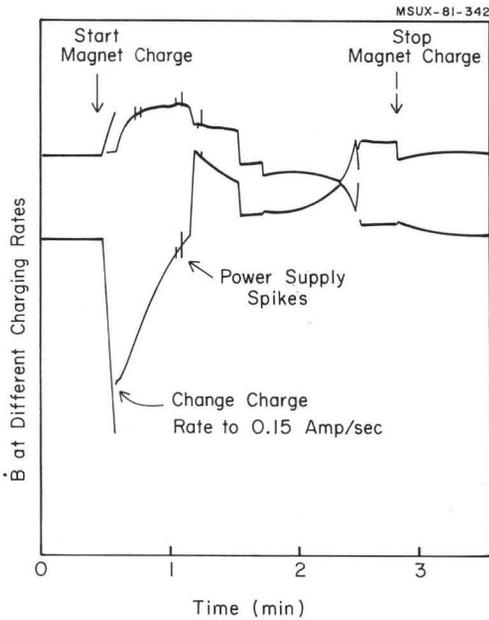
A hard short, the condition of a continuous short, could be produced in the coil by charging the magnet up to maximum field with 800 amperes in the small coil and 600 amperes in the large coil and then swapping current between the large and small coil. The swapping of current results in a small change in magnet field, but a large change in forces on conductors. An example of the B data for a hard short is shown in Fig. 5 and indicates large flux deviations of up to 10,000 ampere turns. Figure 6 is a B measurement made at the beginning of charging the magnet with a hard short present. The asymmetry in the B data is larger when charging the large coil and there is a time lag in the upper B loop relative to the lower; these data then support a "short-in-the-upper-large-coil" hypothesis.

Fig. 5: The  $\dot{B}$  coils are shown for the case of a "hard" short in the magnet coil. Large flux changes are detected as the magnet is charged. Models of superconducting loops being driven up to the current sharing mode and then decaying can be proposed for these fluctuations and also for the generation of a heat load on the liquid helium bath. The hard short effects can be altered by changing the magnet charging rate and by stopping and letting the superconducting flux loops decay.

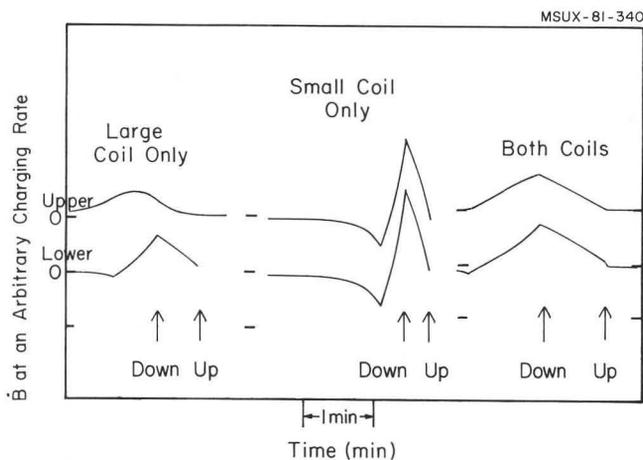
Fig. 6: The  $\dot{B}$  coils are shown for three charging cases of the magnet, starting with the current at zero ampere. The small coils give an almost symmetric pattern whereas the large coil shows a very asymmetric pattern. The upper  $B$  signal appears to initially resist charging as the current is increased in the large coil and then after charging stops and the current is decreasing to zero the upper  $B$  coil shows the short acting to maintain the flux before finally decaying. For both coils charging, the asymmetry is still detectable. These results support the hypothesis that the hard short is in the upper large coil. Increasing time is to the left.

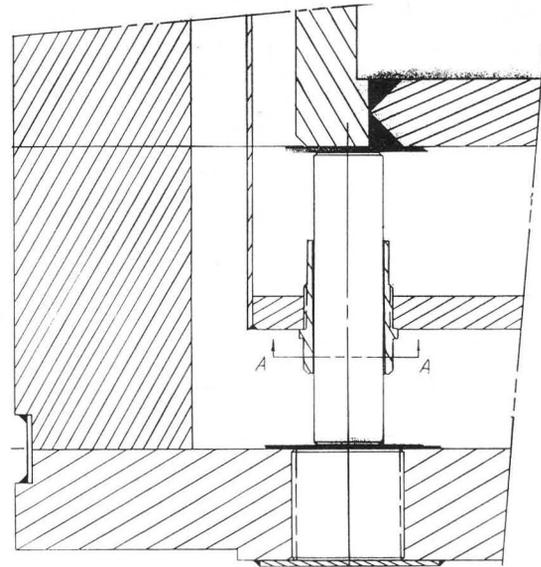
Fig. 7: The mechanical drawing of a lower bumper is shown. The bumpers are made of titanium and are in sliding contact with the liquid nitrogen shield. Coil motion is limited by the bumpers therefore protecting the relatively fragile fiberglass links on the main coil support system from excessive loads.

If the short were driven by a large voltage such as in a quench or if additional turns were to short, it is conceivable that the force imbalance could exceed the breaking strength of the support link system. To guard against this a backup "bumper" system has been installed in the coil. Figure 7 is a drawing of a typical bumper, the system is designed to come into contact with the coil and take over the support load before the links exceed their breaking points.
