MICRON SIZE FILTERS IN LIQUID HELIUM TRANSFER LINES

M.L. Mallory, H. Laumer, A. Gavalya, J. Yunker, R. Zarobinski, J.A. Nolen  
NSCL, Michigan State University, East Lansing, Michigan 48824

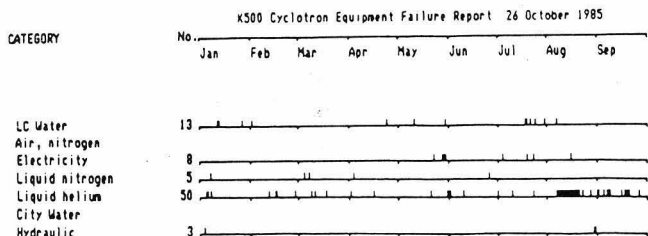
After a planned upgrade of the K500 cyclotron, during July 1985, the startup of the accelerator in August was characterized by an increased rate of occurrence of cryogenic problems. Figure 1 illustrates this, where each tick mark as a function of time shows an accelerator cryogenic problem resulting in a delay of K500 operation. A major effort at understanding

Fig. 1 The equipment failure report of the K500 cyclotron showing the increase in incidents due to problems with the liquid helium distribution system.

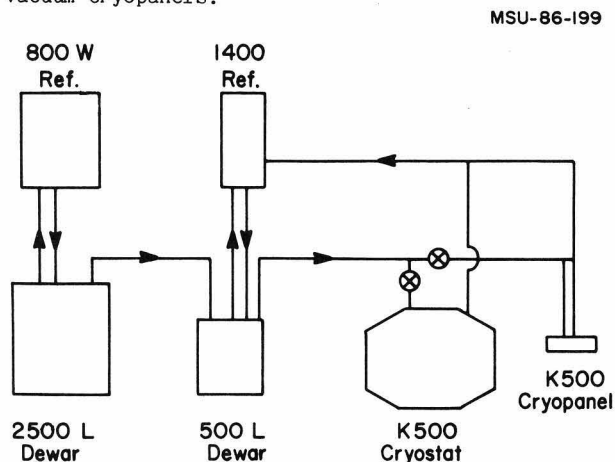
The first indication of a cryogenic distribution problem was a decline in liquid helium level of the K500 cryostat. This decline in level was diagnosed to be due to a plug in the cryogenic distribution system. The normal procedure to open a plugged line is to stop the helium distribution, warm up and purge the transfer line. This requires considerable time. After experiencing several of these line plugging episodes, pressure tap points were added along the distribution line and were continuously monitored. The information from the pressure sensors concurred with the line plugging assumption and tended to indicate that one section of the distribution system was the major plugging point. Also in this operational period it was found that the plug could be removed by the simple procedure of just stopping the transfer for one to five minutes. This procedure was christened as "burping" the transfer line. In fig. 3 the pressure drop is shown across a section of transfer line as a function of time. A sample of burping the line is also shown.

Fig. 2 A schematic drawing of the liquid helium distribution to the K500 cyclotron. The plugging was first located in the valve going to the K500 cryostat.

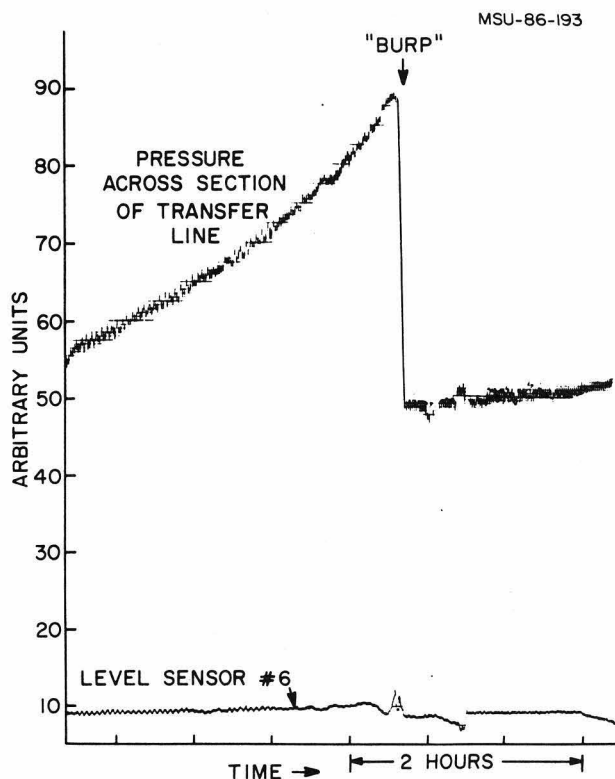
Fig. 3 The pressure across the helium transfer line versus time is shown. The dewar pressure is about 10 psig and the cryostat is ~6 psig. A short closing of the cryostat valve (burp) would restore the transmission of the liquid helium to the cryostat. The liquid helium level in the cryostat is also shown and reflects pressure changes in its level.

This burping procedure allowed cyclotron operations to be interrupted for a shorter time period, varying from

5 minutes to 1 hour. However the intervals between burping the line varied from 3 to 8 hours still resulting in a considerable down time problem.

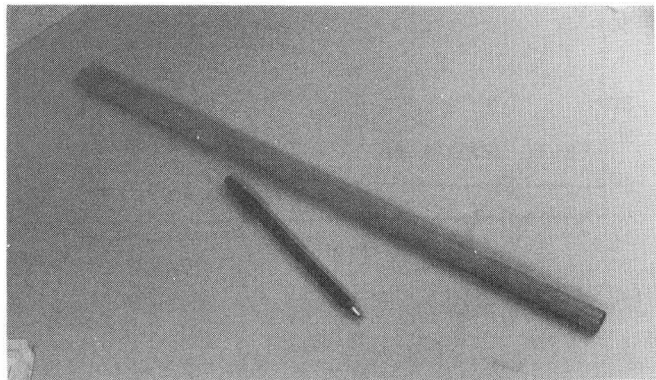
Fig. 4 A photograph of the 2 micron stainless steel filters is shown. It is 18" long and 1/2" in diameter. The liquid helium pressure drop across it is undetected.

Next a 2 micron filter with a large  $C_v$  was located<sup>1</sup> and it is shown in fig. 4. This filter could be inserted into the bayonet end of the transfer line connecting the 800 watt refrigerator dewar to the K500 storage dewar and resulted in successful line operation.

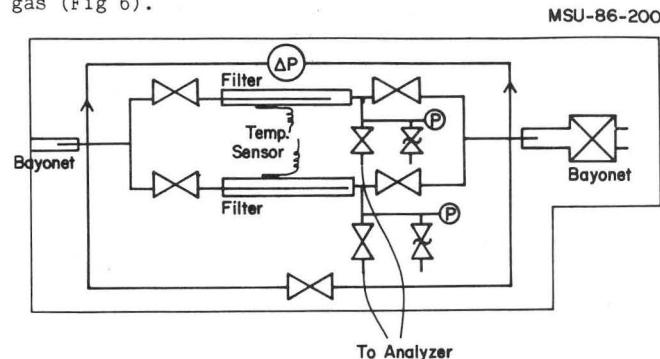
Fig. 5 A schematic drawing of the filter box built to measure what is being trapped in the filters is shown.

A filter box shown schematically in fig. 5 has now been built. It has dual filters and isolation valves. A sample line that connects to an optical spectrometer<sup>2</sup> is provided. This filter box has been installed in the transfer line to the K800 magnet. The K800 line had also shown evidence of plugging. The first attempts at analyzing material trapped in the filter box has indicated an increase in neon and hydrogen content versus samples of the ambient helium gas (Fig 6).

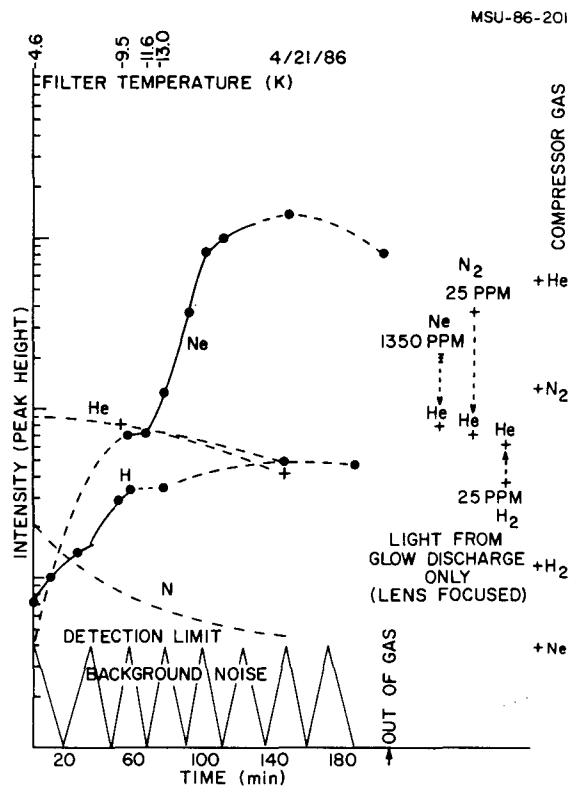
The cryogenic system has now operated with a filter for a period longer than six months and system plugging problems have been non existent during this period. Continuous monitoring of the neon gas contaminate shows that the system purifies itself. After resupplying the system with new helium gas, the neon contaminate increased to ~ 25 ppm. A verification experiment of the filters removal capability was performed, when they were removed after the new helium gas with large neon contaminate was added to the system. The transfer line plugged after several days. Insertion of the filter slowed down the plugging rate and after 1 week the problem had again completely disappeared. All our present data indicates that the neon gas contaminate in the helium gas is the source of the plugging problem.

Fig. 6 The relative intensity of the spectrometer lines for material trapped in the 2  $\mu$ m filter is shown as a function of time after isolating the filters. Also the filter temperature is correlated with time at the top of the graph. The graph indicates that neon is trapped in the filter in large quantities. To the far right is the measured impurities of the compressor gas and next to it various measurements of known calibration gases.
