MULTIPACTOR PROBLEM OF J-PARC SDTL

Takashi Ito[†], Takatoshi Morishita, Jun Tamura, JAEA/J-PARC, Tokai-mura, Japan
K. Nanmo, Takashi Sugimura, KEK, Tukuba, Japan

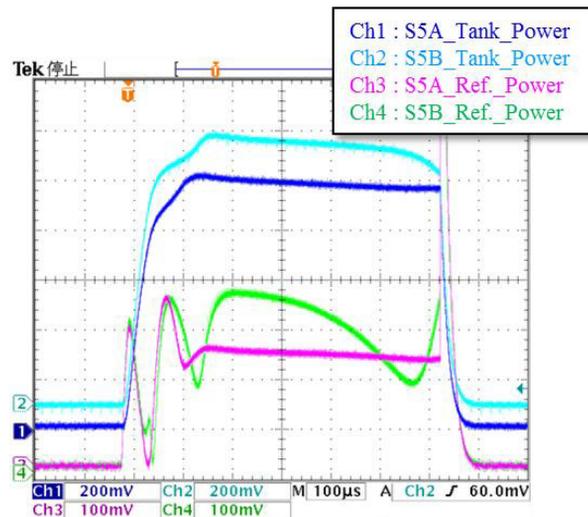
In the multipactor region, the rf power reflected by a cavity increases abnormally. The rf macro-pulse waveform takes on a strange shape in the multipactor region. Figure 1 shows the typical macro-pulse waveform of SDTL05A and 05B in the multipactor region. The blue and the cyan waveforms denote the tank power, and the magenta and the green waveforms denote the reflection power. These waveforms are extremely distorted, and the rf amplitude and phase are unstable in this power region. In addition, vacuum pressure in the tank increases from 10^{-6} Pa to 10^{-5} Pa due to outgassing by the multipactor.

Figure 1: Macro-pulse waveform of SDTL05A and 05B in multipactor region.

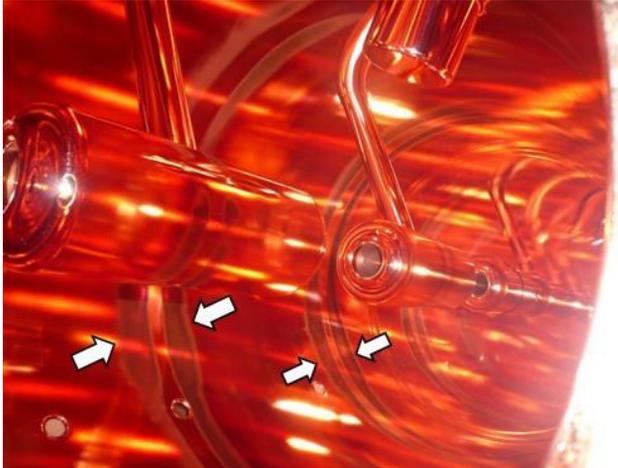
Figure 2 shows a photograph of the inside view of the SDTL05B cavity. As shown in this photograph, there are two circumferential discolored bands on the inner surface at each drift tube (DT) gap position.

Figure 2: Photograph of inside view of SDTL05B. The arrows show the discolored bands.

We thought that one of the causes of the multipactor effect was contamination on the inner surface of the cavity. Before the earthquake, a rotary oil pump was used from SDTL01A to 06B. We suspected that an oil component was adhered to the inner surface derived from the rotary pump.

It was thought that the multipactor region expanded because the level of contamination of the inner surface worsened as the interior of the SDTL was exposed to air owing to destruction of the beam monitors and the bellows due to the earthquake [5].

Then, based on observation of the inner surface and the simulation, we decided to clean the inner surface of SDTL05A, 05B, 06A, and 06B. We used acetone to remove the oil component from the inner surface. As shown in Figure 4, the surface was densely covered with adhering foreign substances, mostly the oil component.

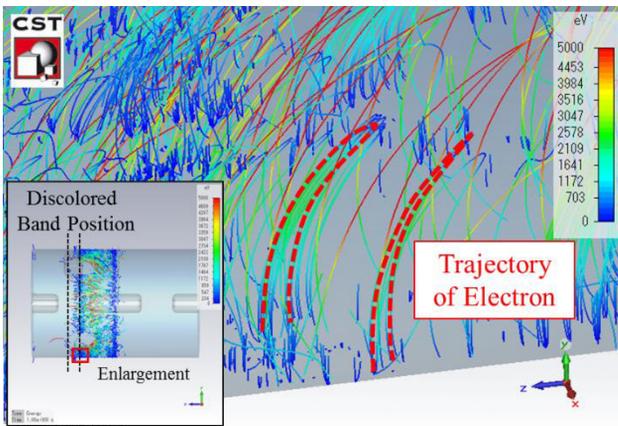
The particle tracking simulation (CST PARTICLE STUDIO) was conducted in the peripheral areas such as rf coupler, tuner, and DT, but we could not find any multipactor condition in these places. Then, we conducted the simulation by focusing on the cavity wall. The simulation showed the occurrence of one-point multipactor at the same position as the observed discolored bands within the reasonable rf amplitude range. Figure 3 shows the simulated trajectory of electrons. The electrons return to the generated area.

Figure 3: Example of particle tracking simulation.

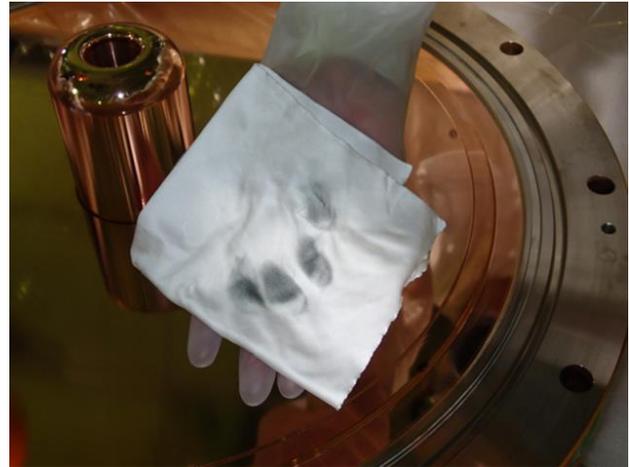
Figure 4: Wiping cloth after wiping inner surface of end plate of SDTL05B.

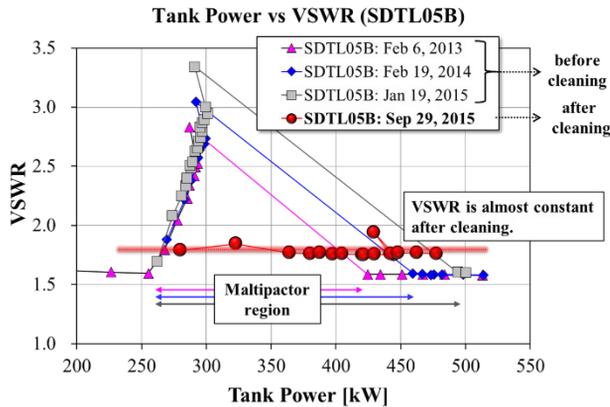
Figure 5 shows VSWR as a function of tank power before and after cleaning of the SDTL05B cavity. Before the cleaning, as the tank power increased, VSWR increased in the multipactor region. After cleaning, the multipactor region disappeared, and VSWR was almost constant over the entire tank power region. Therefore, SDTL05B can be operated in all power regions. The multipactor problem has not reoccurred ever since.

Figure 5: VSWR as a function of tank power before and after cleaning (SDTL05B).

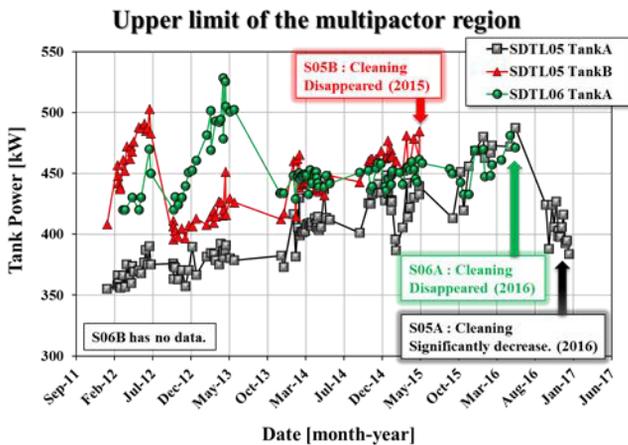
Figure 6 shows trends of the upper limit of the multipactor regions of SDTL05A, 05B, and 06A (there is no data to plot for SDTL06B because the multipactor condition was not serious, so there was no upper limit value). To mitigate the multipactor problem, we employed a few countermeasures in 2012, 2013, and 2014, for example, replacement of the rotary pump with an oil-free one, changing the direction of the rf coupler loop, and frequent cavity conditioning. After these countermeasures were performed, the cavity condition improved, and the multipactor region shrunk. However, the multipactor power region expanded gradually during the operation.

Figure 6: Trends in upper limit of multipactor regions of SDTL05A, 05B, and 06A.

In 2015, SDTL05B was cleaned, and the multipactor region disappeared. Similarly, we cleaned SDTL05B, 06A, and 06B in 2016. As a result of cleaning, the multipactor

region of SDTL06A disappeared, and the upper limit of the multipactor region in SDTL05A was reduced.
