THE DATA ACQUISITION SYSTEM AND INSPECTION EQUIPMENT ON VIBRATION EVALUATION FOR DEIONIZED AND COOLING WATER PUMPS IN TPS *

Yung-Hui Liu[†], Yen-Ching Chung, Chien-Kuang Kuan, Zong-Da Tsai
National Synchrotron Radiation Research Center, Hsinchu, Taiwan.

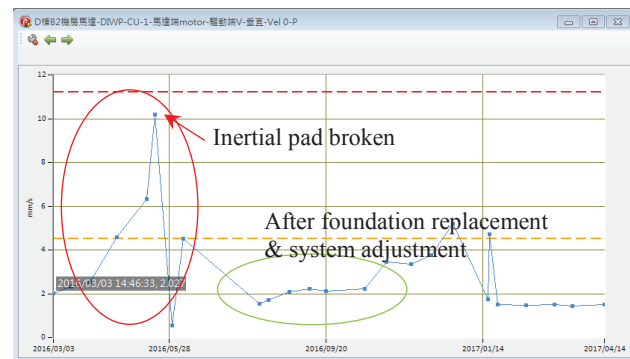
Figure 2 showed the total vertical vibration velocity amplitude for DIWP-CU-1 in the drive-end of motor. The vibration inspection system started to operate from March 3, 2016, and regular inspection were conducted for about every 2 weeks. The vibration amplitude increased rapidly from April 2016. After DIW pump system operated continuously over one month, the vibration amplitude rapid increased over 10 mm/s approach damage amplitude.

Figure 2: Vibration test for DIWP-CU-1 deionized water systems. (Vertical direction for drive-end of motor).

The green area shown in Fig. 2 and Fig. 3 indicated the vibration amplitude after new inertial pad replacement and system readjustment. The total vibration in different locations reduced dramatically. The DIWP-CU-1 DIW pump system operate normally for recent few months.

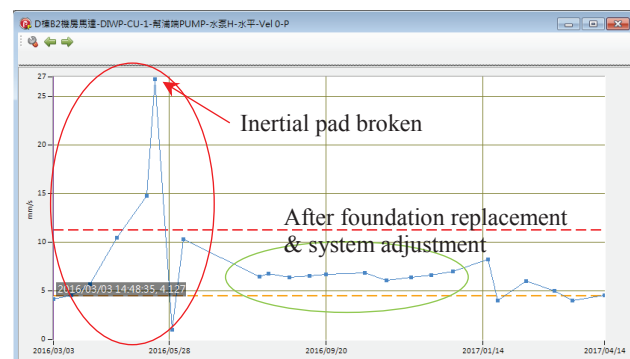
Figure 3 showed the total horizontal vibration velocity amplitude for DIWP-CU-1 in the drive-end of pump. The vibration amplitude also increased rapidly from April 2016, and the total vibration amplitude exceeded 26 mm/s much higher than ISO 10816 system damage amplitude. The foundation of DIWP-CU-1 pump system was found fracture through the middle of whole concrete base in May 17, 2016. The change of vibration amplitudes in different location gave clues that the pump system going to crash in some aspect. The vibration inspection could complete preventive maintenance in this case, and provide enough time (over 4 weeks) to shut down and repair pump system which is under abnormal condition.

Figure 3: Vibration test for DIWP-CU-1 deionized water systems. (Horizontal direction for drive-end of pump).

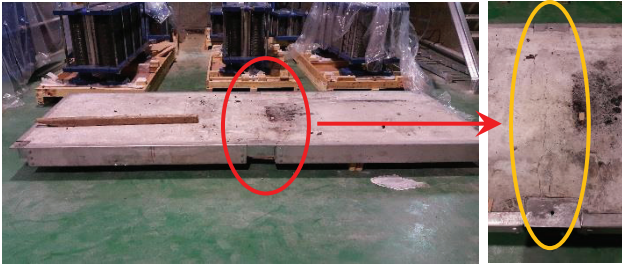
Because the foundation of DIWP-CU-1 DIW pump system was broken through the middle of inertial pad, the new designed of inertial pad is needed. Figure 4 showed the fracture status of the original foundation. The apparently fracture in the middle of the inertial pad caused by poor structure design and unbalance of motor-pump system. The high vibration amplitude shown in Fig. 2 and Fig. 3 indicated the motor and pump operate separately because of broken inertial pad. The coupling of the system was dislocation and in very danger situation.

Figure 4: Original foundation for DIWP-CU-1 DIW pump system. (Broken inertial pad).

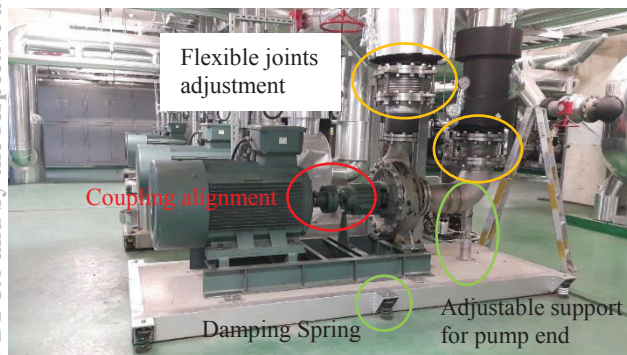
Figure 5: New designed foundation for DIWP-CU-1 DIW pump system. (Coupling alignment and system adjustment).

Figure 5 showed the status of DIWP-CU-1 DIW pump system after replacing new designed inertial pad. The new designed inertial pad strengthens the structure in the middle and move the damping spring to the outside. Thus, the length and width of inertial pad form a complete cuboid. Besides, the altitude and horizontal amplitude for motor and pump readjusted. The support in the end of pump was also changed to adjustable type in order to reduce the lift force from water pressure in pump end. After foundation replacement works, the coupling realignment and flexible joints adjustment were implement before operation.
