# OPERATIONAL EXPERIENCE AND REDESIGN OF THE TUNER WITHOUT SPRING FINGERS FOR THE LEReC WARM CAVITY\*

Binping Xiao<sup>†</sup>, J. M. Brennan, J. C. Brutus, K. Mernick, S. Polizzo, F. Severino, S. Seberg, K. Smith, A. Zaltsman, Brookhaven National Laboratory, Upton, NY, USA

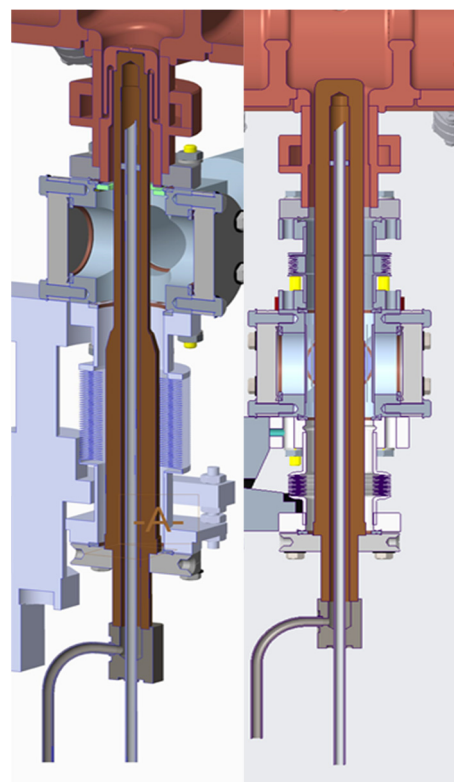
Figure 1: Left: folded coaxial tuner design; right: straight coaxial tuner design.

The new tuner design is shown in the right of Fig. 1. With this tuner, the cavity design, especially the tuner port, can be remain unchanged. Mechanical polishing was done to

smooth the damaged surface of cavity tuner port, and the cavity was re-cleaned in cleanroom. The gap between the tuner and tuner port was enlarged from 1 mm to 2.5 mm. A straight structure was used to eliminate the folded structure with screw-in treads. A more robust tuner drive that machined from solid aluminium block with dual precision machined guided rails and stainless-steel brackets is used. This tuner drive also has location indicators on both sides, and encoder and potentiometer are added. Port aligner was added right below the tuner port and was used to fine tune the tuner.

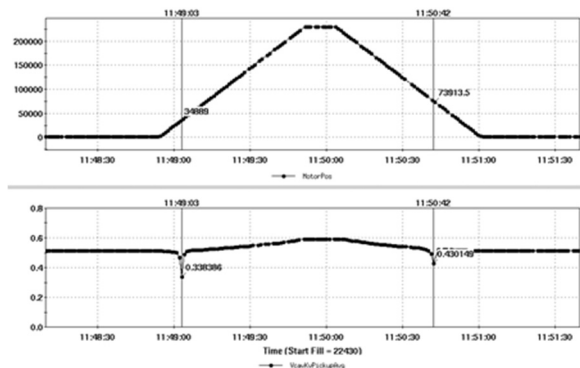
At low voltage (0.5 kV or so), we scanned the tuner locations, monitored the voltage response, and it is noticed that at certain tuner locations, cavity voltage was lower than normal (other locations). See Fig. 2. This is not related to multipacting or field emission, since it happened with extremely low cavity voltage, it is the RF response of tuner misalignment. Geometric survey also suggested that the tuner cap might touch the tuner port at certain locations. A Cu block was added on the bottom of the tuner, with its weight and torque carefully adjusted, so that the voltage decreasing can be eliminated.

Figure 2: Voltage response of the problematic tuner, from top to bottom: Tuner location (steps) versus time; Voltage versus time.

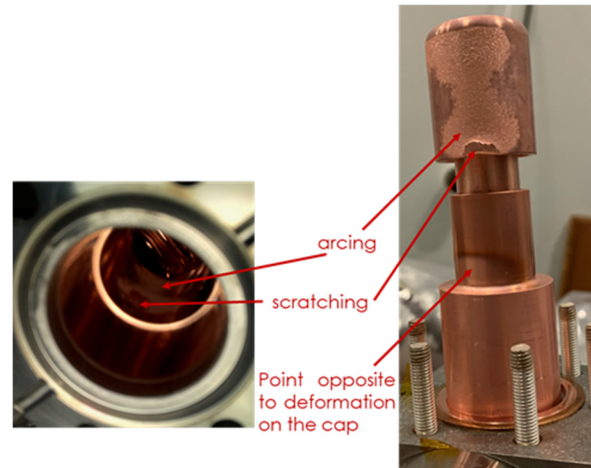
damages, see Fig. 3. It was found that the Cu cap that was threaded onto the tuner rod came out loose, and marks of arcing between cap and cavity port were also found. The cap was also deformed, it is believed that RF induced heat softened the Cu cap, and the loose cap touched the center rod and caused deformation.

Figure 3: Damages on the cavity tuner port (left) and the tuner (right).

The folded coaxial tuner showed a complex problem including mechanical, RF, thermal and vacuum issues. The cause is the misalignment that comes from: 1, inadequate actuator design that cannot handle the vacuum force associated with the tuner weight, and the force was uneven due to the design of guiding rod; 2, the tuner cap that was threaded onto the tuner rod became loose during operation; 3, the port aligner was not in correct location; 4, grease was not applied after baking.

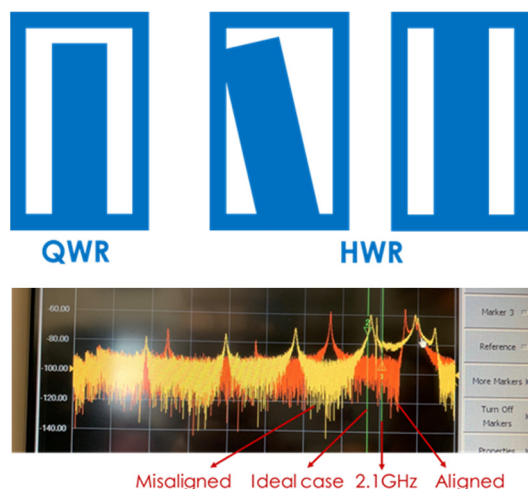
A simple model is used for explanation, see Fig. 4. With tuner perfectly aligned in the tuner port, the resonances within the tuner can be treated as a quarter wave resonator (QWR), while the tuner is tilted to touch the tuner port, it becomes a half wave resonator (HWR). With the tuner length to be  $L$ , the resonant wavelengths  $\lambda_Q$  in QWR can be determined using  $L = (2n+1)\lambda_Q/4$ , and the resonant wavelengths  $\lambda_H$  in HWR can be determined using  $L = (n+1)\lambda_H/2$ . The bottom plot of Fig. 4 showed the measurement results, with orange curve aligned and yellow curve misaligned to touch. Ideally, one would like to choose a tuner length that 2.1 GHz mode is right in the middle of two adjacent resonating frequencies (ideal case).

Figure 4: With tuner aligned, it is a QWR (top left); with tuner touches the port (top middle), it is equivalent to a HWR (top right); Bottom: measured resonances in the tuner, with x-axis frequency and y axis  $S_{21}$  in dB, with the tuner aligned (orange) and tilted to touch the center (yellow).

Based on the above analysis, it is suggested that alignment is important in this tuner design. A conventional tuner design with spring fingers is not considered since: 1, conventional design also requires good alignment; 2, conventional design produces particulates, which affects the performance of adjacent SRF cavity; 3, conventional design is known to be fragile and will fatigue over time.

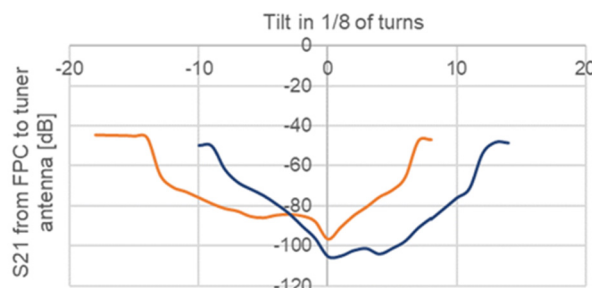
From the simulation, as well as the measurement, it is found that RF is not sensitive to transverse tilt, as long as the tuner does not touch the port. In the original design, the weight of the actuator makes it possible to tilt the tuner along the beampipe. In the new design, the actuator was rotated 90 degree, thus only possible to tilt transversely due to the tuner weight.

Figure 5: Tilting along the beampipe (in 1/8 of turns of the screws) versus  $S_{21}$  from FPC to tuner antenna in dB. Two curves are with different tuner lengths, and the  $S_{21}$  the lower the better.
