# REPORT ON COLLIMATOR DAMAGED EVENT IN SuperKEKB

S. Terui<sup>†</sup>, T. Ishibashi, M. Shirai, Y. Suetsugu, K. Shibata,  
 K. Kanazawa, H. Hisamatsu, Y. Ohnishi, Y. Funakoshi, M. Tobiya  
 High Energy Accelerator Research Organization (KEK), Tsukuba, Japan

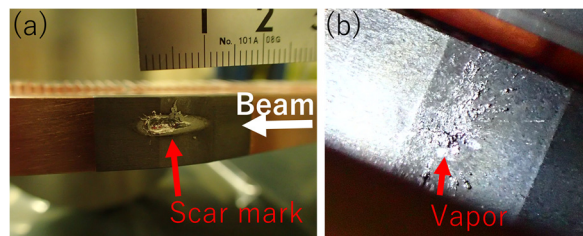
The jaws damaged by the abnormal beam hitting are shown in Fig. 1. A scar-mark can be observed (Fig. 1 (a)) on the tip of the top jaw. When a beam passed through tungsten, it caused pair creation. Owing to its energy deposit, tungsten was sublimated as the temperature rose sharply. Then, a protrusion was formed by the vapor deposition of tungsten on the jaw on the opposite side (Fig. 1 (b)).

Figure 1: (a) Damaged jaw, (b) protrusion by vapor deposition on the opposite side of the damaged jaw.

Figure 2 shows the LER beam current and the value of the BG observed using the VXD in Belle II before and after the jaw damage event. The peak value of the BG after this event was approximately 200 times higher than that before it. As the accelerator operation was difficult after this event due to the high BG, we replaced the damaged jaw with a new one during the 2020c run (from 10/14/2020 to 12/18/2020).

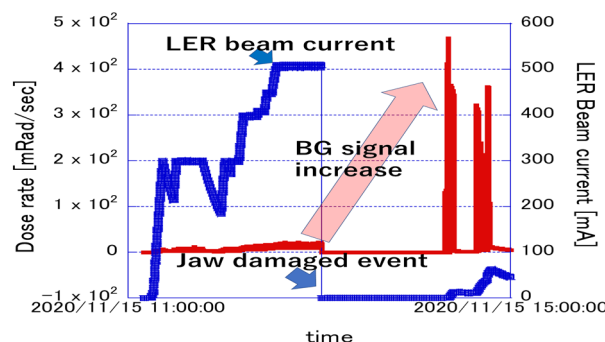
Figure 2: BG signal before and after the event of the damaged jaw.

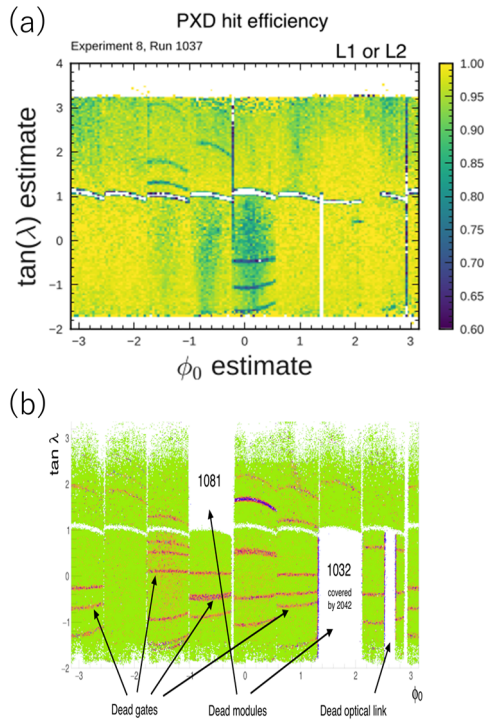
When a jaw damage event occurred, a large beam loss was observed in Belle II. The soundness of the DEPFET pixel detector (PXD) in Belle II before and after the jaw was damaged during the 2019b run (from 4/1/2019 to 7/1/2019) is shown in Fig. 3. The white part in Fig. 3 (b) indicates that the modules in the PXD are no longer functioning [4]. It was revealed that an event during which the current collimator could not protect Belle II occurred.

Figure 3: Soundness of the PXD (a) before and (b) after the jaw damage event that occurred during the 2019b run.

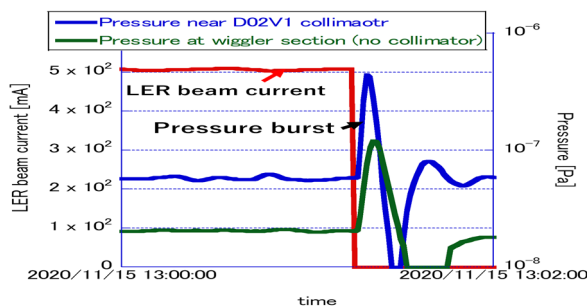
In this event, the pressure burst near the collimator (blue line) with the beam abort is shown in Fig. 4. In addition, a smaller pressure burst (green line in Fig. 4) was observed at a location different from the location at which the collimator was installed. The beam abort during this event was mainly triggered by the beam loss monitor. It is believed that the pressure burst at the green line was caused by the beam interacting with the dust. We consider that these events were triggered by a sudden change in the beam energy because the beam collided with the dust. We consider dust to be the cause of these events because of two reasons.

Figure 4: Pressure burst when a jaw damaged.

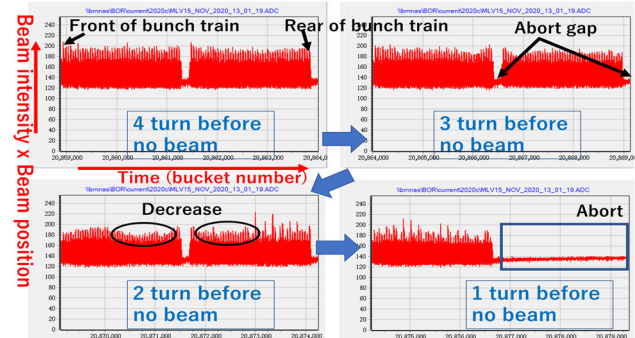
Next, we describe the second reason. We illustrate the data obtained using the bunch oscillation recorder (BOR) (Fig. 5), where the horizontal axis represents the bucket number, and the vertical axis represents the product of the beam intensity and vertical beam position.

Figure 5: Plot observed using BOR when a jaw was damaged.

In conclusion, when this event occurred, there was no sign of oscillation indicating beam instability, and the data indicated that the intensity of the part of the bunch train suddenly decreased a few turns before the abort. We consider that part of the bunch train was abnormal upon interacting with the dust particles.

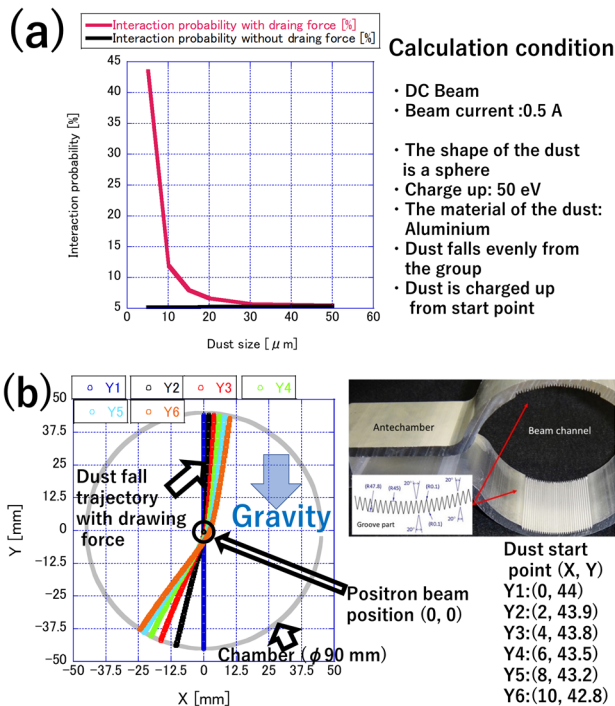
though the beam size in SuperKEKB is very small. When the dust falls out of the groove, it almost does not interact with the beam if it is not attracted to the beam. Assuming that the beam has a circular transverse cross-section with a diameter of 2 mm and the material of the dust particles is aluminum, the probability of interaction between the dust falling from the groove and the beam is very low (see the black line in Fig. 6 (a)). We believe that the electron cloud may cause an increase in the probability of interaction between the dust and the beam. The mechanism is believed to be the charging of the free-falling dust when it passes through the electron cloud. Thereafter, the charged dust is drawn to the positron beam. Figure 6 (b) shows the orbit of the dust with the drawing force caused by the electron cloud, assuming that the energy of the charged-up dust is 50 eV [8] and the dust radius is 10  $\mu\text{m}$ . If the above process occurs, the probability of interaction between the dust and the beam increases dramatically (see the red line in Fig. 6 (a)).

Figure 6: (a) Probability of interaction with/without the drawing force, (b) orbit of the dust (radius = 10  $\mu\text{m}$ ) with the drawing force caused by the electron cloud.

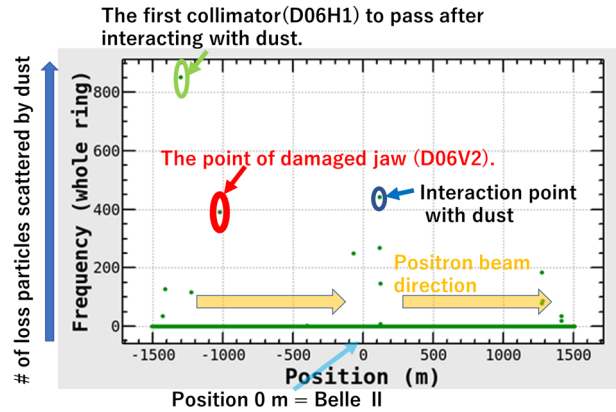
using PHITS [9] and Strategic Accelerator Design (SAD) [10]. Figure 7 shows the results of beam tracking when the D06V2 collimator jaw was damaged. See reference [1] for the collimator location. Figure 8 shows a comparison of the scatter plots of particles that collided with D06H1 and D06V2. We observed that the particles were concentrated within a narrow range in D06V2. If high-density particles hit the jaw, the jaw may be damaged.

Figure 7: Result of tracking the scattered beam that interacted with dust using PHITS and SAD.

Thus, we developed a low-Z collimator as a countermeasure for these events. This development has been reported in other studies [11].

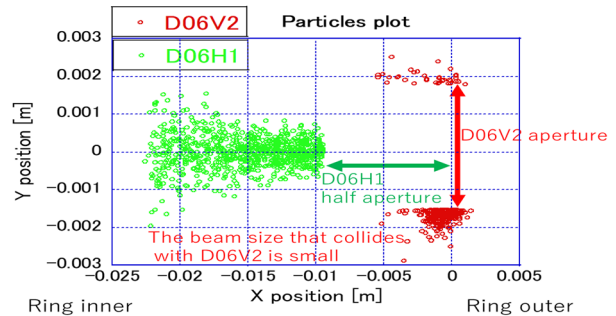
Figure 8: Comparison between the sizes of beams that collided with D06H1 and D06V2.
