THE LAMPF KLYSTRON REPAIR FACILITY*

P. J. Tallerico
University of California
Los Alamos Scientific Laboratory
Los Alamos, New Mexico

Major and minor repairs on the 1-1/4 MW, 805 MHz LAMPF klystrons are being performed in-house. This paper discusses the repair facility and the processes and procedures used to effect these repairs. The minor repairs usually consist of cleaning the outside of a ceramic insulator and hi-potting the electron gun. The klystron is cut open for a major repair; one or more parts are repaired or replaced, the cathode is cleaned and recoated and the tube is reassembled, evacuated, baked out and reprocessed. Several of the more critical procedures such as the vacuum bakeout and cathode cleaning, coating and activation are discussed in some detail. The observed failure rates and mechanisms are presented for the klystrons and for several other high-power tubes which are used at LAMPF.

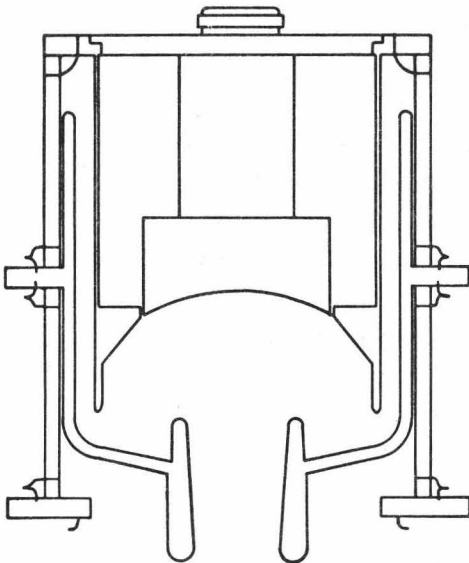
Fig. 2. Klystron electron gun assembly.

The LAMPF klystrons (Types VA-862-A and L-5120) were both designed with ease of rebuilding in mind. Figure 2 is a simplified drawing of the electron gun assembly which shows the four kovar-welded joints which are used to assemble the gun. When the four seals are opened by grinding away the welded joints, the gun is disassembled into four components; the two ceramic insulators, the modulating anode and the cathode/focus electrode assembly. Any arc marks on the insulators are removed by grit blasting. The mod-anode and ceramics are then chemically cleaned. The old cathode coating material is removed by boiling the cathode assembly in distilled water. Weak acetic acid (3 to 5%) is used to loosen any stubborn areas of cathode material. Next the cathode assembly is hydrogen fired at 1100°C and then vacuum fired for 24 h with 10% over-voltage applied to the heater. After the vacuum firing, a commercial cathode mixture is applied by brushing and spraying to the nickel cathode. The work schedule is arranged so that the klystron is assembled, leak checked and evacuated on the day the cathode is coated.

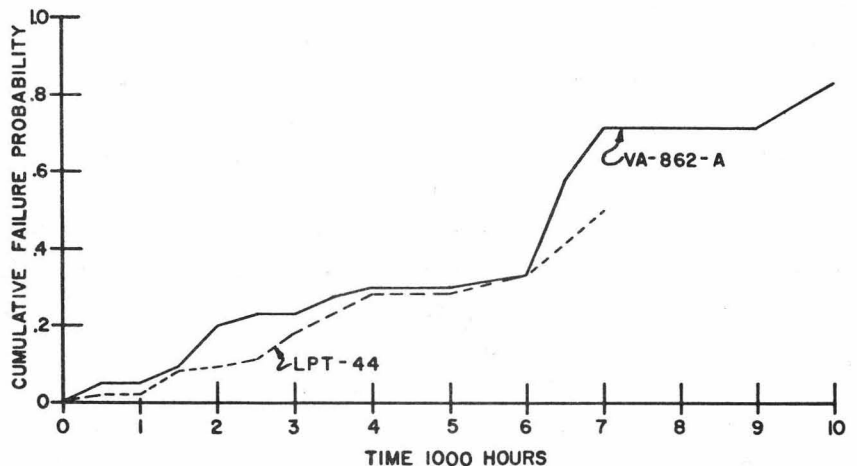
Fig. 3. Cumulative failure probability for LPT-44 triodes and VA-862-A klystrons.

The cumulative failure probability for the triodes and klystrons is shown in Fig. 3. The respective life expectancies are 7,000 and 6,350 filament hours.

The observed life expectancy for the klystron is about 6,350 filament hours. This implies that more

than half of the klystrons will have to be repaired each year. The life of the triodes is about 7,000 h but grid processing is often required before 3,000 h.
