PERFORMANCE OF THE CERN HIGH-INTENSITY RFQ

E. Tanke, M. Vretenar and M. Weiss
 PS Division, CERN, CH-1211 Geneva 23, Switzerland

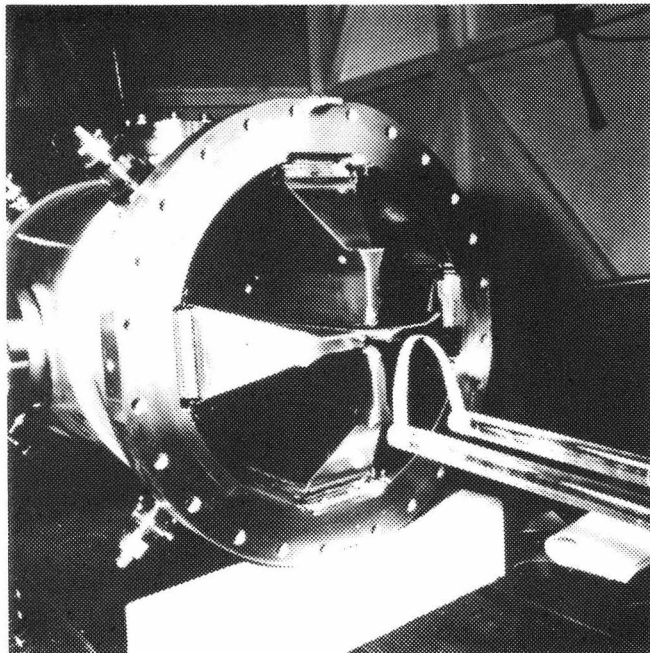
To clean such a complicated structure as the RFQ2, containing a lot of weldings and brazings, is far from obvious. The oil deposited on various surfaces could have been removed, but the cracked oil on the vane tips was the real problem. It rendered any normal operation impossible, in particular in view of the high fields which are required for the RFQ2 (2.5 \times Kilpatrick limit). To remove the cracked oil, chemical or mechanical cleaning has to be employed. Chemical cleaning requires subsequent rinsing with distilled water, which is incompatible with the tank being made of mild steel. Therefore, mechanical cleaning making use of inorganic abrasive paper with aluminium-oxide grains deposited on a substrate was used. The danger is that, after the cleaning, the grains remain encrusted in the cleaned surface. Several papers were tried out and it was found that grains of at least 5 μm were necessary to remove the cracked oil. Before starting the cleaning, a sample of the vane material (Cu-Cr alloy) was gently cleaned with such a paper, rinsed with alcohol, and then analysed under a microscope: no encrusted grains were seen on the sample.

Figure 1: Mechanical cleaning of the vane tips

A strip of the abrasive paper was fixed on two Plexiglas rods, which permitted progressive cleaning of the vane tips, see Fig. 1. The progress of the cleaning was continually checked by an endoscope. A few hours were necessary to clean a vane. After all the vane tips were cleaned, the RFQ2 was placed in vertical position and rinsed with alcohol and freon, and then left to dry.

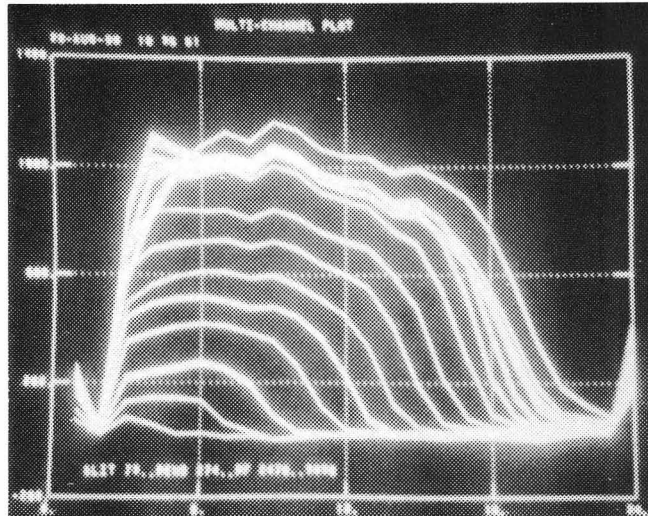
Figure 3: Energy spreads of the RFQ2 beam for different vane voltages. (Horiz. scale: 39 keV/div.)

Energy spread: about ± 70 keV was measured, for an output beam of 200 mA and a 5% higher vane voltage (note that the space charge increases the energy spread by a factor of about 3 between the RFQ2 and the measurement device). In Fig. 3 one sees the energy spreads for different vane voltages, ranging from 70 to 105% of the nominal value. There are practically no particles in the right energy range for voltages below 70%. The areas under the various curves are proportional to the accelerated beam.

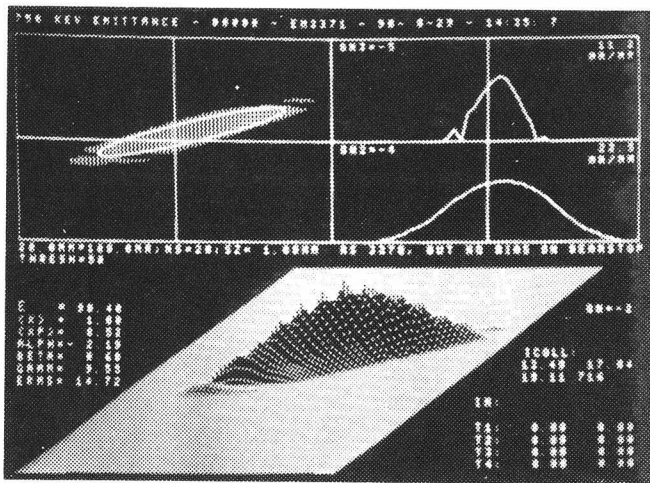
Output beam emittances: the measured output emittances are shown in Figs. 4 and 5. The normalized r.m.s. value, $\epsilon_{\text{rms},n}$, is about 0.6π mm-mrad. For comparison, we also show emittances measured before the accident, see Figs. 6 and 7. Their $\epsilon_{\text{rms},n}$ value is about 0.5π mm-mrad. The corresponding input emittance values are $\epsilon_{\text{rms},n} \approx 0.4\pi$ mm-mrad.

It seems that the impaired field symmetry slightly reduces the output beam and increases the output emittances.

Figure 4: Horizontal output beam emittance

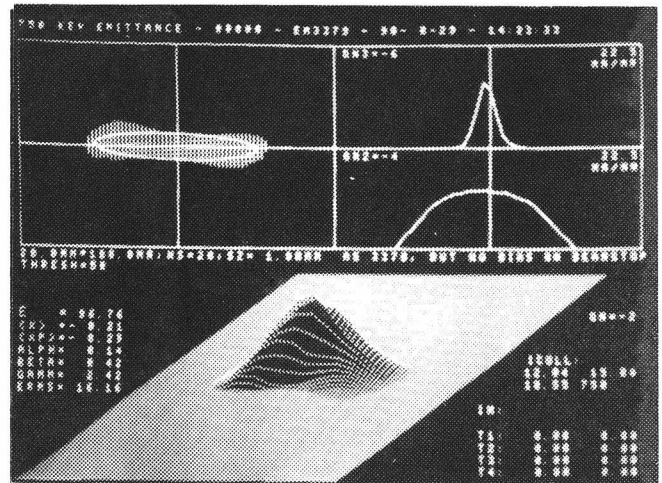
Figure 5: Vertical output beam emittance
