Solving the USB Communication Problem of the High-Voltage Modulator Control System in the European XFEL

M. Bousonville*, S. Choroba, S. Göller, T. Grevsmühl, A. Hauberg, T. Weinhausen, DESY, Hamburg, Germany

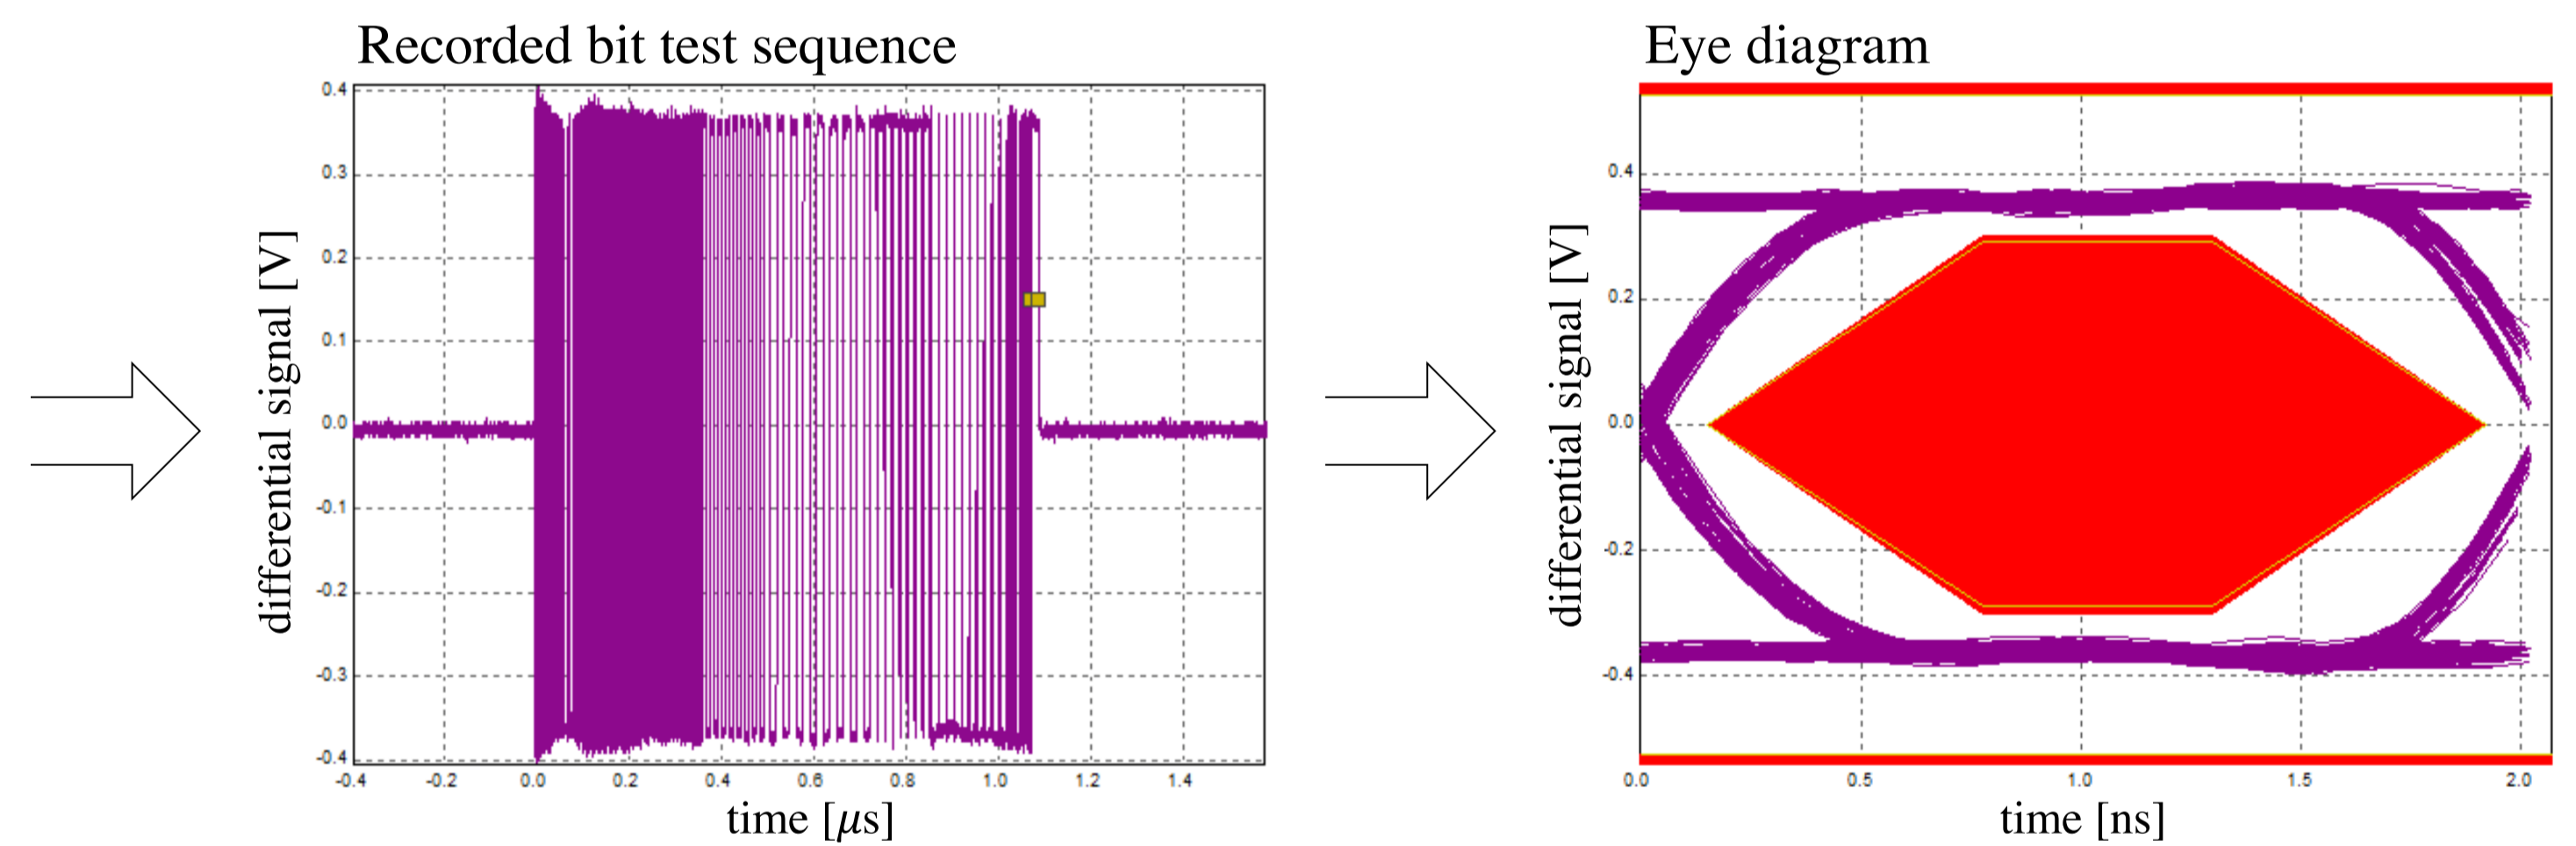
Measurement 1

- By superimposing all bits of the test sequence, an eye diagram is created.
- The wider the eye is open, the better the signal quality.
- It turns out that the eye diagram of the modulator server and the boards is 5 to 9 % less wide open vertically than with other typical USB devices. On the other hand, the cable used at that time reduced the eye opening by another 8 to 11 %.

After these findings, we used a USB cable with lower attenuation and thus increased the eye opening.

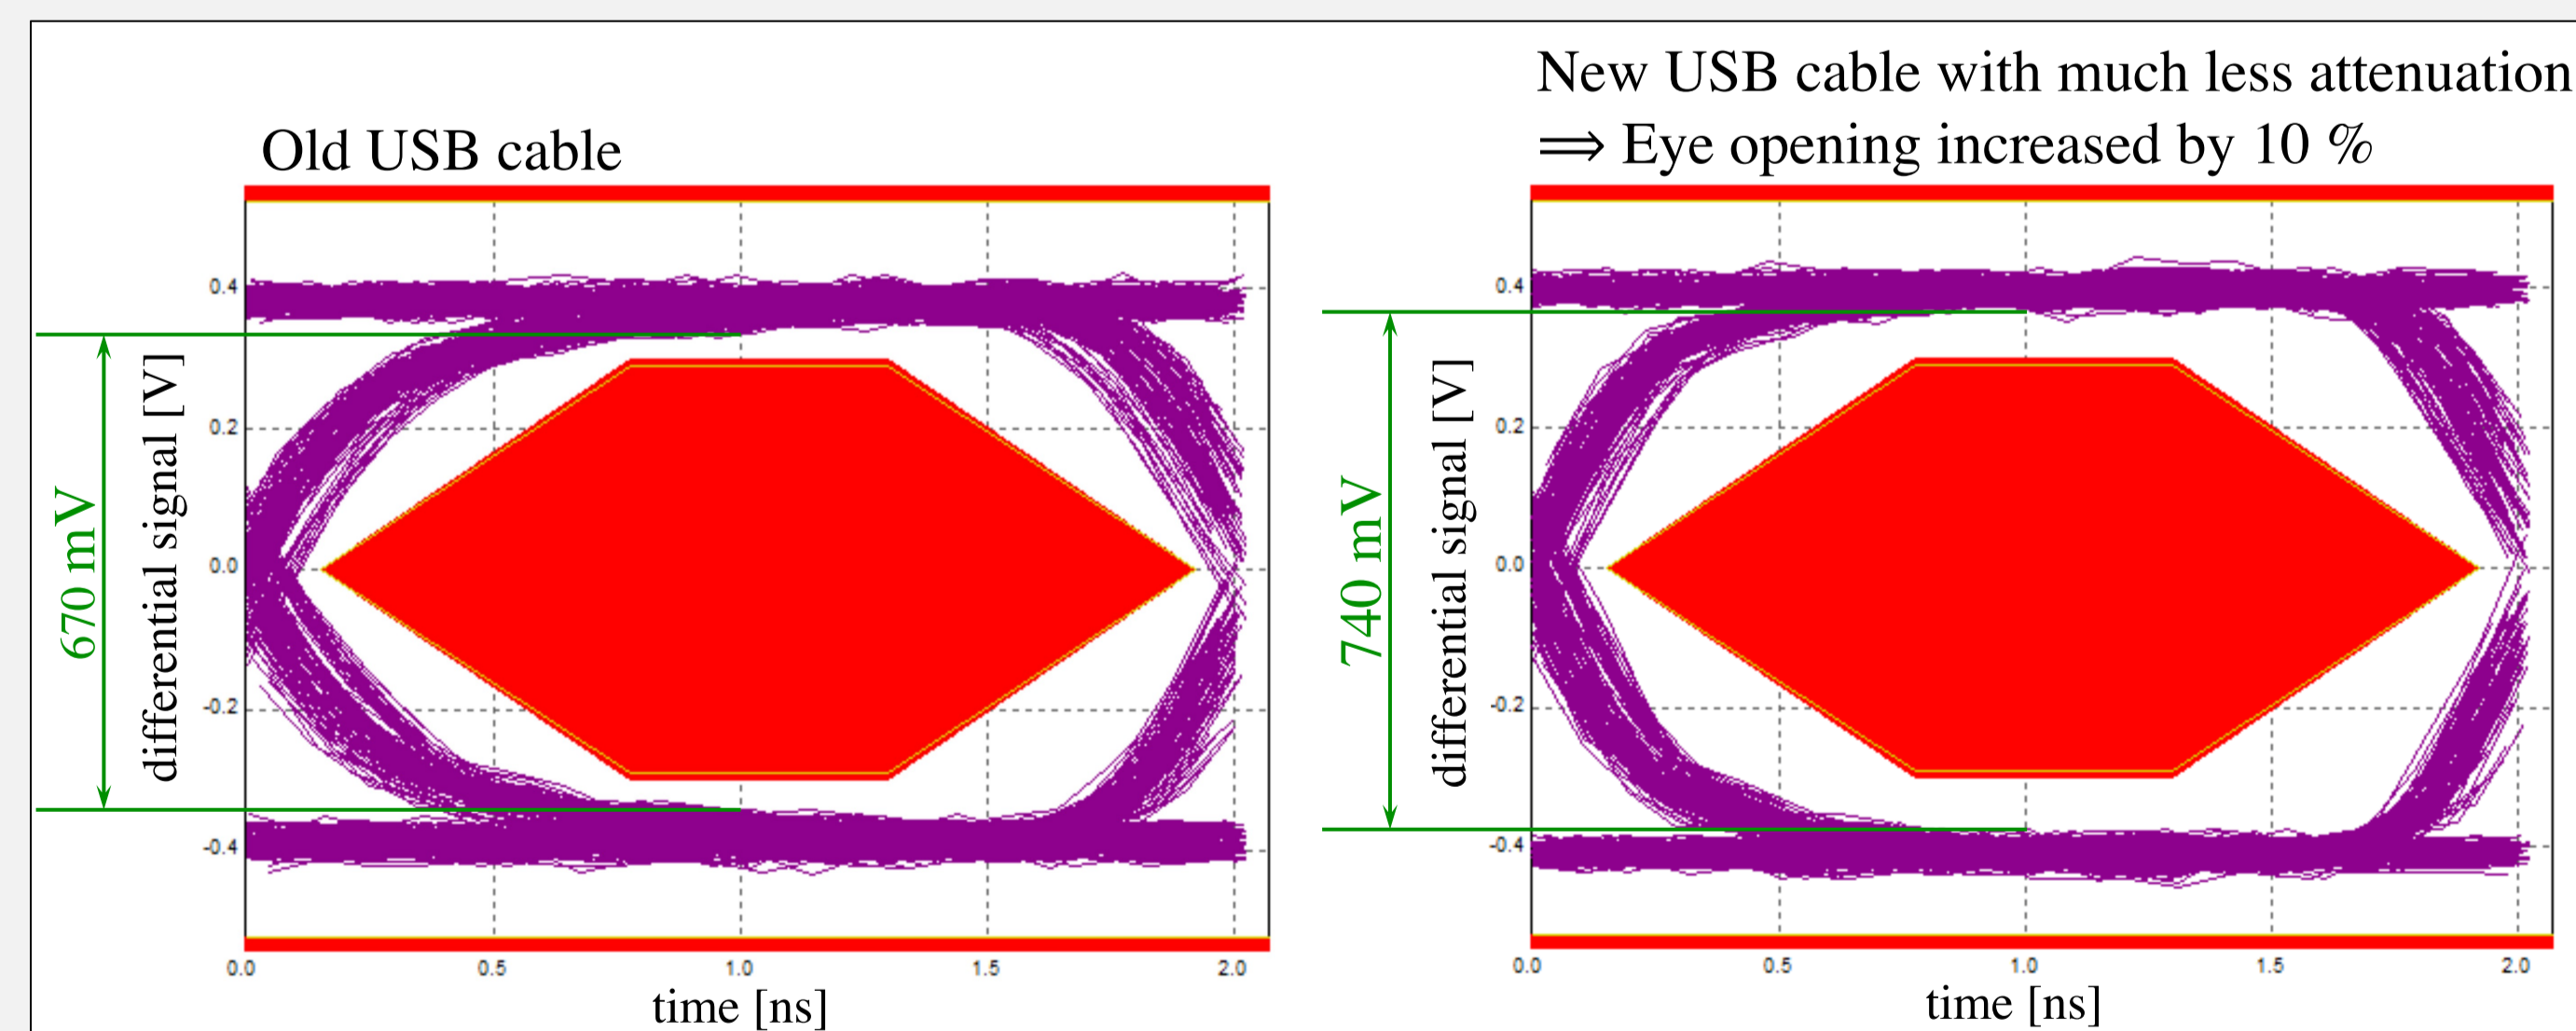
This worked at first. The error did not occur again for a good 4 months. But then the red spider returned.

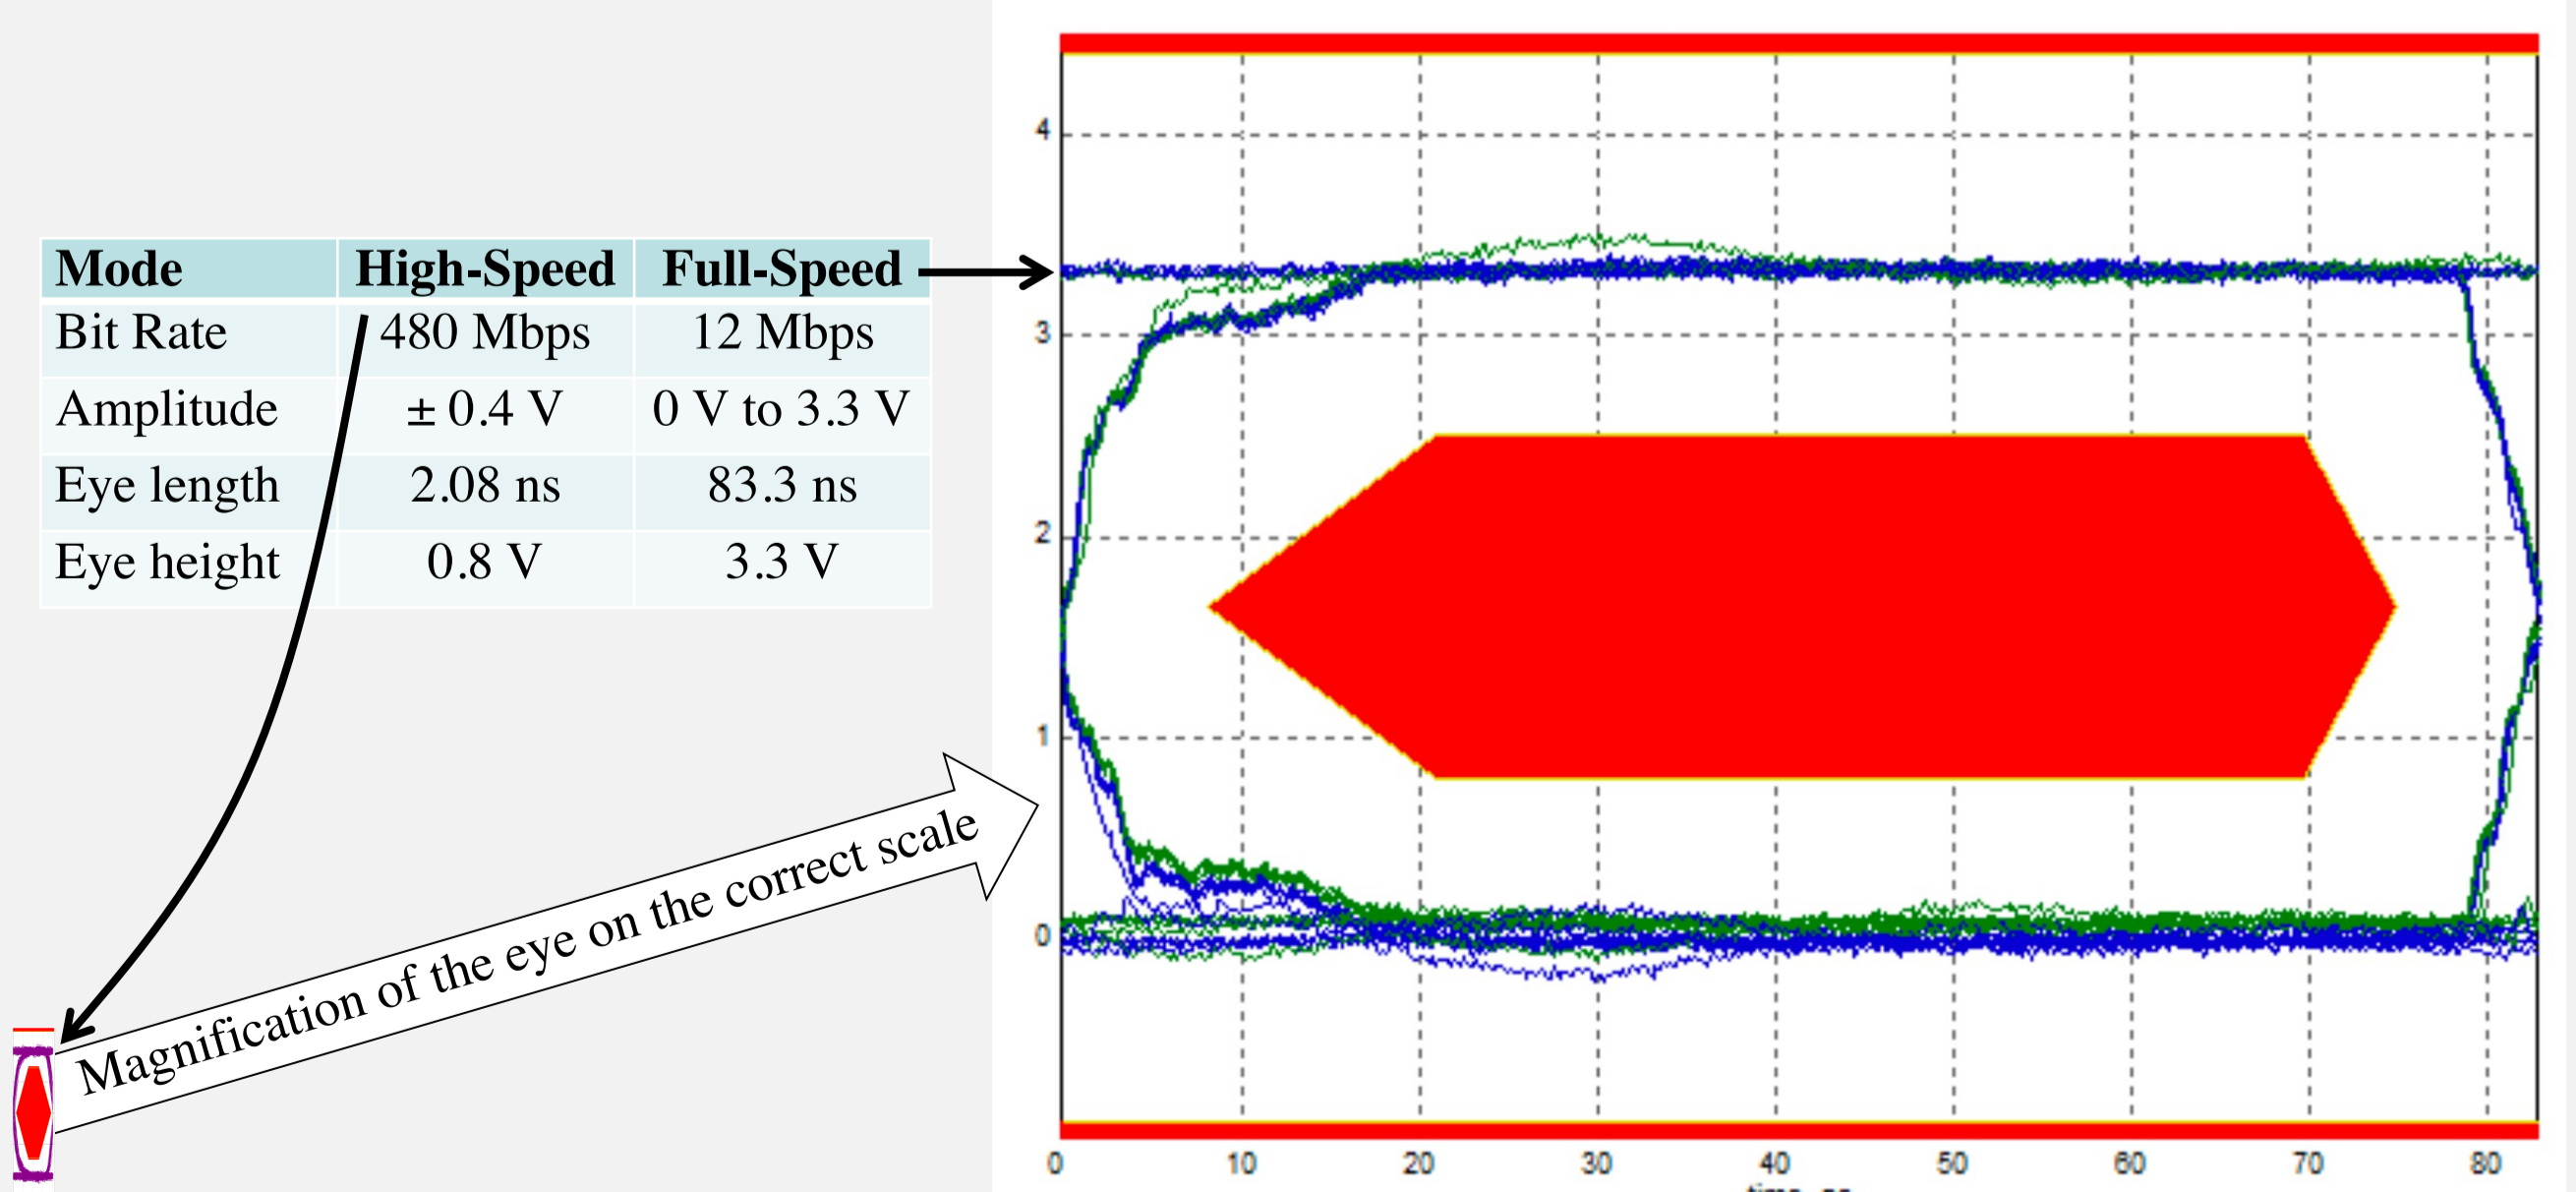
Measurement 2

- To do this, we used the backwards compatibility of the USB standards (see above).
- A repeater was inserted that can only handle full-speed.
- This reduces the data rate and increases the level of the data transmission.
- Each bit becomes 40 times longer 4.125 higher. ⇒ Much bigger eye opening.

Magnification of the eye on the correct scale

By lowering the data transmission from high-speed to full-speed on purpose and using low-attenuation USB cables, the signal quality was improved so much that the error has not occurred again in the last 12 months of operation.
