## NSLS-II BEAM APERTURE SLIT VIBRATION STUDIES

C. Spataro, C. Amundsen, H. Bassan, S. Sharma  
Brookhaven National Laboratory, Upton, NY 11973 USA

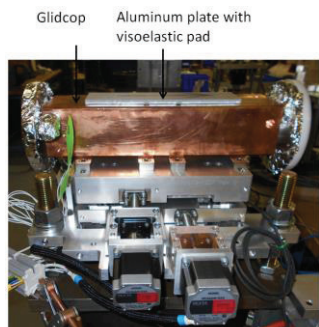
Figure 2: Slit assembly with viscoelastic pad.

An experiment was then performed in which a viscoelastic pad was added to the top of the slit to help dampen

out the vibrations (Fig. 2). This reduced the peak vibration levels but at the expense of broadening the bandwidth. The runaway vibration problem was still not resolved.

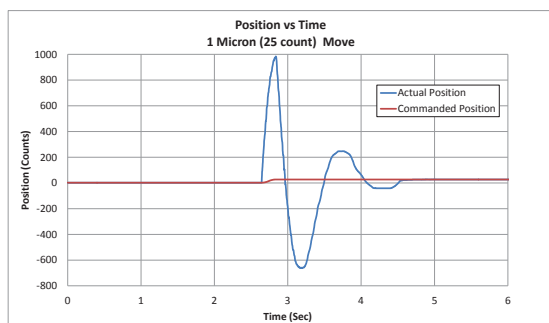
Figure 4: Actual and Commanded Position vs Time.

Current tuning of the motors followed by the PID loop tuning was done to get a better response. It was found that when moving the motor by a small number of encoder counts (for instance, 25 counts, which is equivalent 1 micron in position) the motor actually moved up and down over one thousand counts ( $\pm 40$  microns) before arriving to the desired position (Fig. 4).

The motors were re-tuned and this reduced the unwanted excursion to 14 microns, which is still large but much better than the original tuning.

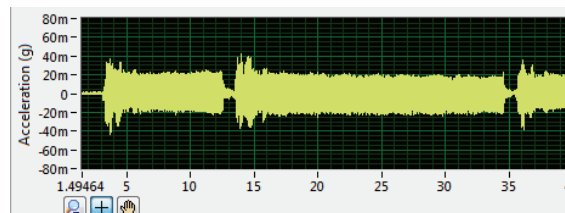
Figure 5: Acceleration vs Time - Default Velocity.

A large factor in the vibration was the default motor velocity. Tests were performed at various velocities. It was found that there was a linear correlation between vibration levels and the default motor velocity. After numerous rounds of tests, a reduced velocity of 1/3 of the default velocity was deemed to be a good compromise which reduced the vibration levels by a factor of three (Fig. 5 and 6).

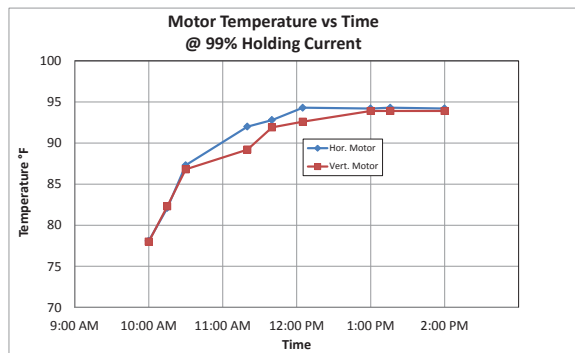
Figure 7: Motor Temperature vs Time.

A holding current vs temperature test was performed. The holding currents for both motors were set to 99% of the nominal and monitored for over 4 hours (Fig. 7).

Temperatures reached equilibrium within two hours and were within specifications. This meant that the holding current could be increased without overheating the motors.

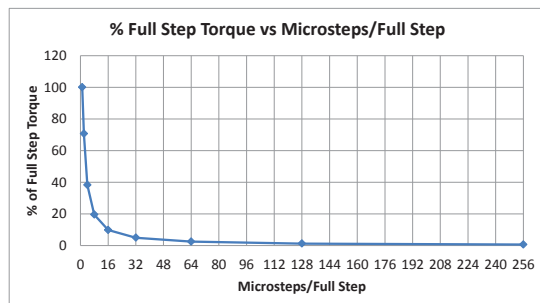
Figure 8: % Full Step Torque vs Microsteps/Step.

The intermittent nature of the problem is likely to be caused by the reduction in the motor torque when microstepping is used. At the 32 usteps/step setting of the motor, the torque drops to 5% of its rated value (Fig. 8).

Depending on the exact position in relation to the motor steps, the torque will vary, so in some micro-stepping positions the torque is higher and the motor does not squeal, whereas in other positions, the torque is lower and the motor starts to squeal. While reduced torque has been established as the cause of motor squealing, the sequence of events in terms of motor current, pulse counts, and position, is still under investigation.

It is now planned to increase the holding current and reduce the number of micro-steps for the inclined-axis motor. If the motor squealing persists then 90° worm-gear reducers will be used to increase applied torque to the stages.
