## POST IRRADIATION EXAMINATION RESULTS OF THE NT-02 GRAPHITE FINS NUMI TARGET\*

### Abstract

The NT-02 neutrino target in the NuMI beamline at Fermilab is a 95 cm long target made up of segmented graphite fins. It is the longest running NuMI target, which operated with a 120 GeV proton beam with maximum power of 340 kW, and saw an integrated total proton on target of  $6.1 \times 10^{20}$ . Over the last half of its life, gradual degradation of neutrino yield was observed until the target was replaced. The probable causes for the target performance degradation are attributed to radiation damage, possibly including cracking caused by reduction in thermal shock resistance, as well as potential localized oxidation in the heated region of the target. Understanding the long-term structural response of target materials exposed to proton irradiation is critical as future proton accelerator sources are becoming increasingly more powerful. As a result, an autopsy of the target was carried out to facilitate post-irradiation examination of selected graphite fins. Advanced microstructural imaging and surface elemental analysis techniques were used to characterize the condition of the fins i

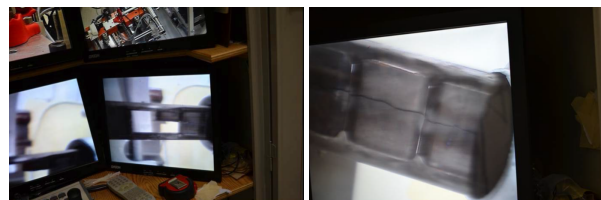
During the removal and disassembly of the NT-02 target at Fermilab, several graphite fins were discovered to be cracked near the centerline or broken away from the cooling water tubes as shown in Fig. 2. It was unclear whether the separation and fracture of the fins had occurred during the removal and disassembly operations. As a result, studies were initiated to explore the NT-02 graphite fins. The main objectives of the investigation were to determine whether the neutrino yield degradation was a result of radiation damage, by measuring bulk swelling, evaluating the fin fracture surfaces to determine whether they occurred in service or during disassembly, and finally by evaluating the microstructural condition to assess the extent of radiation damage of the POCO ZXF-5Q [3] graphite.

Figure 2: Boroscope images of NT-02 graphite fins during target autopsy. Broken fins from cooling tubes (left) and fractured fin at centerline (right).

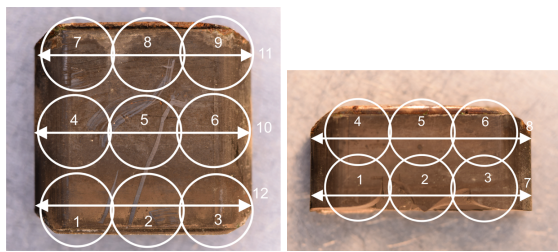
Figure 3: Dimensional measurement locations on full fins (thickness: 1-9, width: 10-12) and half fins (thickness: 1-6, width: 7-8).

Results indicate bulk swelling, with greater swelling measured in the middle of the fins versus the ends and in the upstream fins versus the downstream ones. Relative swelling (middle-to-end) of up to 2% was measured for the upstream half fin. The results are consistent with the higher proton fluence in the middle of the fins as well as the greater damage rate at the upstream end of the target. Another trend observed in the measurements is larger swelling in the half fins versus the full fins, possibly indicating stress relief after fracture.

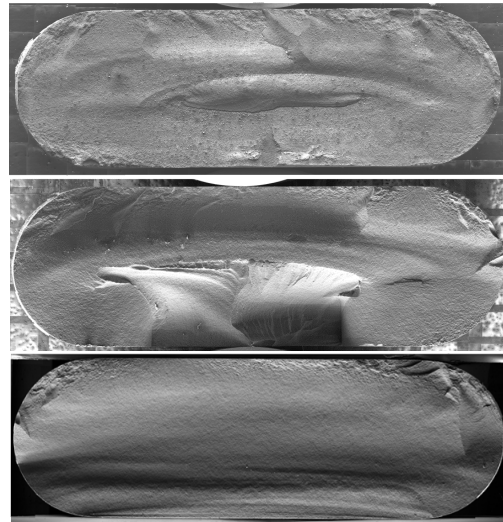
Optical and Scanning Electron Microscopy (SEM) images of the fin fracture surfaces were taken to analyze how the fractures initiated. Figure 4 shows SEM images of the fracture surfaces of the upstream half fin (top image), the downstream half fin (middle image), and of an intentionally fractured upstream full fin (bottom image) with pressure from a razor blade. The preliminary conclusion from these images is that the fracture likely initiated from the center of the fins in the region of peak proton fluence. The evidence for this is in the symmetry propagation pattern exhibited by the half fractured fins. Even though the patterns are not entirely symmetrical, the contrast to the asymmetrical fracture pattern of the intentionally fractured upstream full fin is very

clear. For the half fins, the fracture propagation ripples can be seen from the central fracture initiation point.

Figure 4: SEM images of fracture surfaces of upstream half fin (top), downstream half fin (middle), and intentionally fractured upstream full fin (bottom).

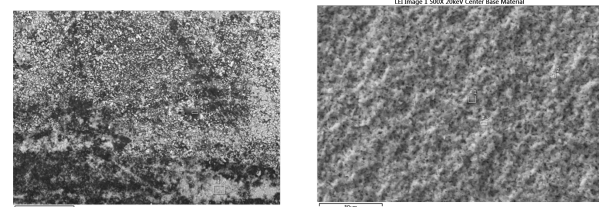
Also evident from SEM images of the fractured surfaces are loose particulate dispersed across the fracture surfaces of the already fractured fins. On the other hand, debris are not observed along the fracture surface of the intentionally fractured full fin. This observation again supports the notion that the fins likely fractured during operation. Additionally, discolorations and structural formations that are optically visible on the fractured fins are not visible on the fracture surface of the intentionally fractured fin, as shown in Fig. 5. This is additional evidence of material transport along the fracture surface during operation, further suggesting that the fins fractured during operation.

Figure 5: Magnified SEM images of fracture surfaces of upstream half fin (left) and intentionally fractured upstream full fin (right).

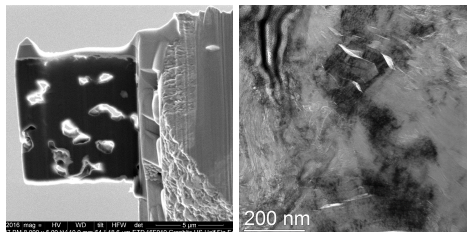
lamella (left) and the TEM image of the microstructure. The microstructure is seen to be a mix of larger crystalline regions and smaller nanoscale crystalline regions. Mrozowski cracks that commonly exist in as-fabricated graphites are also visible. These cracks are identifiable by the brighter lamellar bands on the TEM image and usually develop parallel to the graphite basal planes during cool-down after graphitization. The microstructure observed is highly consistent with as-fabricated microstructure.

Figure 6: SEM image (left) and TEM image (right) of the lamella lift out from the side of the upstream half fin.

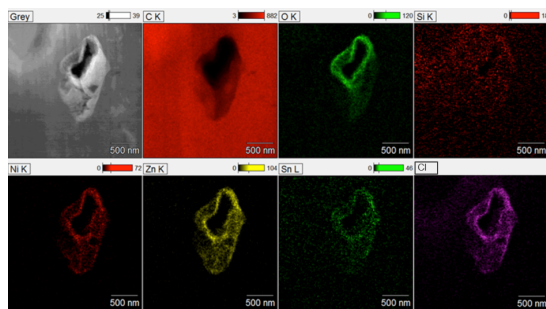
The elemental map in Fig. 7 shows impurities decorating the interior surface of a pore. Sn, Zn and Cl impurities are likely associated from the solder and flux used to join the graphite fins to the cooling water tubes. The location of these impurities suggests that vapor created during fabrication or operation penetrated the open porosity and deposited within the pores of the graphite.

Figure 7: EDS elemental mapping of a pore located on TEM sample from the side of the upstream half fin.

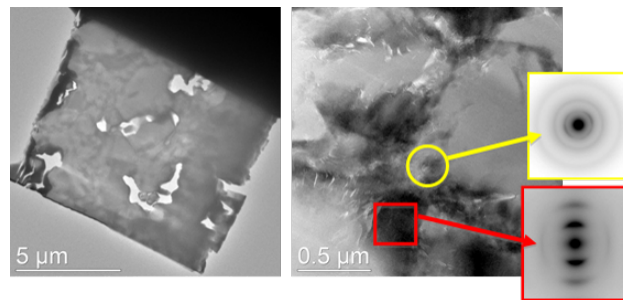
Another TEM sample was lifted out from the center of the fracture surface of the downstream half fin to examine the microstructure of the graphite exposed to the peak proton fluence. As shown in Fig. 8, the lamella has mixed regions of what appear to be amorphous (encircled yellow diffraction pattern) and nanocrystalline microstructure (encircled red). Mrozowski cracks are also present at the interfaces between the two regions, suggesting that lattice swelling is moderate. Therefore, the bulk swelling measured may be a result of a combination of moderate lattice swelling and localized amorphization caused by radiation damage and thermal effects.

Figure 8: TEM bright field image of TEM specimens taken from center of fracture surface of downstream half fin.
