# STATUS OF THE RF SYSTEM FOR THE 6.5 GEV SYNCHROTRON LIGHT SOURCE PF-AR

S. Sakanaka, K. Ebihara, S. Isagawa, M. Izawa, T. Kageyama, T. Kasuga, H. Nakanishi, M. Ono, H. Sakai, T. Takahashi, K. Umemori, and S. Yoshimoto, High Energy Accelerator Research Organization (KEK), 1-1 Oho, Tsukuba, Ibaraki 305-0801, Japan

In this paper, we report the operations, troubles, and modifications of an rf system for the 6.5 GeV synchrotron light source PF-AR for the past two years. It includes a strange trouble in one of the cavities, our efforts to recover this cavity, and the work of transferring two cavities from the west to the east rf section.

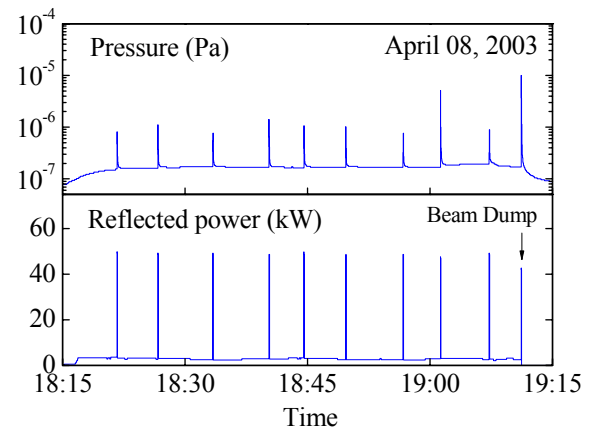
Figure 1 shows a typical operation of the cavity (W-3) at a low beam current of 15 mA. We observed periodic spikes in both the reflected power and the vacuum pressure. These spikes eventually triggered a cut in the input power due to protection, where a threshold for the reflected power was initially 40 kW/cavity and was raised afterward. The period between the spikes tended to be short at high currents. Typical reflected signals at the spikes are shown in Fig. 2. We also monitored picked-up signals from the HOM couplers, and then observed dips in the HOM signals from the accelerating cells of No. 4 (most frequently), 5, and 8 at the events of the spikes. A typical observation is shown in Fig. 3. This suggested that the discharges might happen near these cells.

Figure 1: Vacuum pressure in the cavity (W-3) and reflected power from two cavities (W-3 and W-4). The beam energy was ramped at 18:16 with a beam current of 15 mA. An rf voltage was 16 MV with 6 cavities.

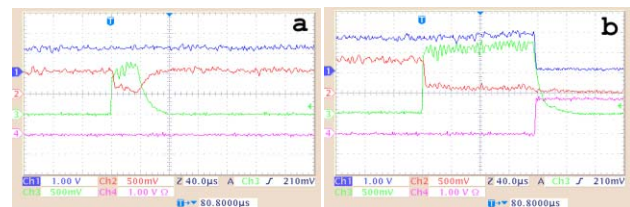
Figure 2: Detected rf signals from the cavity W-3 at the spikes, where typical two cases are indicated. The beam was held in case (a) while it was lost in case (b). Ch1 (blue): an input rf to the cavity, ch2 (red): a signal from the cavity pickup, ch3 (green): a reflected rf from the cavity, ch4 (pink): rf on/off status. Horizontal scale: 40  $\mu$ s/division.

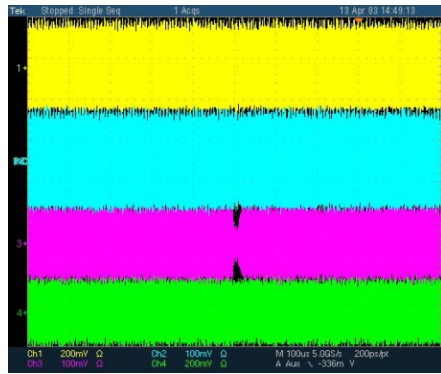
Figure 3: Picked-up signals from the HOM couplers at a spike event. The traces (upper to lower) show the signals from the cells of No. 2, 3, 4, and 5, respectively. Horizontal scale: 100  $\mu$ s/division.

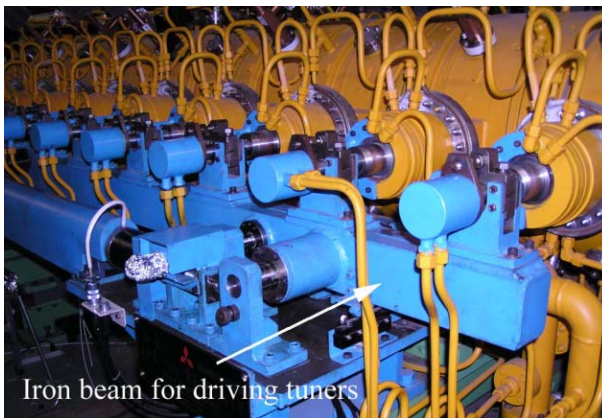
Figure 6: Common driving mechanism for the tuning plungers of the APS cavity.

During replacing the wrong cavity with a spare one, we experienced a degradation of Q-value of the spare cavity. This cavity had a Q-value of 39,000 for an accelerating  $\pi/2$ -mode before transportation, but the Q-value reduced to 32,000 after installation. We first checked the inside of the cavity using a fiber scope, but found no particular problems. After some inspections, we found that a field distribution of the  $\pi/2$ -mode was distorted considerably; this was found by a perturbation measurement using tuners. Because the coupling cells having low Q-values were excited considerably, the Q-value was degraded. After we tuned the  $\pi/2$ -mode, the Q-value recovered to 37,500.

It was guessed that an iron beam used to drive the tuners commonly (see Fig. 6) should be inclined during the installation, and it should cause the distortion in the field distribution.
