THE FACILITY FOR RARE ISOTOPE BEAMS SUPERCONDUCTING CAVITY PRODUCTION STATUS AND FINDINGS CONCERNING SURFACE DEFECTS*

C. Compton[†], H. Ao, J. Asciutto, J. Craft, K. Elliott, W. Hartung, S. Kim, E. Metzgar, S. Miller, E. Oswald, J. Popielarski, L. Popielarski, K. Saito, T. Xu
Facility for Rare Isotope Beams, Michigan State University, East Lansing, MI, 48824, U.S.A.

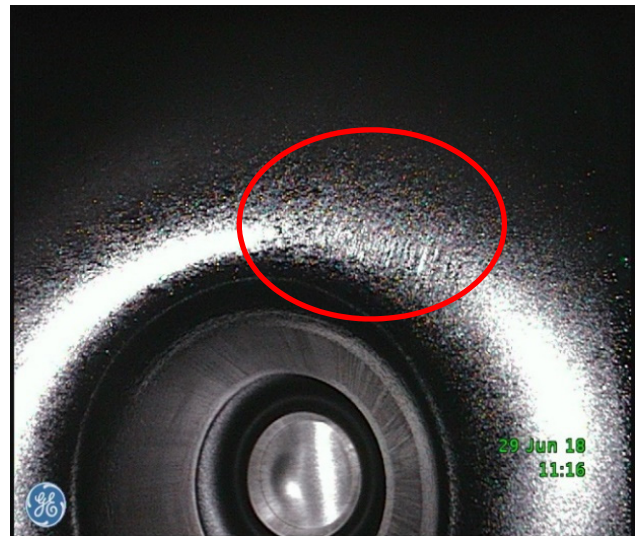
Figure 6: Surface scratches/ledges on the drift tube, possibly due to acid erosion, observed after the first Dewar test ($\beta = 0.53$ HWR, S53-113).

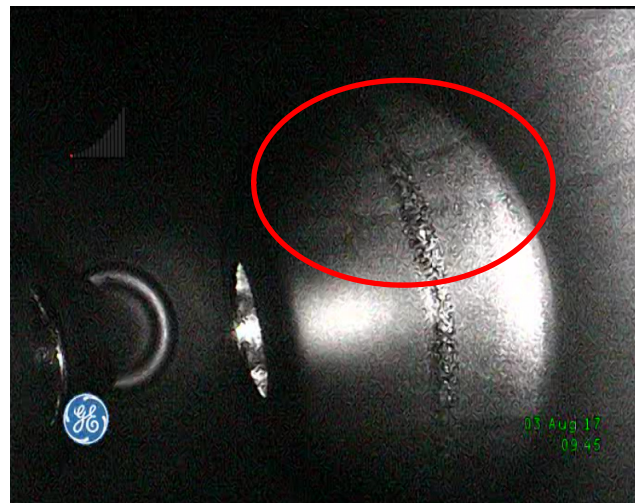
Figure 7: Acid vapour marks on outer conductor observed after first Dewar test ($\beta = 0.085$ QWR, S85-951).

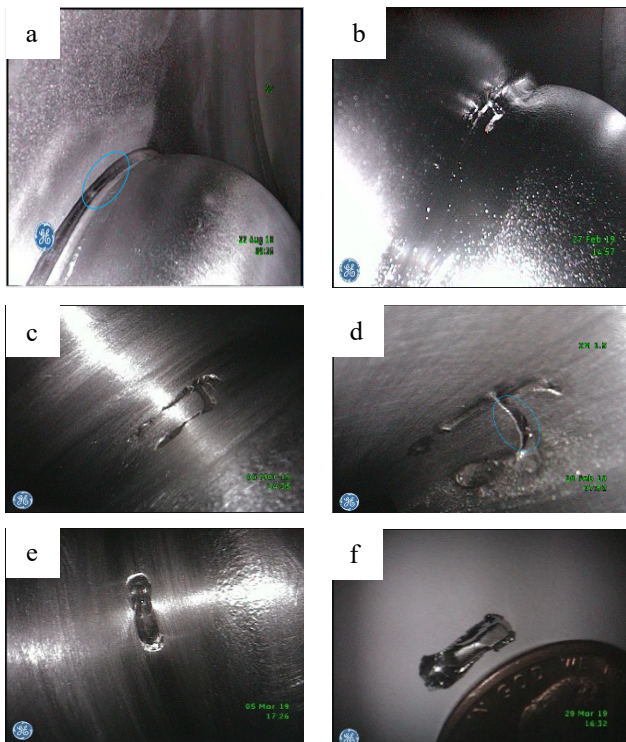
Cavity S53-128 ($\beta = 0.53$ HWR) showed marginal performance in the first certification test and had a Q-switch behaviour, as shown in Figure 9 (cyan): Q_0 and the field jumped downward at $E_a = 5$ MV/m and dropped further at about 8 MV/m. The incoming borescope inspection had shown a surface feature on the beam cup to outer conductor weld (Figure 10a). The initial thought was that the feature was residual oxide from acid etching or a weld inclusion; hence a polishing rework was implemented.

During the initial stages of polishing, the feature “opened up” revealing additional voids in the weld and along its edges (Figure 10c). Further material removal showed the area was a weld overlap with a void underneath, producing a small pocket (Figure 10d). The material over the pocket was polished away and the remaining pocket was blended into the adjacent sides (Figure 10e). Partway through polishing, a piece broke away (Figure 10f).

Figure 10: Polishing of S53-128 feature: (a) as received, before etching; (b) after etching and test; (c) after initial polishing, “opening up”; (d) shelving with void underneath; (e) top material removed, blending void area to adjacent surface; (f) fragment broken off during polishing.

After polishing, the cavity was reprocessed and Dewar tested again. In the second test, it met the FRIB certification requirements with good margin for field and quality factor (Figure 9, blue).
