The Stub to Plate Weld in Quarter Wave Resonators -
An Investigation.

M. Malev, J.S. Sokolowski*, D.C. Weisser

Australian National University, Canberra, Australia.

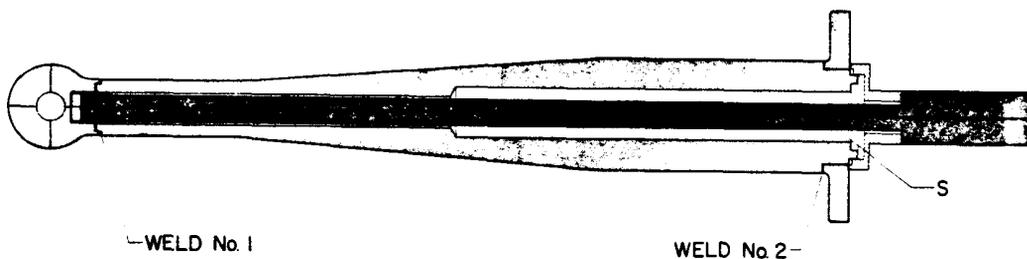
Cracks in the internal weld between the stub and end plate of quarter wave resonators have been reported by the Weizmann Institute and Washington University. Even before these problems became known, we decided to increase the width of the step joining these pieces from 1 mm to 5 mm. More importantly, it was decided to use a draw bar to squeeze the stub between the end plate and donut, as shown in the figure. This bar is mounted in the chuck of the electron

beam welder and allows the internal plate to stub weld to be done before any external welding. This assures a strong joint. The weld chosen penetrates 1.7 mm as opposed to the 1 mm possible in the previous design. A similar weld

joins the stub to donut and this too is accomplished with the draw bar keeping the joint under compression. Evidence of this compression is that the finished weld is convex. This greatly simplifies polishing.

Subsequently, the whole assembly was polished in preparation for final welding. When packing the stub assembly for shipment, it was convenient to use temporarily, an obsolete aluminum draw bar to ease handling. Upon unscrewing this, the draw bar shaft seized into the copper at point S. Removal of the draw bar required four men each on a 60 cm lever arm unscrewing the thread. Indeed this was only just possible when the draw bar was cooled with liquid nitrogen. After running out of threads, the draw bar was finally removed using a wheel puller pressing down on the end plate.

These exertions resulted in an unplanned weld test. The plate to stub weld was fine but the donut to stub weld had stretch marks. We therefore hope that this extreme test validates the plate to stub welding procedure.

It may be of some interest to describe the repair of the stub to donut weld. The proper copper draw bar was inserted to restress the weld. The weld was done at 15 ma instead of the original 12 ma to assure a complete remelt of the failed volume. This was followed by our standard cosmetic weld which is accomplished by starting with the beam focussed well above the surface just welded. The focus is slowly brought down toward the surface and held just as melting occurs. One pass is usually sufficient to produce an excellent surface finish. In this case, that was not true, and so the operator continued the weld for a second pass. This weld is the best looking one we've seen. The fact that the normal first pass didn't sufficiently smooth the surface might suggest residual fissures even after the primary weld. These observations might well imply that less vigorous treatment of stretched welds, by swaging for example, might not be adequate.
