TESTING OF COPPER PLATING QUALITY ON REA3 COUPLER BELLOWS AND APPROACH TO IMPROVED PLATING FOR FRIB PRODUCTION*

L. Popielarski[#], M. Hodek, M. Goodrich, I. Malloch, N. Putman, R. Oweiss, J. Popielarski, K. Saito, D. Victory, Facility for Rare Isotope Beams (FRIB), Michigan State University (MSU), East Lansing, MI 48824, USA

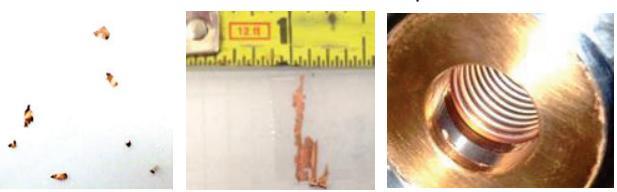
from three of eight bellows (Fig. 1). A flake removed from bellows 5 was measured to be about 20 μ m thick.

Figure 1: Flakes collected after HPR (left) and removed with scotch tape (center) and (right).

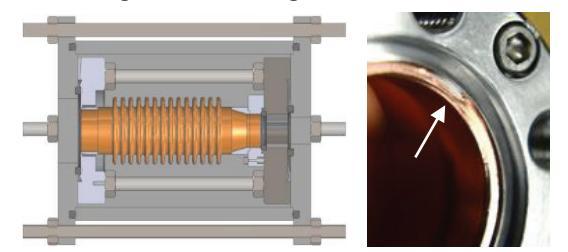
Figure 3: MSU fixture (left) and peeling seen at mini CF flange by vendor 2 (used their own fixtures) (right).

The masking fixture design was multifaceted because the small bellows must extend to open convolutions, but also provide compression on ends to create a clean O-ring seal. Fixtures were designed by MSU for re-plating efforts with vendor 1. The fixtures eliminate the use of unreliable manual masking paints commonly used by the plating industry that can cause cross contamination. Peeling at the masking seal edge is a concern and was seen on all three vendors' bellows (Fig. 3). Feedback on masking effectiveness was provided to the vendor, which led to a clean Viton gasket seal being used.

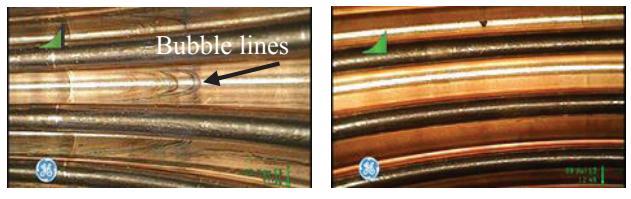
While the visual quality of the plating is not directly linked to all aspects of its performance, it can provide insight into the performance and guide in improving the plating process. The surface appearance, specifically how smooth and shiny it is, affects the thermal radiation properties between the inner and outer conductors. The quality was noticeably different between the three vendors. There were obvious discoloration patterns in the bellows from vendor 1. The bellows from vendor 2 appeared to have a shiny surface almost free from discoloration (Fig. 5, 6). While the plating from vendor 3 had a uniform dull appearance throughout the bellows.

Figure 6: Vendor 1 (left) and vendor 2 (right) plating.

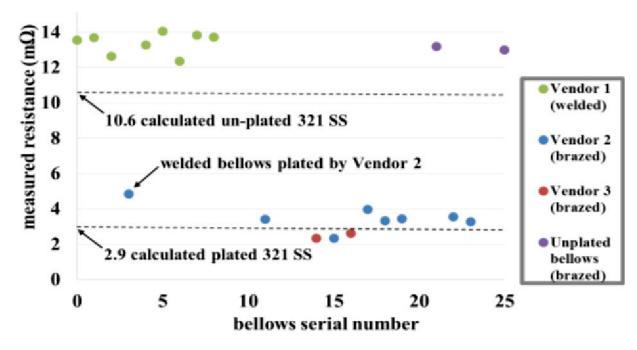
recorded as soon as the current settled. The Vendor 2 and 3 plated bellows measured 3.5 m Ω average, as expected compared to calculation. The unplated bellows was 13.1 m Ω . The vendor 1 plated bellows were similar to the un-plated, with an average resistance of 13.4 m Ω . Bellows number 3 was plated by vendor 1 and re-plated by vendor 2. The data suggests that vendor 1 bellows has, overall poor quality plating, based on electrical resistance measurements.

Figure 7: Measured resistance at room temperature.

In the future the resistance measurements, possibly at cryogenic temperatures, will be considered as part of the ACL to provide information on bulk copper properties.

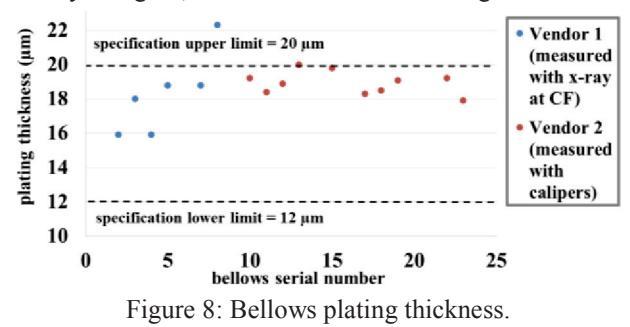
Vendor 1 plating was measured by x-ray on the conflat face, while micrometers were used by vendor 2 (Fig. 8). The step at the copper plate edge for the vendor 3 bellows, was measured 36-43 µm with a profilometer. It is common to have thicker plating at the ends, where the current density is higher, and is referred to as the dog-bone effect.

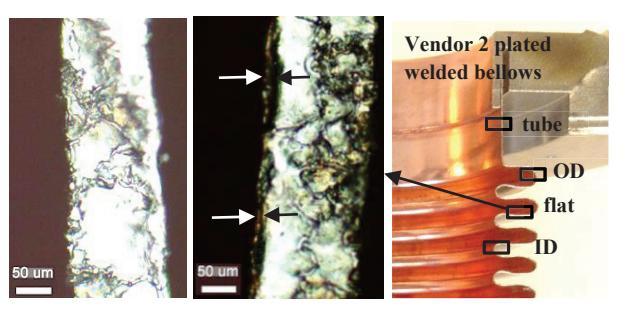
One bellows each from vendor 1 and 2 was cut in half to measure the plating thickness in four spots with a microscope. In the bellows plated by vendor 2 plating was seen on the convolution flat and varied in thickness from a few microns up to 25 μ m (Fig. 9). The plating could not be discerned on other locations and was not sufficiently identified on bellows plated be vendor 1. A better technique will be considered for future.

Figure 9: Magnification of vendor 1 plated bellows (left) and vendor 2 plated bellows (right) at convolution flat.

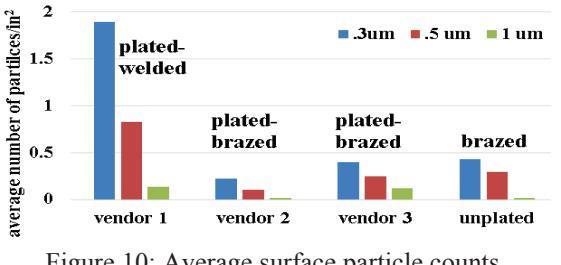
Figure 10: Average surface particle counts.

Vendor 1 bellows had the highest counts and vendor 2 averaged the fewest counts. Vendor 3 exhibited particulate on one bellows. The un-plated bellows also presented some particulate, however they did not have the same cleaning as the plated bellows, which were also degreased at the vendor. The brazed bellows showed a significant improvement in particle count reduction from the welded bellows, supporting the importance of reducing small crevices in the design to minimize trapped contamination.
