OPERATION EXPERIENCES FOR THE 1.5 GEV TLS ULTRA-HIGH VACUUM SYSTEM

G. Y. Hsiung, S. N. Hsu, T. F. Lin, K. M. Hsiao, C. C. Chang, C. K. Chan, J. Y. Yang, K. Y. Kao, NSRRC, Hsinchu, Taiwan J. R. Chen, NSRRC, Hsinchu, Taiwan; NTHU, Hsinchu, Taiwan

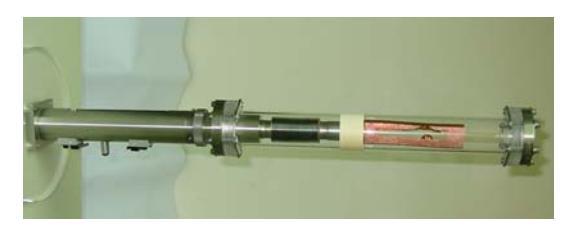
A photon aperture (PA), horizontally installed in a front end, was melted down due to insufficient cooling water supply, as a photograph shown in figure 4. When the supplied cooling water for the PA had been stuck, the cooling water for the Cu aperture was not sufficient. It caused the PA deformed due to thermal expansion. The more deformation on the upper part of PA, the closer the part moved to the center of photon beam. The higher heat load subjected to the deformed part that made the deformation worse. Finally the Cu was melted. The problem was solved by connecting the flow rate meters to the interlock system and the beam dump system.

Figure 4: Photograph of a Cu photon aperture that has been melt on upper side of the aperture.

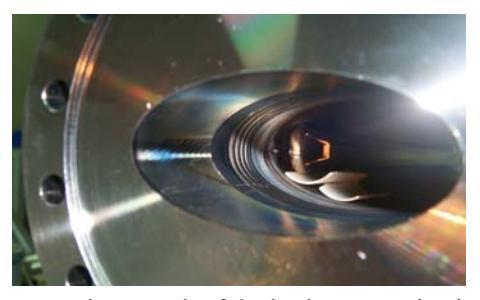
The ceramic insulation pieces were broken due to directly hitting by the upstreaming SWLS synchrotron light.[5] Figure 5 shows the broken ceramic pieces inside a kicker chamber downstream the SWLS. There is no preabsorber in front of the ceramic chamber to shield the insulators from wide-span synchrotron light from SWLS. A pre-absorber has been welded on the water cooled taper of SWLS later to shield the ceramic chamber.

Figure 5: Photograph of the broken ceramic pieces inside a kicker chamber downstream the SWLS

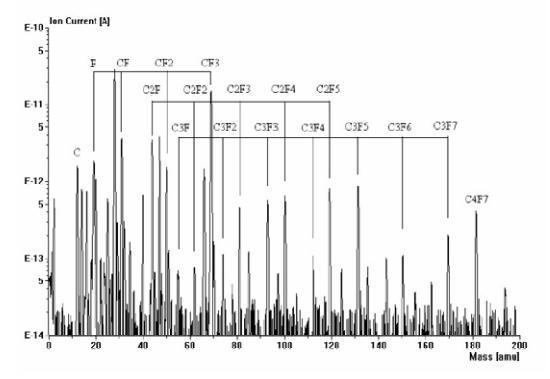
An unsuitable baking for an O-ring sealed gate valve to a temperature of 300°C was occurred at once of baking a bending chamber in the storage ring [6]. The overheated O-ring stuck on the flange when opening the valve, and then directly hit by the synchrotron radiation and melted. A residual gas analyzer (RGA) located at the bending chamber illustrated a mass spectrum, shown in figure 6, that some of the massive gas species, e.g. CxFy, be clearly observed. The problem has been solved by replacing all of the O-ring sealed valves by the all metal valves for the storage ring vacuum system.

Figure 6: A mass spectrum shows the families of cracking for "CxFy" gas species.
