# RETREATMENT OF EUROPEAN XFEL SERIES CAVITIES AT DESY AS PART OF THE REPAIR OF EUROPEAN XFEL ACCELERATING MODULES

S. Sievers<sup>†</sup>, N. Krupka, D. Reschke, S. Saegebarth, J. Schaffran, M. Schalwat, P. Schilling, M. Schmoekel, N. Steinhau-Kuehl, B. v. d. Horst, E. Vogel, H. Weise, Deutsches Elektronen-Synchrotron DESY, 22607 Hamburg, Germany M. Wiencek, Instytut Fizyki Jądrowej PAN, 31-342 Kraków, Poland

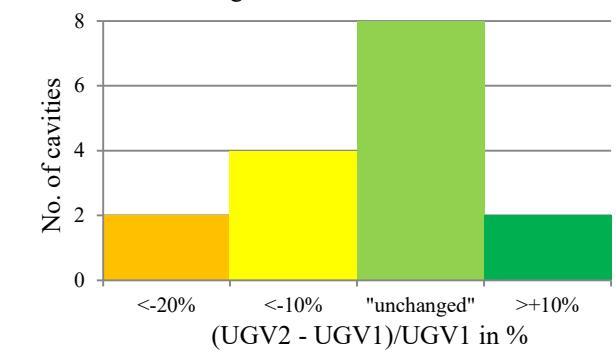
15 of 16 cavities retreated during the repair actions of the accelerating modules XM46 and XM50 met the acceptance criteria of European XFEL serial production phase and qualified for the reassembly of the cavity string. Nevertheless some cavities did not recover their original performance. The difference between the usable gradient in vertical test before accelerating module assembly and after the retreatment in the framework of the accelerating module repair efforts are compiled in Fig.1.

Due to the typical uncertainties of cold rf measurements, a variation of  $\pm 10$  % of the previous performance is marked as "unchanged".

Figure 1: Difference in usable gradient in vertical tests before accelerating module assembly and after retreatment.
