LCLS-II CRYOMODULES PRODUCTION EXPERIENCE AND LESSONS LEARNED AT FERMILAB^{*}

T. Arkan, J. Blowers, C. Ginsburg, C. Grimm, J. Kaluzny, T. Nicol, Y. Orlov, K. Premo, R. Stanek, G. Wu, Fermi National Accelerator Laboratory, Batavia, IL, USA

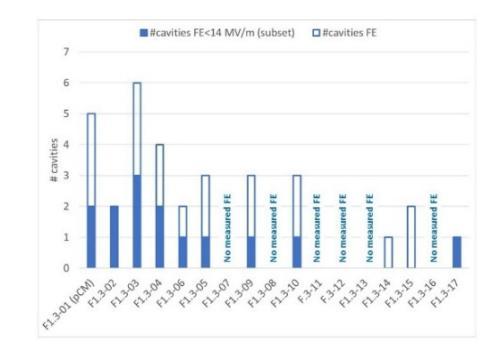
During testing of the F1.3-1 through F1.3-3 at CMTS [4], we experienced excessive field emission (FE). The FE specification requires the onset of measurable field to be above a gradient (Eacc) of 14 MV/m for all cavities. Starting from F1.3-5, we started to increase quality oversight during cavity string assembly in the cleanroom, and the FE problem started to improve significantly. During the F1.3-7 cavity string assembly, the cavity beamline vent procedures were optimized. F1.3-7 is the first cryomodule tested with no measurable FE. During F1.3-9 cavity string assembly, an external expert audit was conducted by Stephane Berry from CEA/Saclay. Audit recommendations (infrastructure and assembly processes improvements) are mostly implemented to achieve consistent FE performance [5]. F1.3-17 is the latest cryomodule tested at CMTS. Figure 1 shows the FE performance of the tested cryomodules at CMTS [6,7].

Figure 1: Field Emission Performance.

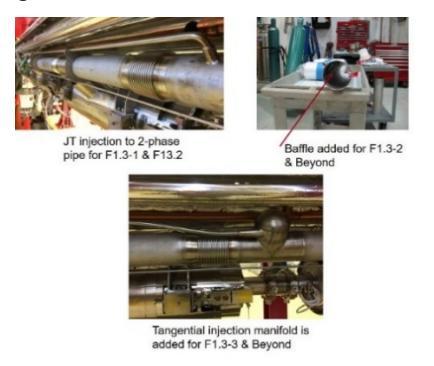
During F1.3-1 testing, microphonics detuning exceeded the specification [8]. Thermal acoustic oscillations (TAO) in the cryogenic valves internal to the cryomodule were found to be the main culprit. Design and assembly modifications to reduce microphonics were immediately introduced during F1.3-2 assembly. During F1.3-2 testing, microphonics problems were reduced but the cavity at string position #1 still did not meet the requirements of the 19th Int. Conf. on RF Superconductivity ISBN: 978-3-95450-211-0

Figure 2: Better Liquid Management and Microphonics Optimization.

LCLS-II project. Additional design and assembly modifications were done for F1.3-3 through F1.3-7. These modifications reduced the microphonics detuning. F1.3-7 is the first module where all the cavities met the microphonics requirements [3]. The most significant modifications are shown in Figs. 2-4. Most of these modifications were later retrofit to earlier cryomodules F1.3-1 through F1.3-6.

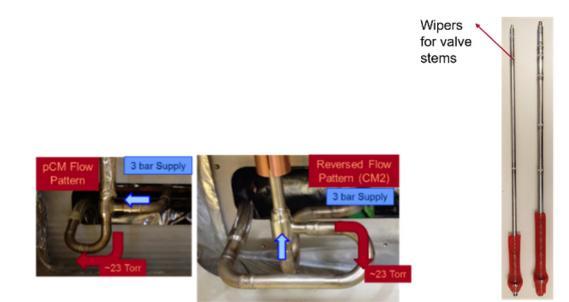
Figure 3: Wipers added to valve stem and reverse configuration welding of the valves to reduce TAO.

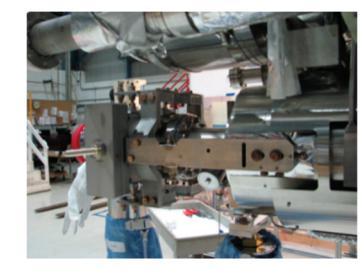
Figure 4: Added bellows between gate valve-Cav#1 and decoupled gate valve support from HGRP to reduce Cav#1 microphonics.

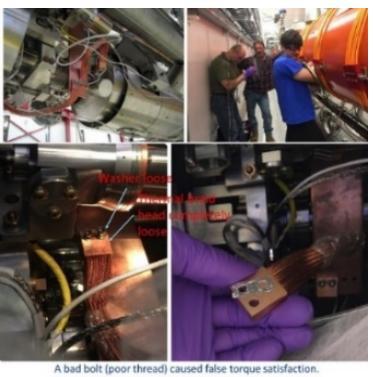
During the testing for F1.3-3, the cavity at string position 3 experienced end group heating [4]. Further diagnosis was done at CMTS after warm-up by accessing the thermal intercepts for the high-order mode (HOM) for this end group via the access ports on the side of the vacuum vessel. There are 7 access ports on the opposite side of the fundamental power coupler (FPC) ports which are designed mainly for tuner access. These access ports have proven to be very useful for repairing several other problems and eliminated the needed to pull the cold mass off the vacuum vessel for many repairs. The thermal intercept clamp installed on the HOM connector was installed with indium and torqued to specified value in a specified sequence, but a bad thread on the fastener caused a false torque reading and resulted in a loose thermal intercept installation during cryomodule assembly. Corrective actions that were immediately introduced: extra QC steps such as checking the assembled thermal intercepts by wiggling the clamp and sink and giving more attention to the torqued fasteners by peers, lead techs and the responsible engineer.

Figure 5: Thermal intercept repair.

Figure 5 shows the repair done in-situ at CMTS while F1.3-3 was warm but still on the test stand.

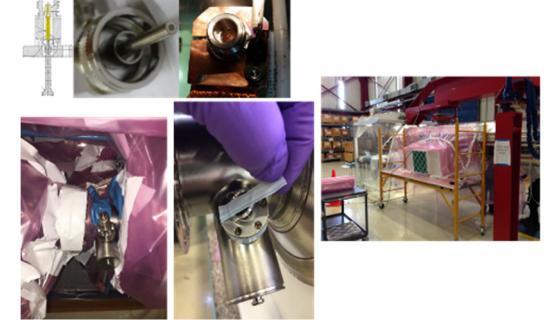
During the assembly of F1.3-5, the RF group found that Cav#2 HOM feedthrough center pin in broken. This was found during the final HOM notch frequency tuning before the lower heat shields were welded. After the RF cable was removed, the broken pin was diagnosed. A tent cleanroom was built. A nitrogen fogger was used to optimize the location and rotation speed of the fan filter unit. Particle-free UHV disassembly and assembly procedures were developed and tested on the bench with a spare cavity. A HOM feedthrough with a broken pin was replaced and leak checked successfully. This was a one-time incident, and an official root cause analysis was not done. The mitigation strategy to eliminate re-occurrence is to ensure that protective caps are installed throughout the cold mass assembly. The RF group also changed the procedure for HOM notch frequency tuning by keeping the RF cable connected during tuning. See Figure 6.

Figure 6: Broken HOM feedthrough replacement.

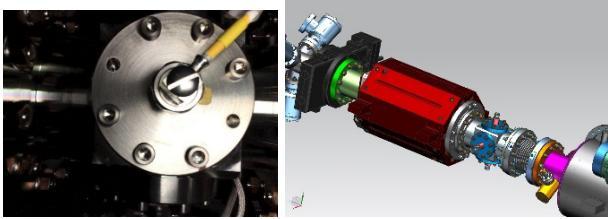
Figure 7: BPM.

psig with boiled off nitrogen gas. During incoming quality control checks at SLAC, it was found that the beamline vacuum was at atmospheric pressure. Further investigation at SLAC showed that the BPM electrical feedthrough flange which faces down lost 2 out of 8 fasteners. One fastener was fully disengaged and fell; the other fastener was hanging only by a thread. See Figure 7. Tuner access ports were used to determine that some fasteners from the cavity string position 1 tuner and cold mass upper assembly got loose and fell during cryomodule shipping. The LCLS-II project halted cryomodule production immediately to start a formal investigation for the root cause of this catastrophic failure.

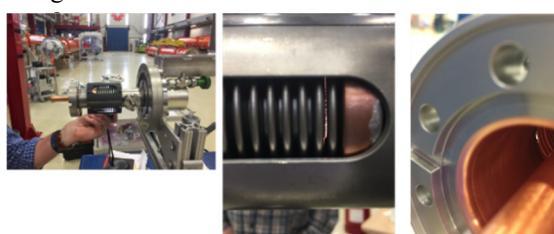
The disassembled cold end couplers showed that the convolutions of the bellows were damaged for both couplers and caused the catastrophic beamline failure for F1.3-6. See Figure 9.

Figure 9: First convolution of the bellows is broken.

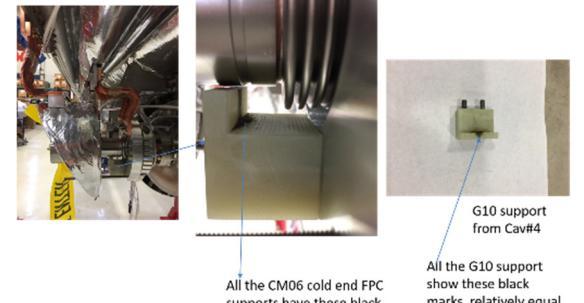
A new investigation was started to understand the root cause of these bellows convolutions failures. Looking at the fundamental power coupler design [9] and performing an autopsy on the F1.3-6 couplers, we found that the G10 coupler support parts experienced some scoring and G10 dust was found on all the supports. See Figure 10.

All the CMU6 cold end FPG supports have these black dust on the G10 supports (Dust is being analyzed) All the G10 support show these black marks, relatively equal size for all the cavities except Cav6 which has a larger mark

Figure 10: G10 coupler supports friction dust and scoring points to excessive motion during cryomodule shipping.

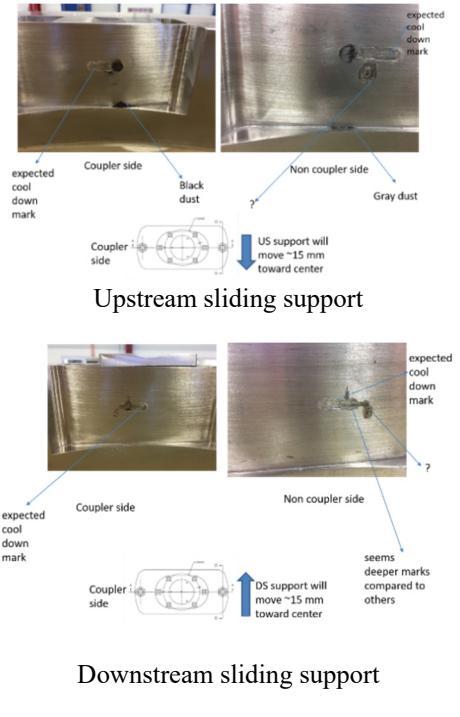
The vacuum vessel removed from F1.3-6 was inspected for damage and some unusual wear marks were found inside the vacuum vessel (Figure 11). These wear marks indicated that the cold mass moved and shifted inside the vacuum vessel during cryomodule shipping.

Center fixed support Figure 11: Wear Marks on F1.3-6 Vacuum Vessel.

These findings triggered a review of the cryomodule assembly travelers; we changed the procedures and added torque and multiple check-and-verify requirements to ensure that the cold mass is properly secured inside the vacuum vessel. An extensive investigation was also done by several multi-laboratory teams to better understand the root cause of the coupler bellows failures. These investigations concluded that the bellows used on the couplers is properly manufactured and properly handled during cryomodule assembly. There were no indications that anything done by coupler vendor nor the cryomodule assembly group which could have caused these bellows to fail during cryomodule shipping. As part of this extensive investigation, cryomodule shipping procedures and fixtures were also investigated to further understand the root cause of the cold end coupler bellows failure. [10] Simulations, shaker table tests using actual coupler components, road tests using the concrete dummy cryomodule with extensive and sophisticated instrumentation (such as shock logs, accelerometers, laser displacement sensors etc.) indicated that performance of the LCLS-II shipping end caps and shipping frame fixture are very different from those for XFEL (the design basis for the LCLS-II fixture). The shipping caps as designed did not provide reliable support of the cold mass inside the vacuum. The shipping frame fixture isolation system was very stiff; the isolation springs were not properly sized to dampen unwanted shocks and to restrict the undesired motion. After improvements were done and approved by the project team, F1.3-5 was used for local transport tests with the improved fixtures and procedures. To our surprise, F1.3-5 experienced a beamline failure during local transport tests. In further investigation of the beamline failure, we found the same cold end bellows failure on Cav#1 cold end coupler bellows. An in-depth analysis of the data showed that the fundamental power couplers as assembled in the cryomodule experience motion which results in failure of the cold end coupler bellows. This was not experienced for the 100 XFEL cryomodules shipped from CEA/Saclay France to DESY, Germany. The reason for this is currently being investigated by DESY team with some shaker table bench tests.

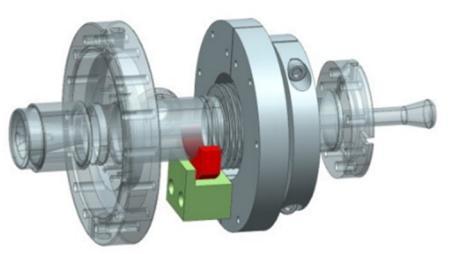
Figure 12: M-mount installed on an LCLS-II coupler.

For LCLS-II cryomodules shipping, it was decided that we need to reduce / eliminate this unwanted coupler motion. One alternative is to remove and ship the cryomodule without warm end couplers. The beamline is under vacuum during cryomodule shipping. In order to support the vacuum forces on cold end coupler bellows, restraint rods also called "Berry Bolts" are used. These are shipping restraints and need to be removed during warm end coupler assembly after shipping. Fermilab shipped the F1.3-4 cryomodule with this configuration to SLAC and it arrived with beamline vacuum intact. Although it was expected to be the most technically safe solution for the cold coupler bellows, the logistics and cost of warm end coupler installation at the SLAC linac area were deemed difficult to overcome and this scheme of cryomodule shipping was dropped. The JLab team developed a scheme to install temporary supports called M-mounts to the coupler. (See Figure 12). This scheme does not require warm end coupler disassembly and provides the needed support to minimize the motion of the coupler which causes cold end bellows failure.
