ABORT DIAGNOSTICS AND ANALYSIS DURING KEKB OPERATION

H. Ikeda*, J. W. Flanagan, T. Furuya, M. Tobiyama, KEK, Tsukuba, Japan
 M. Tanaka, MELCO SC, Tsukuba, Japan

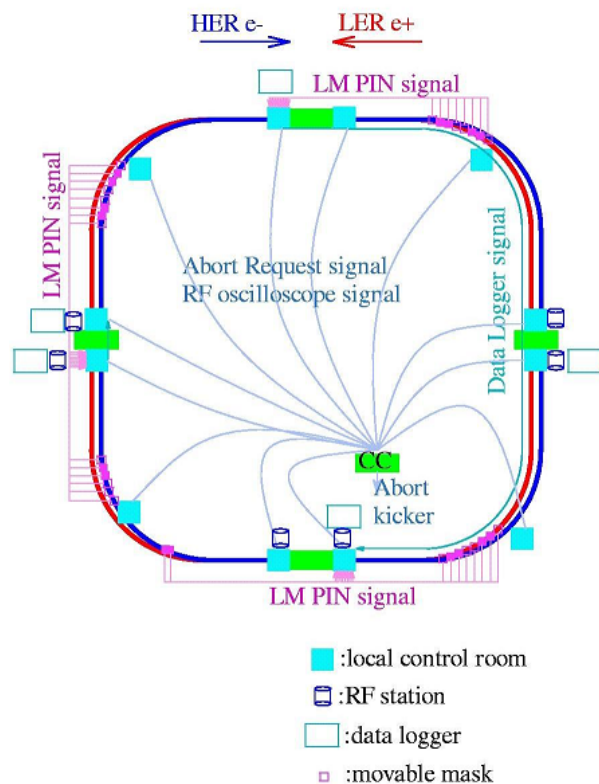
Figure 1: A signal flow of data loggers.

The signal flow of the data loggers is shown in Fig. 1. Logged data were beam current measured by a direct-current-current transformer (DCCT) [2], a part of loss monitor signals from PIN photo-diodes (PD) and ion chambers (ICs), signals from the RF cavities, i.e. cavity voltages and output of klystrons, the beam phase signal showing the deviation of the synchronous phase, the injection trigger timing and the Belle PD signal. Most PDs were fixed on the movable masks of each ring, and determined the ring in which the beam loss occurred. On the other hand, ICs were installed in the whole tunnel and covered the wide range in space, but could not distinguish the ring. These signals were useful to diagnose the cause of the beam abort since they had a strong correlation with the beam condition. The recorded data were sent to the KEKB central control room (CCR) via the KEK internal network then monitored by operators. The information was ready for inspection within a few minutes after the abort. The beam oscillation signals were obtained from the beam oscillation recorder (BOR) [3]. The signals were also ready within a few minutes after the abort. The BOR recorded the bunch-by-bunch beam position over 4000 turns immediately before the beam abort so as to detect vertical and horizontal beam oscillations.

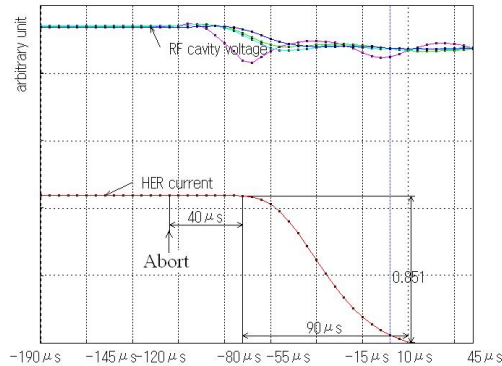
Figure 2: Examples of logged signals at a moment of (a) a manual beam abort, (b) a beam phase abort caused by RF voltage down and (c) a beam loss abort caused by vacuum problem. Signals in (c) are the LER beam current, the beam phase, the loss monitor PD and the Belle PD from top to bottom.

A manual abort is a beam abort triggered manually by switches by operators. An example of the signals at the manual abort in HER is shown in Fig. 2 (a). The DCCT signal shows delay of 40 μs and decay in 90 μs in spite of

the beam being aborted in 10 μs , i.e. one turn. This is a normal behaviour of the DCCT signal when the beam is aborted in one turn. If the decay time and the decay slope differed from this example, the abort was judged abnormal and the data logger information was analyzed to determine the cause of the beam abort.

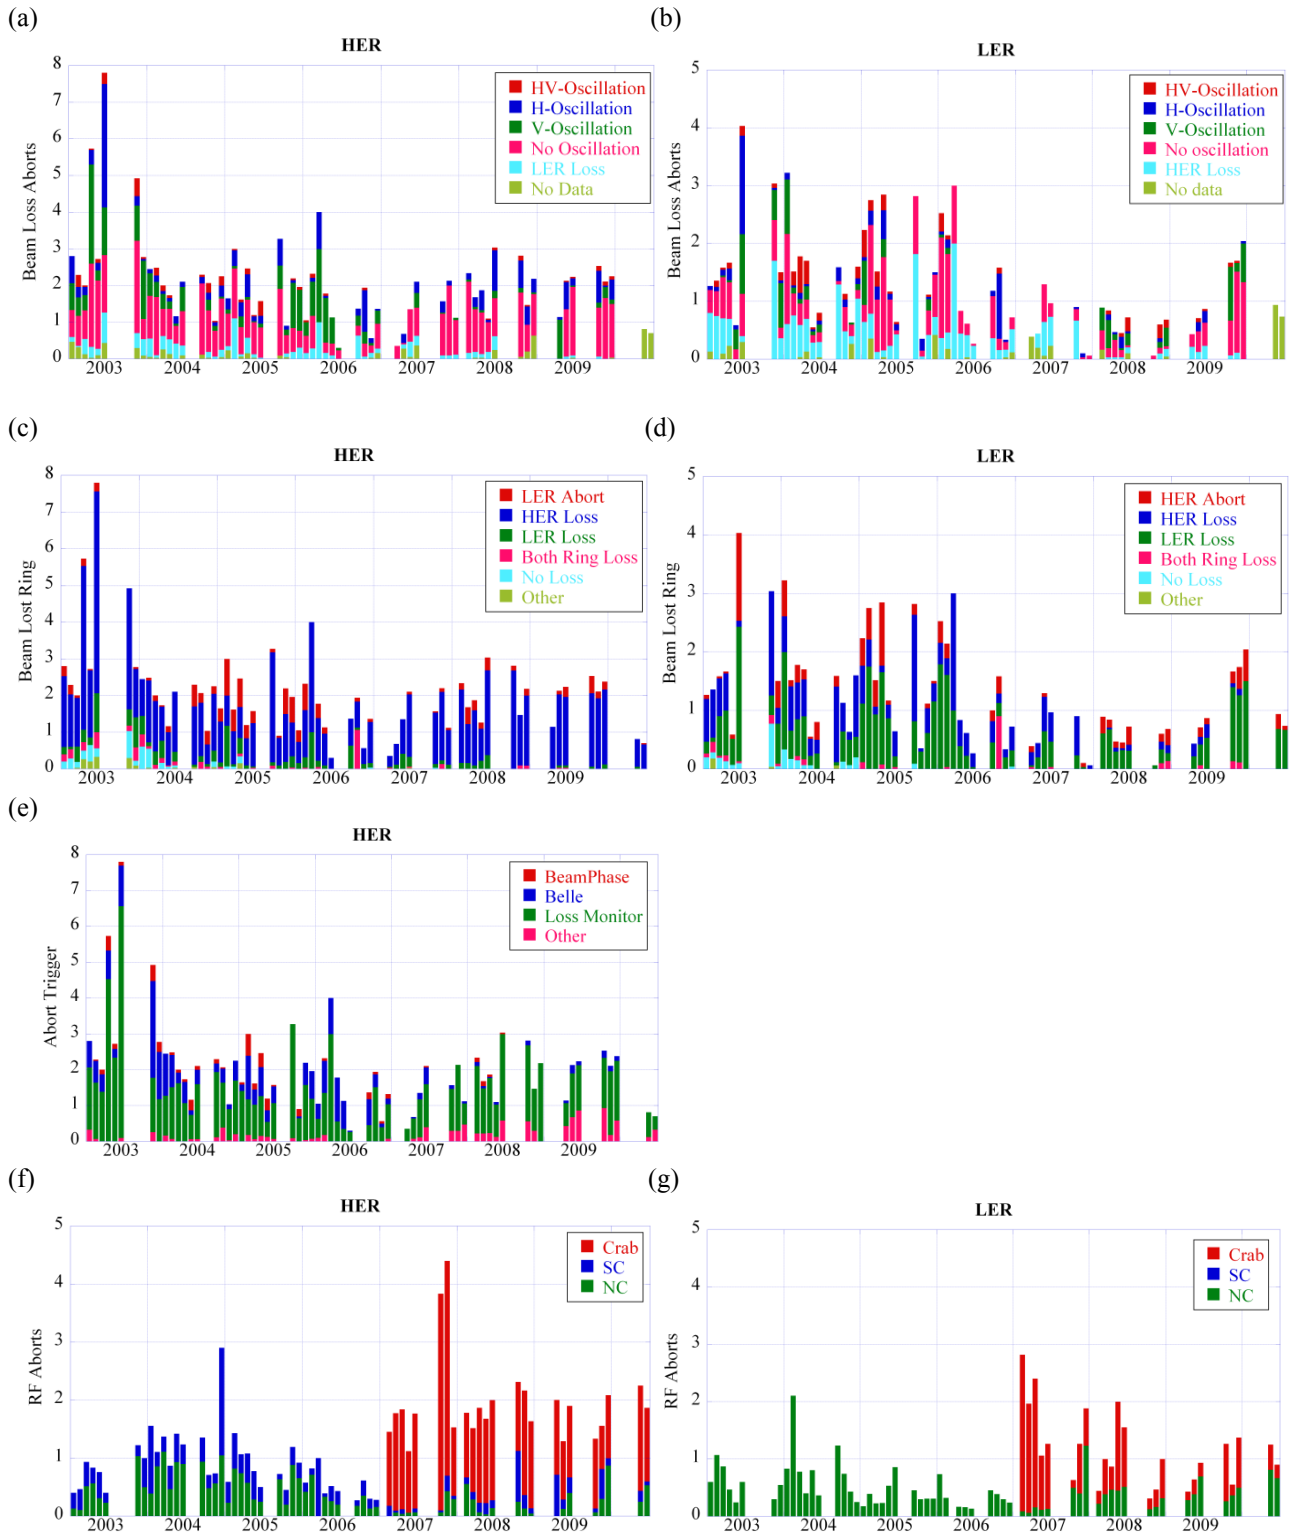
Figure 3: Cause of beam loss in HER (a) and LER (b), status of beam loss and the abort when HER (c) or LER (d) was aborted, signals which requested the abort of HER (e) and aborts triggered by the RF of HER (f) and LER (g).

avoid this situation, the BP was used as an abort trigger [4]. The trigger level of the BP abort was set to one degree in HER and five degrees in LER. We also installed a fast cavity voltage monitor in each RF station. Figure 3 (f) and (g) show the rate of RF aborts. While the HER was equipped with both superconducting cavities (SC) and normal conducting cavities (NC) [5], the LER was equipped with only NCs. The rate of the abort was similar in both types of cavities.

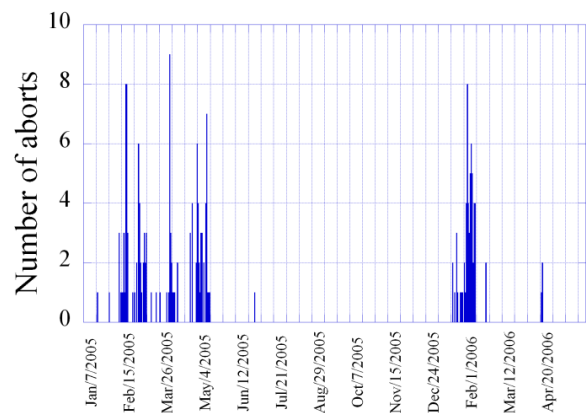
Figure 4: The number of beam loss aborts caused by vacuum troubles.

Figure 2 (c) shows another example of the beam loss abort in which no beam oscillation was observed. The tunes were stable. The beam phase (BP) started to swing before the beam loss happened and also before the loss monitor PD signals and the Belle PD signal appeared. This type of the abort was found in Feb. 2005. It was found that some bellows were troubled. The pressure and temperature near the bellows were higher than usual. By fixing the vacuum problem, the abort ceased. This type of abort happened again in 2006 as shown in Fig. 4. The vacuum troubles were also found again in this case.

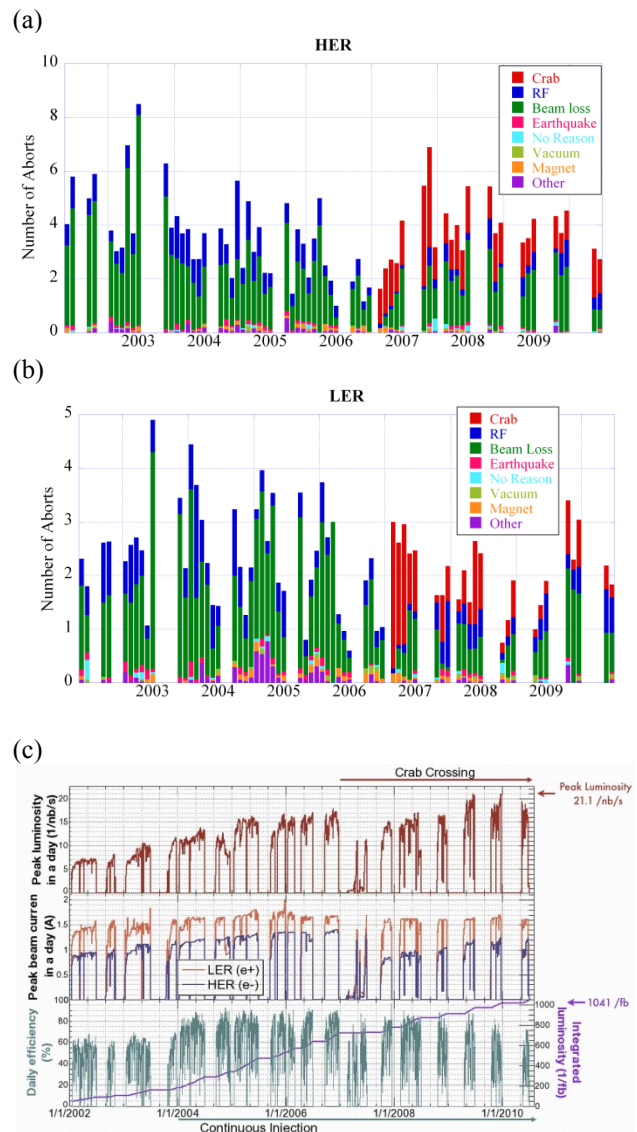
Figure 5: Statistics of the beam abort for last eight years of KEKB operation in HER (a) and LER (b). (c) History of the beam current and the luminosity of KEKB.

The statistics of the beam abort, which are categorized by analyzing the information of the data loggers and other monitors, is shown in Fig. 5. It shows the number of aborts per day averaged over one month during eight years operation of KEKB with high beam current. The manual aborts issued by operators are not included. From the figure, we see that there are two major origins of the beam abort; the RF trouble and the beam loss. Since the coupling between the beam and RF cavities are strong, it is important to clearly classify the cause of the abort in order to improve machine performance. The fractions of the RF and beam loss aborts in all number of aborts were 30% and 60%, respectively, before the crab cavity installation. The ratio of the crab cavity abort was higher than the other RF cavity aborts, but the sum of all aborts

were not changed after the installation of the crab cavities since the beam current at the crab operation was lower than that before the crab operation. There are many other aborts due to earthquakes, troubles of vacuum system and magnet power supplies and so on, though the fraction of these aborts was small. The number of the aborts did not strongly depend on the beam current as shown in Fig. 5 (c) and was reduced by optimization of the abort condition. The number of HER and LER aborts was 3.7/day and 2.3/day respectively. The total number of the aborts was about 6000 and 4000 in HER and LER, respectively.
