CARBON FIBER DAMAGE IN PARTICLE BEAM

M. Sapinski*, B. Dehning, A. Guerrero, M. Meyer, T. Kroyer
CERN, Geneva, Switzerland

Abstract

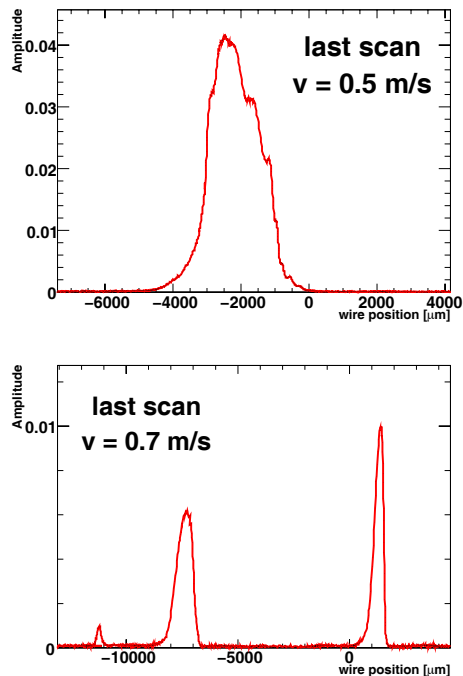
Figure 1: The last profiles before the wires broke. The upper plot shows breakage of vertical wire: deviation of the registered profile from Gaussian shape is visible. The bottom plot shows breakage of the horizontal wire: multiple peaks suggest that the wire was already fragmented.

In Fig. 1 the beam profiles registered during the last scans are shown. The deviations from Gaussian shape and multiple peaks are symptoms of the wire deterioration and breakage. The measurement of the wire resistivity after these scans shows that the wire has been broken.

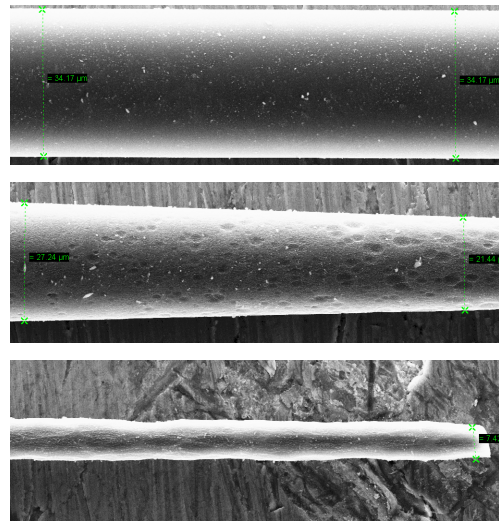
After the experiment the wire scanner was opened and both wires removed. They have been photographed with scanning electron microscope. The images obtained with 1000 times magnification, taken in three positions: at the center of the beam impact, 0.5 mm away and 1 mm away are presented in Fig. 2. They clearly show that the main process deteriorating the wire is sublimation due to the high temperature. In the location of the fracture the remaining wire diameter is only about 7.5 μm, which corresponds to the sublimation of 95% of the material. At 0.5 mm from the fracture the beam traces are visible and sublimation removed about a half of the material. At 1 mm from the beam center the fiber is intact.

Figure 2: Fiber fracture at three distances from the beam impact location: 1 mm (upper plot), 0.5 mm (middle plot) and at beam center location (bottom plot). The presented wire has been installed in the vertical scanner.

In conclusion, the wire breakage mechanism during these scans can be explained as a sublimation of the wire material until the point at which the mechanical properties of the wire does not allow to withstand forces which appear during the scan.

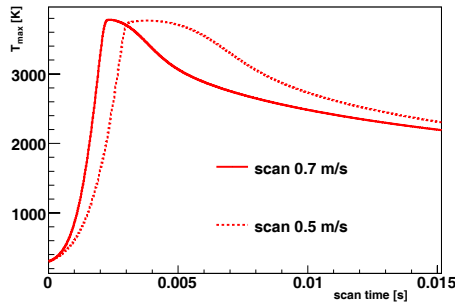
Figure 3: Simulated evolution of the maximum temperature of the wires during final scans.

The simulated evolution of the maximum temperature of the wire in the point where wire crosses the beam maximum is shown in Fig. 3 for scans at 0.5 and 0.7 m/s. At the speed of 0.5 m/s, a plateau of about 2 ms in temperature evolution due to the equilibrium between beam heating and cooling by thermionic emission is observed.

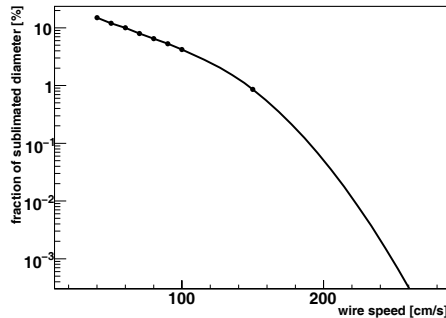
Figure 4: Simulated sublimation of the wire material in the wire center during scans with decreasing velocity.

the wire diameter expected to sublimate during scan as a function of the velocity is shown. Scans with speeds of 0.5-0.7 m/s lead to sublimation of 8-12% of the wire diameter. The whole scan sequence used in the damage test should leave about 12–14 μm of the wire. This expectation is almost two times higher than the wire diameter measured on post-mortem samples.

From Figure 4 it is concluded that the sublimation process removes significant amount of material for all wire speeds slower than 2 m/s. This determines a safety factor of 4, with respect to breakage conditions to assure safe scanner operation. This factor can be obtained by decreasing the beam intensity or by increasing the wire velocity.

In case of the two wire breakages described in this paper the \mathcal{E} is $2.7 \cdot 10^{11}$ and $2.3 \cdot 10^{11}$ MeV/mm. The safety factor 4 has been deduced from Figure 4 and therefore the critical \mathcal{E} is about $5 \cdot 10^{10}$ MeV/mm which corresponds to 8 mJ/mm.
