OPERATING EXPERIENCE OF KICKER MAGNET SYSTEM IN THE J-PARC 3GeV RCS

K. Suganuma[#], T. Togashi, M. Watanabe, M. Kinsho
Japan Atomic Energy Agency, Tokai, Naka, Ibaraki 319-1195, Japan

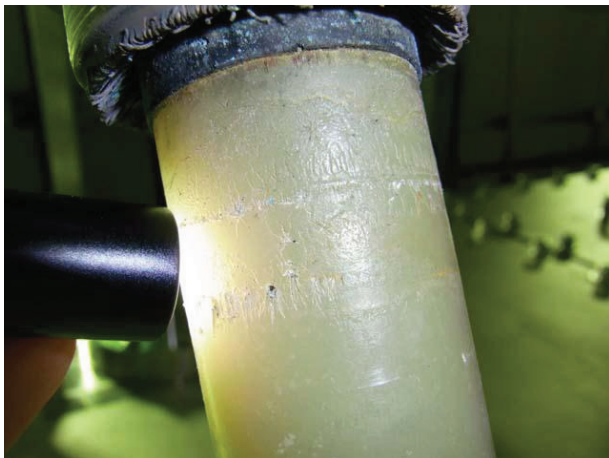
Figure 1 shows a photograph of insulator surface of the high-voltage coaxial cable. Many scratches on the surface of polyethylene can be seen. This phenomenon was caused at near connector part, it was observed for all cables. Figure 2 indicates a dielectric breakdown at the same position. To avoid electric-field concentration, these surfaces were reinforced by a semi-conductive layer with high-dielectric materials.

Figure 1: Scratches on the surface of polyethylene insulation layers.

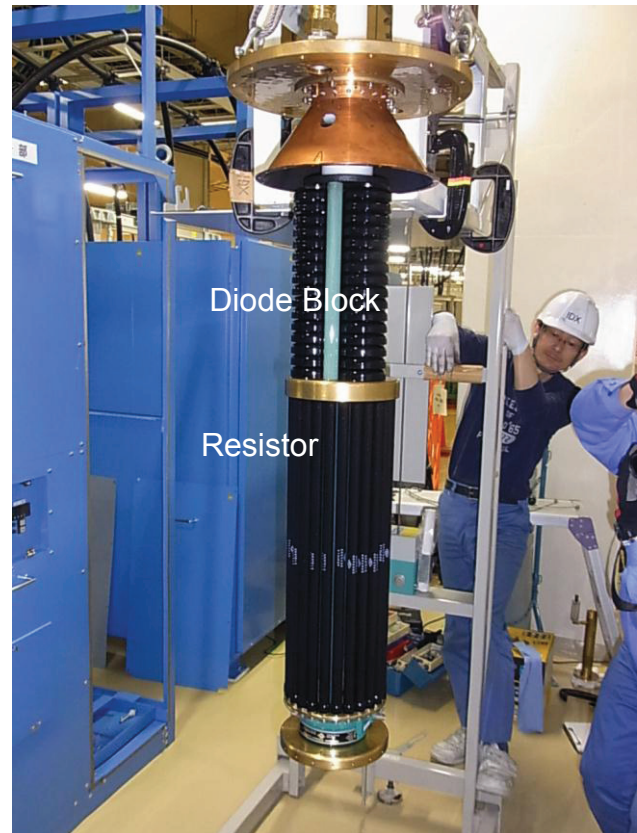
Figure 3 shows a photograph of matching resistor. In 2012, all resistance values were measured, and it was found that some resistance values is increased to 30% of the specification (512.5Ω). By visual inspection, many cracks on the surface of paint film were observed. The cause has not been solved yet whether it is due to deterioration with age or not, the counter measure is under reviewing..

Figure 3: Matching resistor.

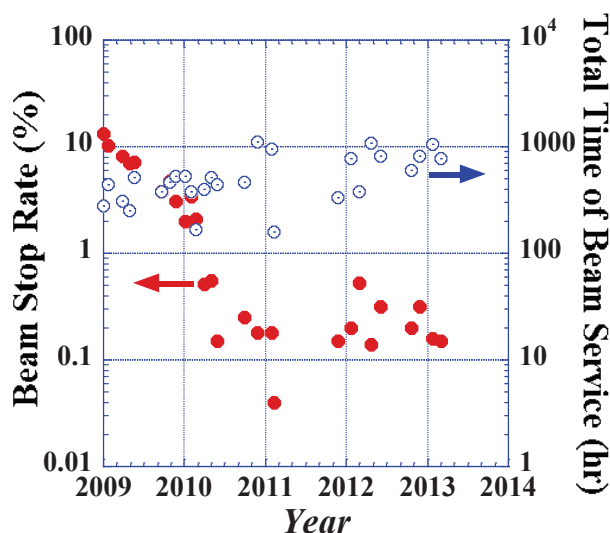
Figure 4: Record of beam stop rate in beam operation.

The thyatron tube of CX1193C which is produced by e2V technologies Ltd., has been used for this switch circuit. The number of 16 tubes is installed into the circuit. Table 3 indicates the number of replacement and the life time in each fiscal year. All tubes of 18 were replaced by new tubes in 2009, 11 tubes in 2010 and 8 tubes in 2012 were replaced. The number has been decreased every year gradually. Figure 4 shows the record of beam stop rate due to false operation of thyatron tube. In 2009, the beam stop rate of 2~13% was recorded. However, the rate has been decreased to less than 1% after March, 2010. Since it was found that adjustment of deuteron gauss by reservoir voltage is a technical key for a stable operation of Thyatron tubes, the adjustments have been done in every maintenance works. From this result, the false operation frequency was extremely decreased, and the

beam stop rate was to be less than 0.5% in November, 2012.

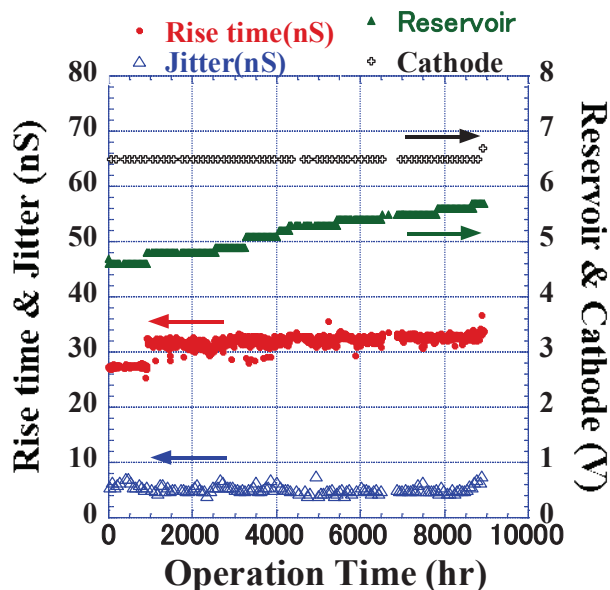
In Fig. 5, operating time of thyatron tube (CX1193C) versus the typical data is indicated. It can be seen that the reservoir voltage has been increased gradually by adjustments. Because deuteron gauss from the reservoir tank has been decreased gradually as operation time passes, the adjustment by increasing reservoir voltage is needed to keep deuteron pressure. This adjustment is indispensable for a stable operation, since deuteron gauss is applied to obtain a rapid current rise time.

Figure 5: Typical data of Thyatron CX1193C.
