SPALLATION NEUTRON SOURCE SUPERCONDUCTING LINAC KLYSTRON TO CAVITY MISMATCH EFFECTS AND COMPENSATION*

Abstract

Observations of several of the 81 klystron output waveforms into their respective superconducting cavities do not correspond with their rectangular klystron inputs in open loop mode. This can't be completely explained by a drooping high voltage power supply especially when the waveform is parabolic. Some possible causes and effects of these anomalies are presented.

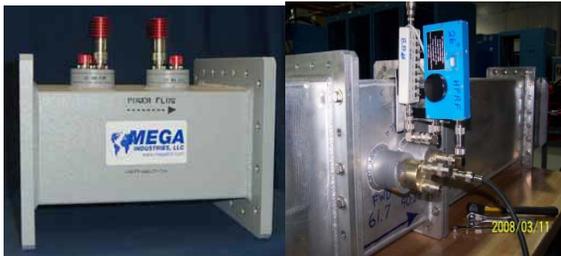
Our standard waveguide directional coupler couples -63 dB of the forward and reflected power to the LLRF detectors (Figure 3a) with a nominal directivity of 26 dB.

Figure 3 a, b: Waveguide Directional Coupler and 60 dB directivity modified unit.

An average circulator might only reflect 0.5 kW of 200 kW forward power. Thus the signal at the reflected directional coupler is comprised of the forward power (down 63 + 26 dB) and the reflected power (down 63 dB). These two signals are of the same order in amplitude. The signals combine with phases which depend on the physical location of the coupler with respect to the circulator and its distance from the klystron. All 81 systems are physically different. If two signals were in phase it appeared as high reflected power and if they were out of phase it appeared as a perfect well-matched circulator. So our reflected power measurements used to adjust the TCU were based on inaccurate coupler values.

has two N-type connectors; one is the output, the other a standard 50 ohm load. The accuracy and part-to-part variation of this standard load is what limits the directivity. This load was replaced with a circuit containing a variable attenuator and variable phase shifter (Figure 3b). These were adjusted to optimize the directivity at 805.0 MHz using a network analyzer. 60-dB directivity (Figure 4) was achieved using this technique and two units were constructed to test on an SCL RF system. With these units we observed that when the reflected power was truly minimized, the klystron output was still distorted.

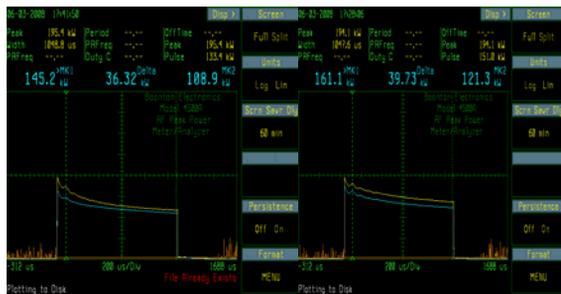
impractical because the RF systems must be off while the linac tunnel is accessible. Fortunately a subset of the measurement appeared to give enough information to make the adjustment during short non-beam periods. Both the SCL klystron output power and cavity input power are recorded by the LLRF High Power Protect Module (HPM) [6]. This is accessible from the control room. The TCUs can be adjusted in-situ with a laptop and auxiliary connection. The problem with using the HPM readouts is the arbitrary scales on each waveform. The actual values can't be read directly. This wasn't a large impediment when it was shown empirically that if the two forward power measurements on the input and output of the circulator had the same slope, the klystron/circulator/cavity match would be satisfactory.

Figure 5: Before (left) and after bias current adjustment with pulse power meter.
