EVOLUTION OF THE DEFECTS ON THE NIOBIUM SURFACE DURING BCP AND EP TREATMENTS

P. Michelato, L. Monaco, INFN Milano - LASA, Segrate, Italy

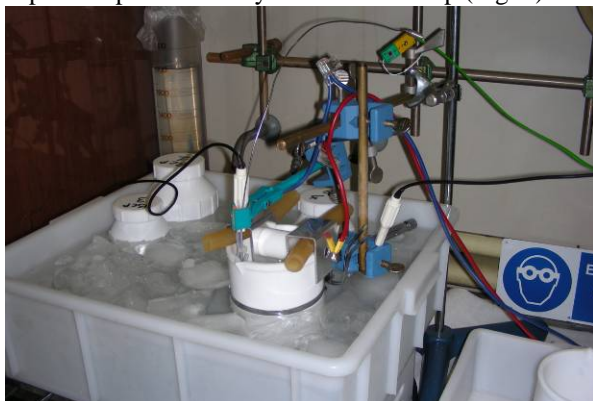
Figure 1: EP experimental set up.

A parallel plate electrolytic cell was set up (Fig. 1).

Two vertical electrodes (front surface about 35 cm²) with an electrode distance of 40 mm have been used. One electrode is pure Al (99.5 %) while the other one is the Nb plate to be treated. The EP solution (1 litre HF: H₂SO₄ 1:9) is contained in a PTFE beaker kept at the desired temperature by immersion in a water basin cooled by ice. A magnetic stirrer agitates the acid during the EP (Fig. 2).

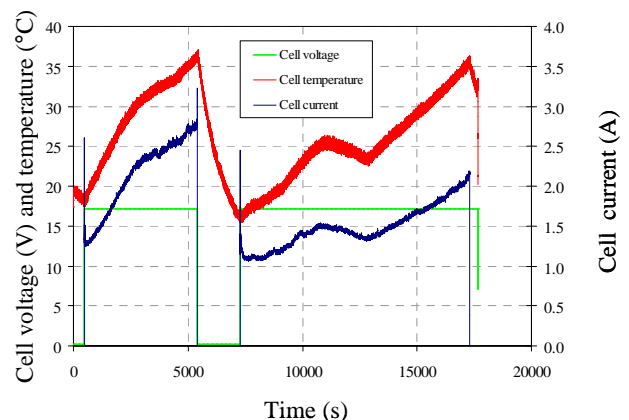
Figure 3: Typical behavior of the voltage, current and temperature during the EP process.

The operative temperature is maintained between 20°C and 35°C: reaching this temperature the process is stopped waiting for acid to cool. Cell voltage and current are recorded at 1 Hz, together with the acid temperature. All measurements described in this paper have been done at constant voltage (17 V).

Typical behaviour of the EP process is shown in Fig 3.

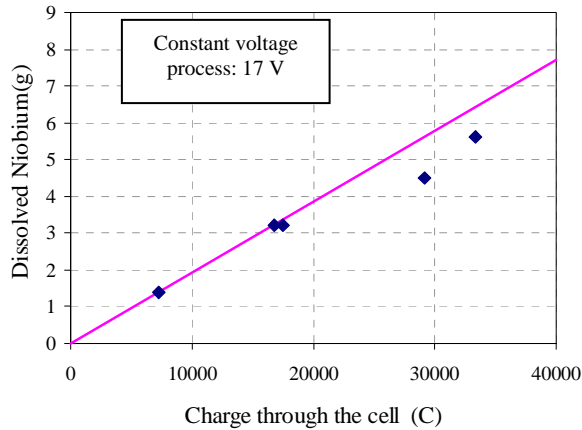
Figure 4: Behaviour of the dissolved Nb vs. the charge through the cell for 5 EPs. Blue dots are the experimental data, the pink line is the Nb₂O₅ theoretical value.

The ratio between the amount of Nb dissolved in the process and the charge passed through the cell gives information about the electrochemical reaction in the EP cell. Data of our processes are shown in Fig. 4. The angular coefficient of the curve indicates what kind of

oxidation reaction is under way in the electrolytic cell. Data are in accordance with the formation of the Nb₂O₅ (2 electrons for each Oxygen atom, Oxygen/Nb ratio 2/5) as shown in Fig. 4.

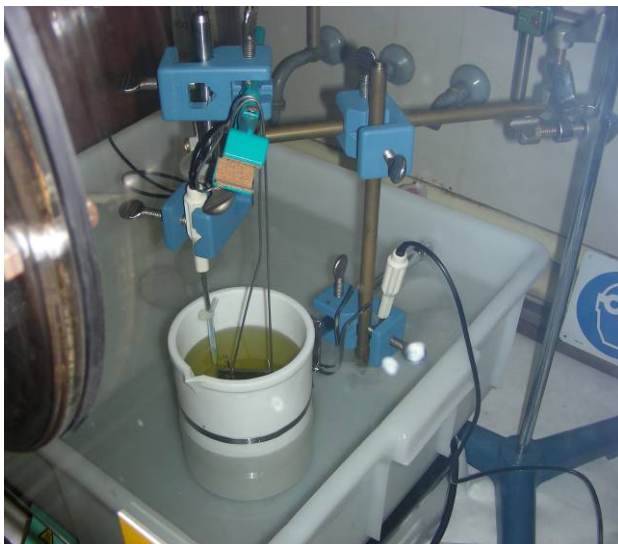
Figure 5: BCP experimental set up.

The BCP experimental set up (Fig. 5) use the same ice cooled basin and PTFE beaker as the EP one. Samples are suspended in the BCP solution (1:1:2, HF, HNO₃, H₃PO₄) while a magnetic stirrer ensures the acid agitation.

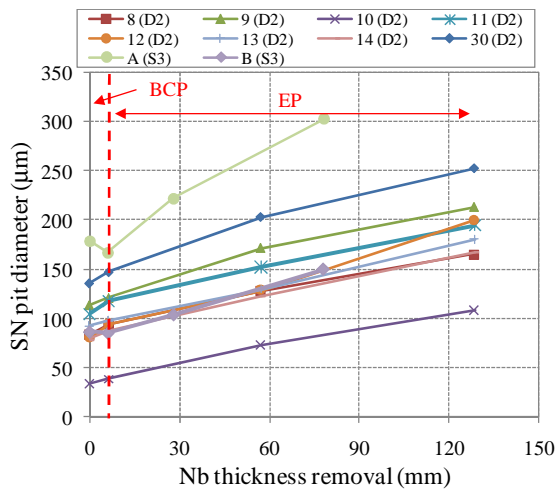
Figure 10: Diameter evolution vs. Nb thickness removal for SN pits.

The diameter evolution, as reported in Fig. 10, of SN pits show a larger increase with respect to the RN pits.
