REVIEW OF OPTICAL INSPECTION METHODS AND RESULTS

K. Watanabe#, KEK, Ibaraki, Japan.

Abstract

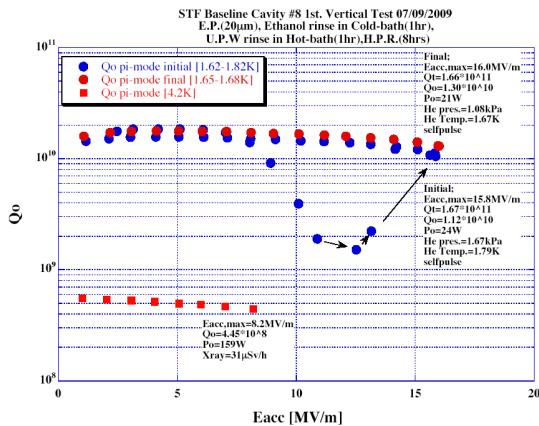
Figure 13: Result of 1st vertical test of MHI-08.

The 1st vertical test of MHI-08 carried out at June 2009. Result of vertical test is shown in Figure 13, 14 [9]. The cavity performance was 16 MV/m in pi-mode. T-map detected a hot spot in pi-mode at 2-cell equator, and the angle which center of heating was about 180 degree. Reason of field limitation was quench at 2-cell equator. The performances of other cells were achieved more than 25 MV/m. Marked suspicious spots were no heating in vertical test. After vertical test, the cavity was disassembly, and inspected at hot spots with T-map result. The result of inspection is shown in Figure 15. A pit type defect was found at hot spot location by T-map. Size of defect was about 700 x 500 µm, and the depth of defect could not measure by Kyoto camera system due to steeply wall gradient. However, the inspection before vertical test at this location was no defect. A pit was made after EP-2 process. A defect like this hot spot was not found at other EBW seam of equators.

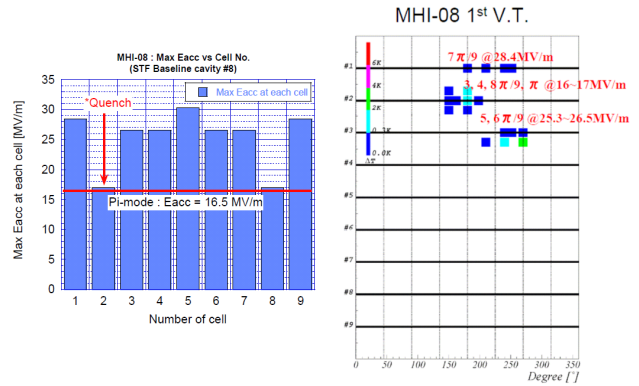
Figure 14: Results of passband measurement and T-map of MHI-08.

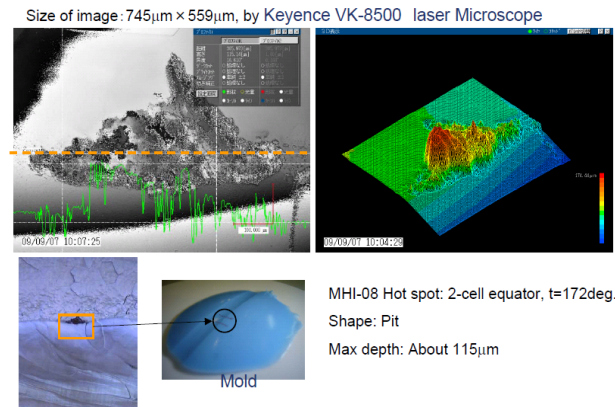
Figure 16: Image of replica and result of shape analysis.

To obtain the information of the defect, the molding method was applied for MHI-08. The mold material used “WACER DENTAL ADS931” (the material is silicones.). The image of replica and result of shape analysis by laser microscope is shown in Figure 16. The depth of the defect was about 115µm. “How to make a defect in this case” is not yet understood.

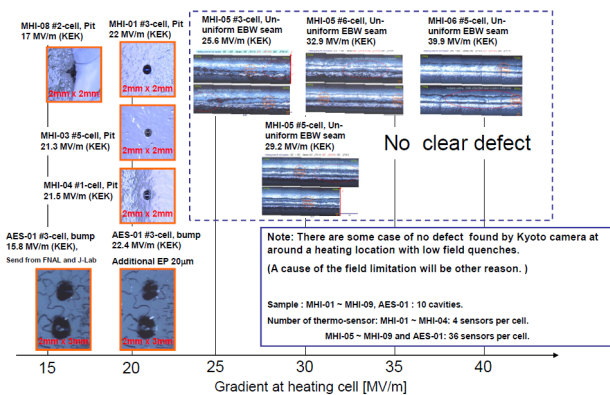
Figure 18: Images of hot spot detected by T-map in KEK-STF.

Ten 9-cell cavities (MHI-01 ~ MHI-09 and AES-01) were inspected from April 2008 to September 2009. Figure 18 is summary of images of hot spot detected by T-map and the gradient at heating cells in KEK-STF. The clear defects were observed at quench location less than 23 MV/m. In the high gradient case, the quench location had no clear defect, the condition of surfaces were un-uniform EBW seam area. Note there are some cases of no defect found by inspection system at around a heating location with low field quenches. A cause of the field limitation will be other reason.

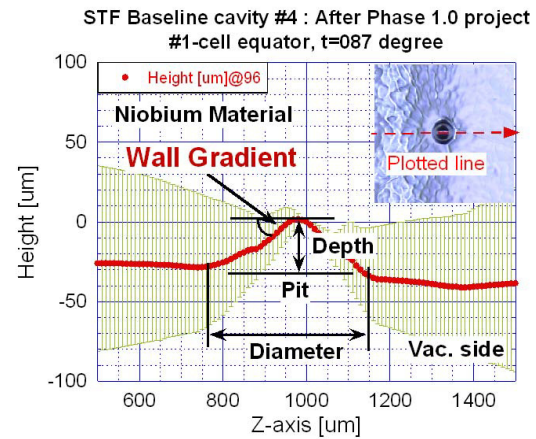
Figure 19: Define of parameter for shape of defect.

The shape analysis of suspicious spots with ten 9-cell cavities (Number of cell = 90 cells, Number of detected spot = 49 spots) has been done from April 2008 to September 2009. The thermo-sensors attached on these suspicious spots every vertical test to study the correlation of spot size and heating. The parameters of defect size are defined in Figure 19. Relation of spot size and heating detected by T-map (Rough estimation) is shown in Figure 20. Red points are heating observed less than 23 MV/m. The type of defects which heating occurred low field were both pit and bump. Blue and purple points are no heating less than 30 MV/m. Larger, deeper (or higher) pits (or bumps) seem to cause quenches. However, not all of the optically observed defects lead to problems. Note preliminary results of analysis which utilizes both the pi-mode and passband measurements.

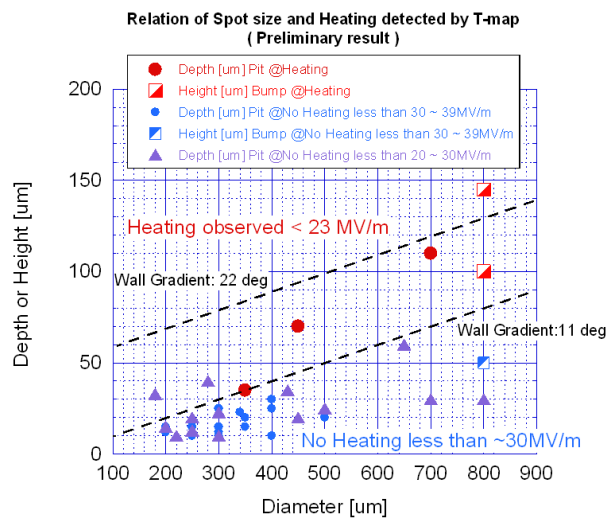
Figure 20: Relation of spot size and heating detected by T-map (Rough estimation).
