FILM DEPOSITION, CRYOGENIC RF TESTING AND MATERIALS ANALYSIS OF A Nb/Cu SINGLE CELL SRF CAVITY *

Thomas Jefferson National Accelerator Facility, Newport News, Virginia 23606

Abstract

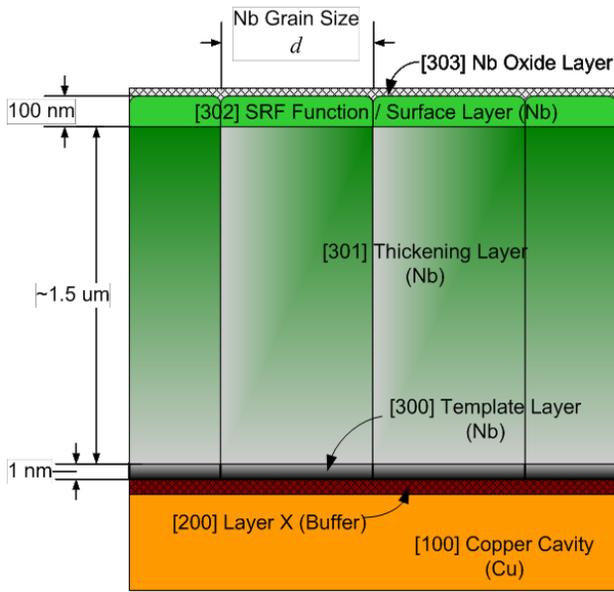
Fig. 1: A conceptual illustration of microstructure design of a multi-layer Nb film coating for SRF cavity.

Fig. 1 schematically illustrates one sample of our conceptual design of this multi-layer Nb film (in a cross-section view). The microstructure has four layers: a Buffer Layer (Layer X), a Template Layer, a Thickening Layer and an SRF function / Surface Layer. The Template Layer, Thickening Layer and Surface Layer are made of pure niobium. Composition of the Buffer Layer can be one of, but not limited to, such choices: magnesium oxide, aluminium oxide, silicon oxide, copper oxide, niobium oxide, aluminium nitride. The Buffer Layer can be of either amorphous or polycrystalline structure.

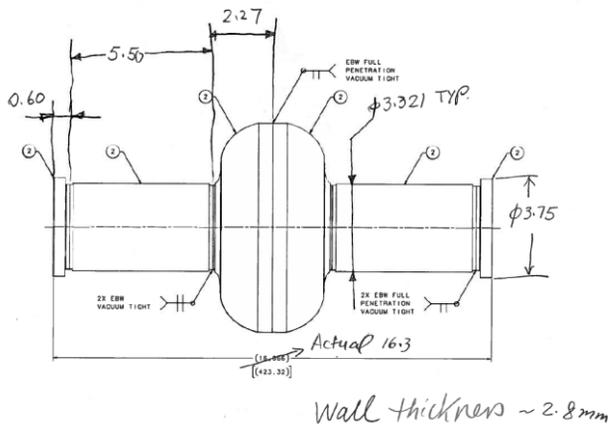
Figure 2: LSF1-1 cavity model and key dimensions. Cavity ID at equator: 7.814 inch typical; Cavity OD at equator: 7.940 typical; Beam tube ID: 3.07 typically.

To conduct the coating work, a single-cell SRF cavity made of a commercial OFHC copper was fabricated at Jefferson Lab. Its structure design has a *low surface field* (LSF) shape. Dimensions of the cavity (called LSF1-1) are shown in Fig. 2.

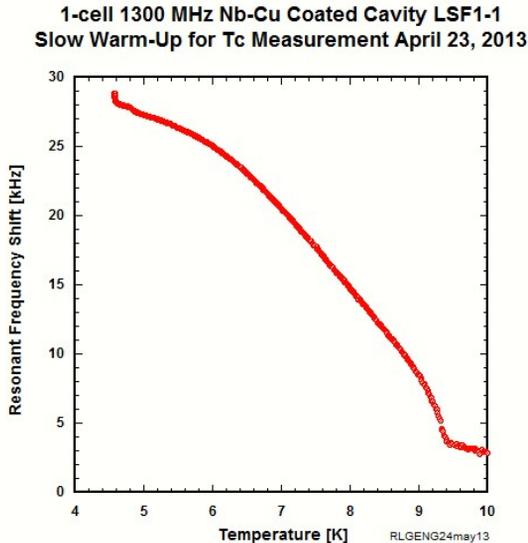
Figure 3: The resonance frequency of the cavity as a function of the cavity temperature.

were monitored automatically with a Labview program. This procedure allows determining the superconducting transition temperature T_c with two independent techniques. The measured T_c was found to be 9.33 K by both techniques. Figure 3 is the curve of the resonance frequency as a function of the cavity temperature.

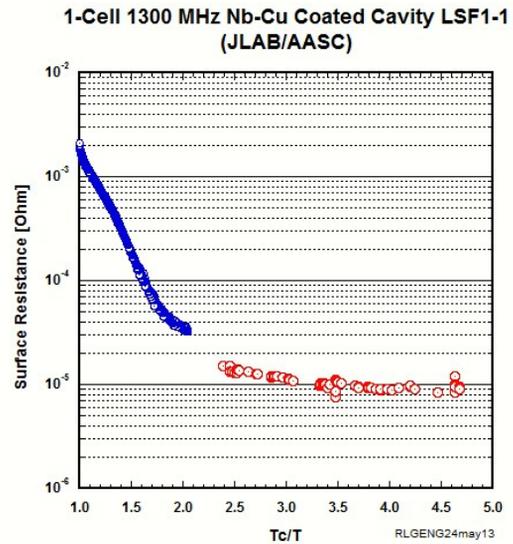
Figure 4: The temperature dependence of the surface resistance. The residual surface resistance is estimated to be $9 \mu\Omega$.

After the T_c was experimentally determined, the cavity was slowly cooled down again to 2 K. The temperature difference between the upper and lower beam tube was measured to be around 20 mK. The cool down rate was controlled at 1.26 mK/sec while crossing T_c . The $Q(E_{acc})$ curve was then measured at 2K. The unloaded quality factor (Q_0) at low field was only 4×10^7 , followed by rapid decline as the gradient was raised. As the gradient was further raised, the rate of Q_0 decline was somehow much reduced. The dependence of Q_0 with temperature was also measured. By using the formula $R_s = G / Q_0$, where G is the geometry factor of the cavity, the surface resistance R_s can be calculated. Figure 4 shows the temperature dependence of the surface resistance. Clearly, the quality factor of the cavity is limited by the residual surface resistance, which is estimated to be on the order of $9 \mu\Omega$.

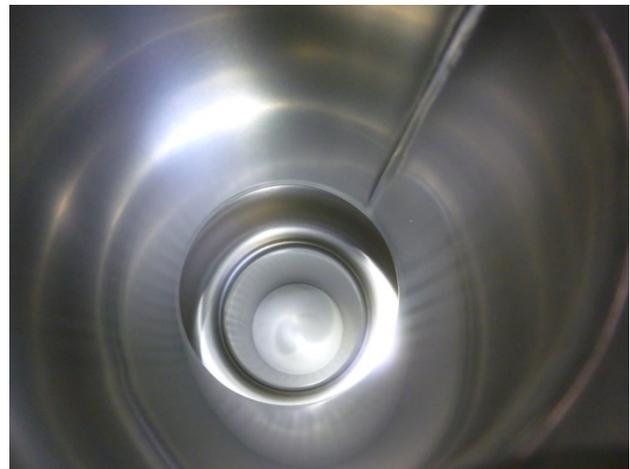
Figure 5: The pristine Nb-Cu surface of the LSF1-1 copper cavity. It appears a clear coating. The inner wall shows a specular, matte, grey and metallic hue of Nb material.

Inner (coating) surface of the LSF1-1 cavity appears smooth and uniform. It shows a specular, matte, grey and metallic hue of Nb material (Figure 5). The welding belt zone on the cavity equator appears no different than the other areas. Note the water-like stains in Figure 6 is a deposit left by the EDM. The pristine Nb-Cu surface was clear.

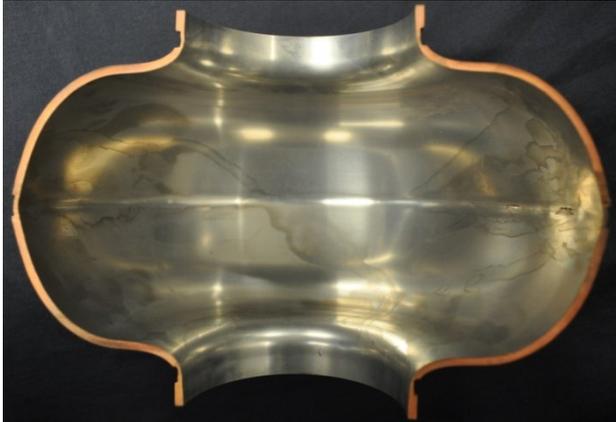
Figure 6: A half-cavity piece cut from LSF1-1 Cavity.

Next, the cavity was cut in half (Figure 6). HiRox optical microscope was applied to inspect its inner wall morphology, from tens toward a few thousand magnification.

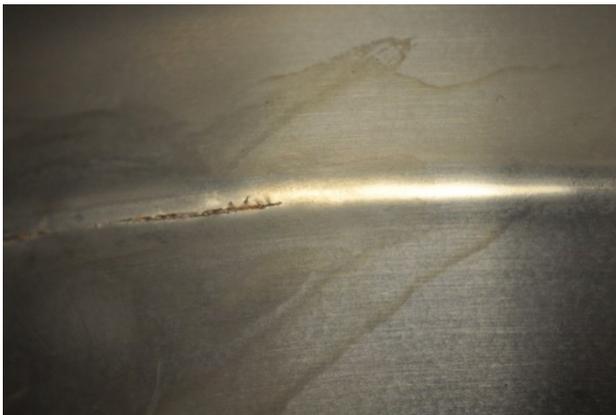
Figure 7: Some visible defects in the equator region showing uncoated copper. These defects are resulted from insufficient melting during electron beam welding. Deep welding defects are not totally removed by CBP.

Some visible uncoated copper areas associated with welding defects were observable in the equator region. They are up to a few millimeters in length, and a few hundred micrometers in width. There are only a few of them observable by eyes (<7 spots). Figure 7 shows a photo of such a defective area. Welding defects in the equator region were already observed before CBP. They were caused by insufficient melting and were not completely removed despite CBP. Please note these macroscopic defects are different from the microscopic cracks/blisters found under SEM analysis, which are in the scales of microns. We will discuss those later.

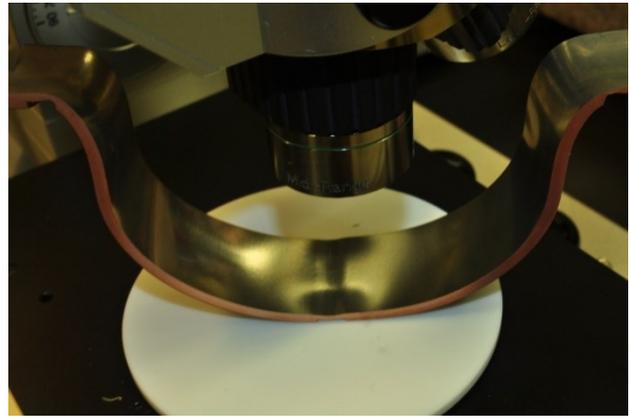
Figure 8: An “Ω”-shaped stripe of one inch wide was cut from a half cell.

One half-cavity (named “LSF1-1.2”) was further cut into 3 pieces, of which the centre one is an “Ω” shaped stripe 1 inch-wide (Figure 8, 9). That “Ω” shaped stripe was further cut into 8 small coupon samples of approximately one by one inch wide (Figure 10). All cutting services were conducted at Jefferson Lab’s machine shop via a wire EDM machine.

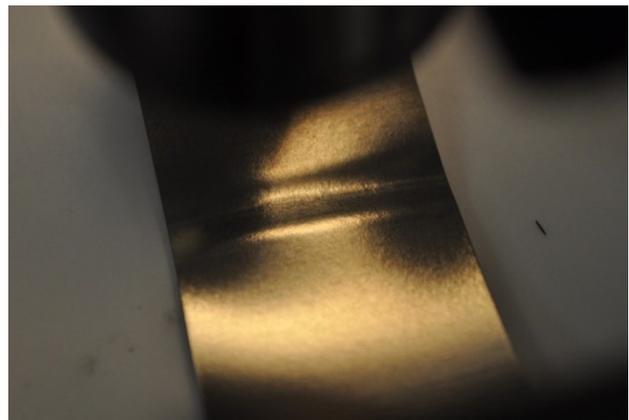
Figure 9: Coupon small sample “LSF1-1.2.4” was cut from the equator area. The welding belt zone appears no different from the other areas. The coatings seemed quite uniform.

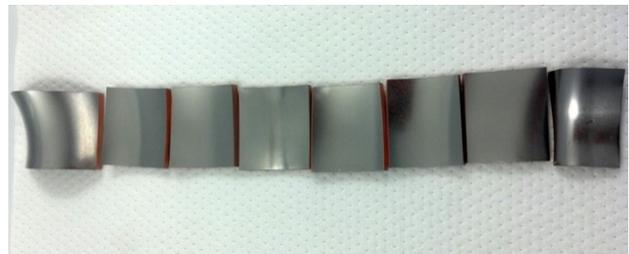
Figure 10: Set of 8 samples cut from the “Ω” shape of Figure 8. Coupon small sample “LSF1-1.2.4” (Left 4), has received SEM and XRD Pole Figure Measurement.

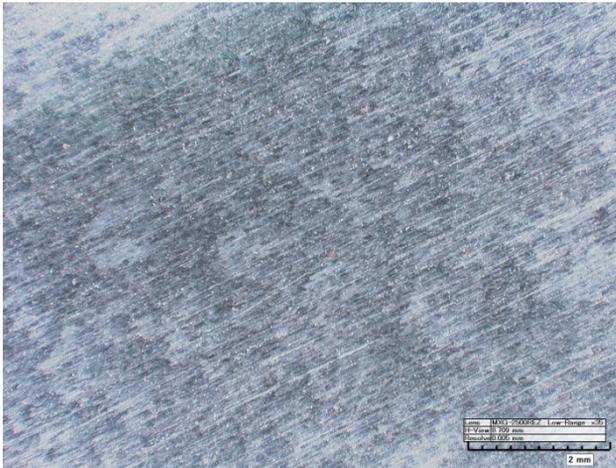
Figure 11: A low-mag micrograph of HiRox. “Stripe-like” topographic character in a macroscopic-scale, which feature is shaped by CBP media tumbling and friction.

All images have some similar features: 1. Numerous round Nb macroparticles (a well-known by-product of unfiltered cathodic-arc-discharge deposition). 2. “Stripe-like” topography in macroscopic-scale, which is shaped by CBP media tumbling and friction. Figure 11 shows such defects.

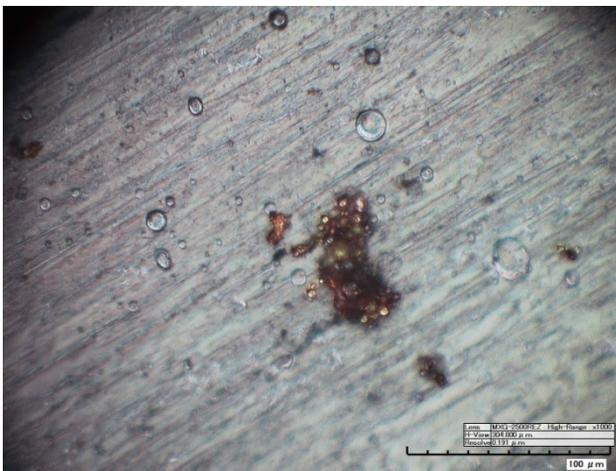
Figure 12: A high-mag micrograph of HiRox. Numerous round Nb macroparticles (a well-known by-product of unfiltered cathodic-arc-discharge deposition), and a few of peel-off areas.

In rare locations, a few peel-off areas were found. On those tiny defect areas, their top Nb films appeared being “skimmed off” by a fractural force. They exposed copper-like metallic hue. The spots were observable by a high magnification (of a few thousand. See Figure 12).

It’s unknown yet, whether they are caused by HPR stripping of weak coating areas. For instance, if debris/falling particles being introduced before coating, those areas have no Nb-Cu bonding. Under HPR, the loosely bound Nb material might be removed or torn off.

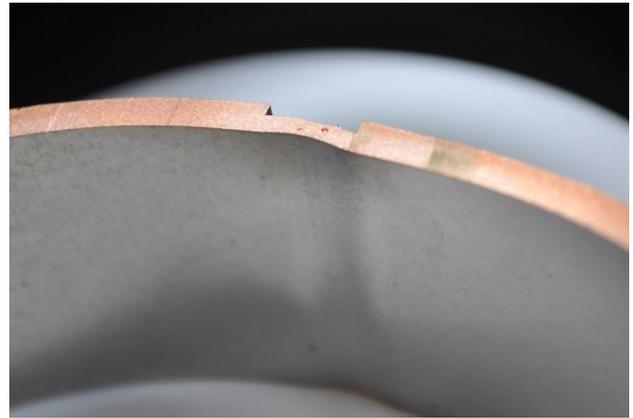
Figure 13: Welding bubbles are visible on EDM cutting planes.

On the EDM cutting plane (cross-section) of the welding zone, we observed two round pits on each side (Figure 13). The four bubble pits were far away from the inner or outer cavity wall (Figure 14). They are tens to a few hundred microns in diameter. Their round profiles and smooth appearance (Figure 15, 16) suggest that they are welding defects, being created by trapped gas bubbles during e-beam welding work.

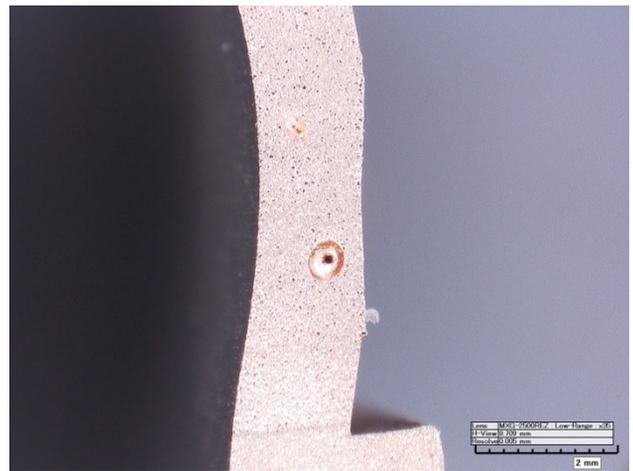
Figure 14: A low-mag micrograph of HiRox. The pits are far away from inner or outer walls.

In this sample, the four pits don’t impact the wall surface topography in this piece of sample. Nevertheless, in extreme cases, if bubble pits were close to the wall surface, a CBP finishing might create reveal a deep pit on the cavity wall.

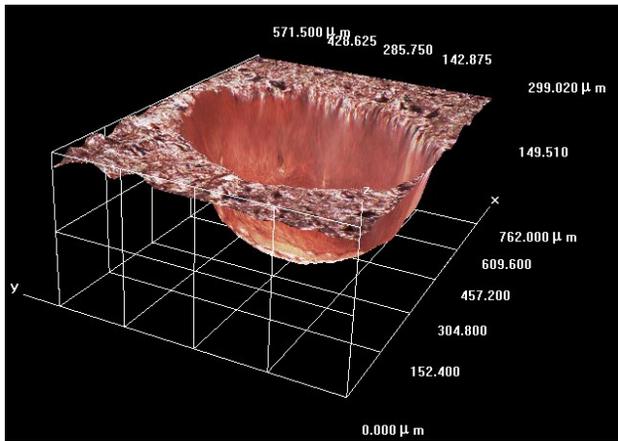
Figure 15: A view of HiRox 3D Imaging on a bubble pit.

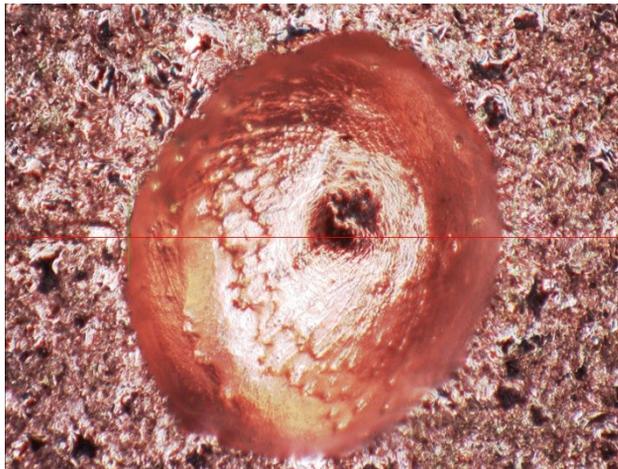
Figure 16: The round up and shining appearance of bubble pits imply they are defects of welding work.

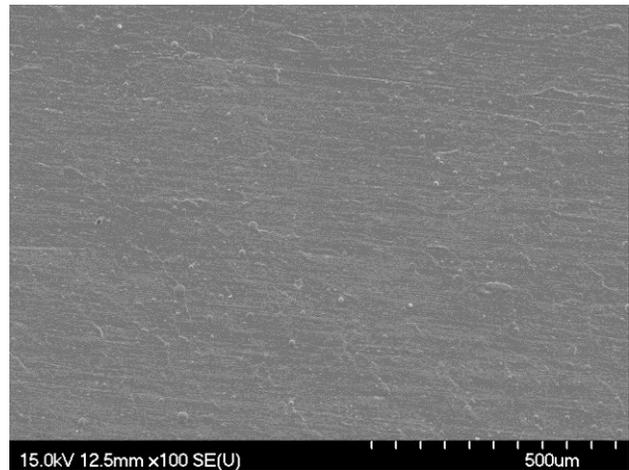
Figure 17: SEM micrograph of a low magnification imaging (100X) on coupon small sample “LSF1-1.2.4”. Spot on a welding zone, whose topography is not different from a non-welding zone.

Under SEM (up from low mag. 100X), the stripe-like CBP finishing morphology is still observable (Figure 17).

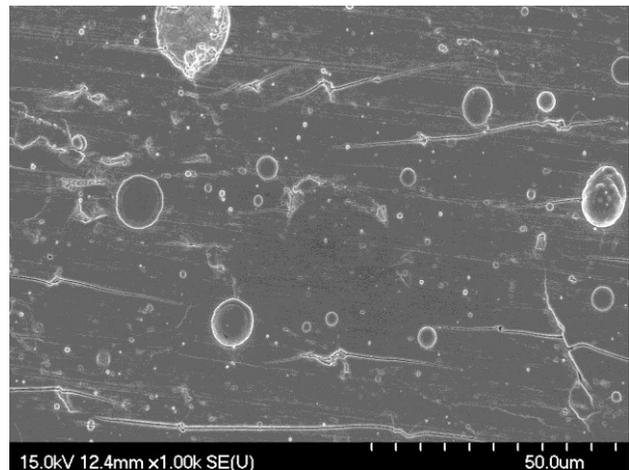
Figure 18: SEM micrograph of sample “LSF1-1.2.4” (mag. 1000X) showing CED arc-discharge particles and microscopic cracks/blisters .

Unsurprisingly, macroparticles of CED cathodic arc discharge are visible everywhere (Figure 18). Nevertheless, under high resolution high magnification imaging, microscopic cracks/blisters were also found everywhere (Figure 19). They are typically from tens to hundreds of microns long, hundreds or tens of nanometers wide at their maximum openings (Figure 20).

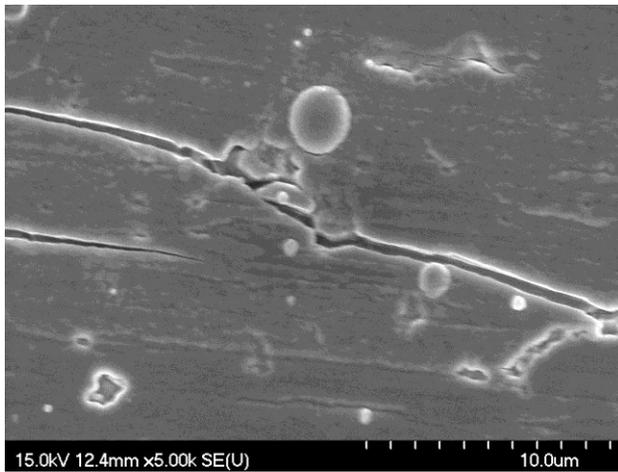
Figure 19: SEM micrograph (mag. 5000X). Microscopic cracks/blisters are typically from tens to hundreds of microns long.

It's not known yet, if the cracks were caused by thermal stress induced film delaminating during coating procedure, or in the oven heat-treatment post the 2nd RF measurement. Film cracking or delamination tensile/compression stress is a well known phenomenon in film deposition technology. Please note these omnipresent microscopic cracks are different than the aforementioned few macroscopic cracks in the weld zone.

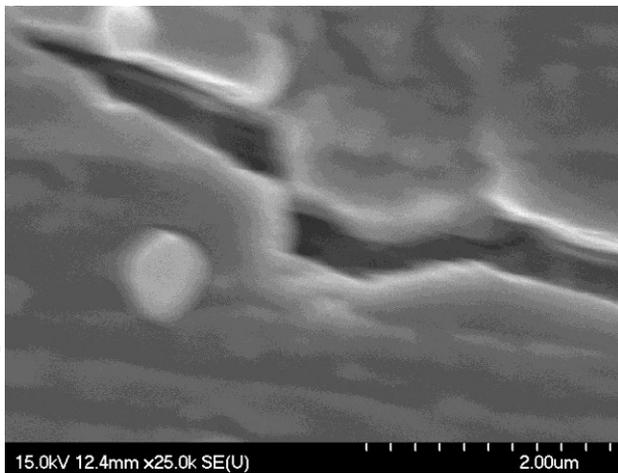
Figure 20: SEM micrograph (mag. 25,000X) of a crack. Microscopic cracks/blisters are hundreds or tens of nanometers wide at their max openings.

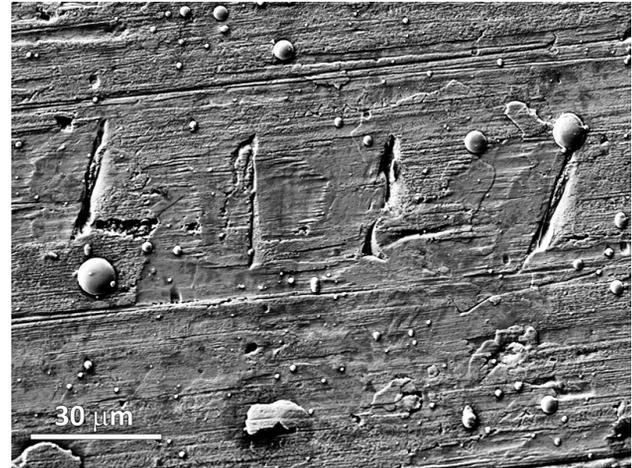
Figure 21: SEM micrograph of Sample "LSF1-1.2.2". Courtesy of NHMFL-ASC, a work by Zu-Hwan Sung.

Sample "LSF1-1.2.2" was located near the iris zone of the cavity. Because the EsB machine has superior resolution, rough surface morphology by CBP finishing is more apparent (Figure 21). By FIBing and viewing the cross-section of the Nb-Cu film interface, SEM indicates the thickness of the film is quite uniform. Its thickness is about 700 nm (Figure 22). Preliminary EBSD survey on this sample doesn't see grain structure. This suggests either the grain sizes are less than 50nm (the limit of EBSD resolution) and/or the grains have large stress/strain. This demonstrates that the Nb-Cu film is by no means an epitaxy film.

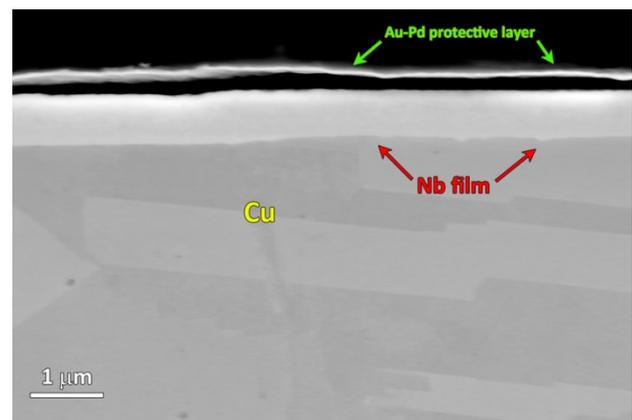
Figure 22: SEM micrograph of Sample "LSF1-1.2.2". The cross-section view of Nb-Cu film interface. Courtesy of NHMFL-ASC, a work by Zu-Hwan Sung.

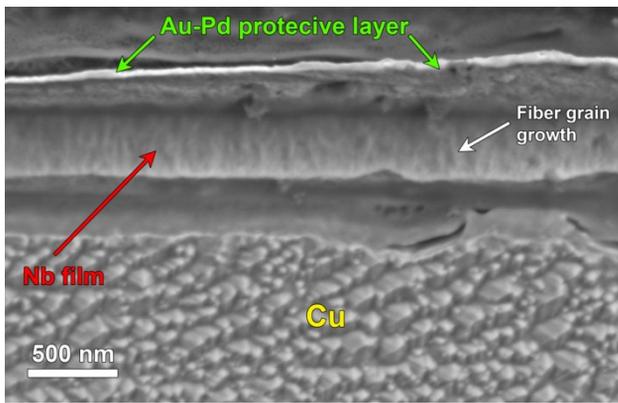
Figure 23: Cross-section view of Nb-Cu film interface, after a BCP etching. Courtesy of NHMFL-ASC, a work by Zu-Hwan Sung.

To observe Nb-Cu interface morphology, the cross-sectional plane of the sample was etched with 50% diluted BCP solution for 20-30sec, it shows fibrous structure of Nb film, a CBP-finished buffer layer, and an underlying crystalline copper substrate in different layers (Figure 23).

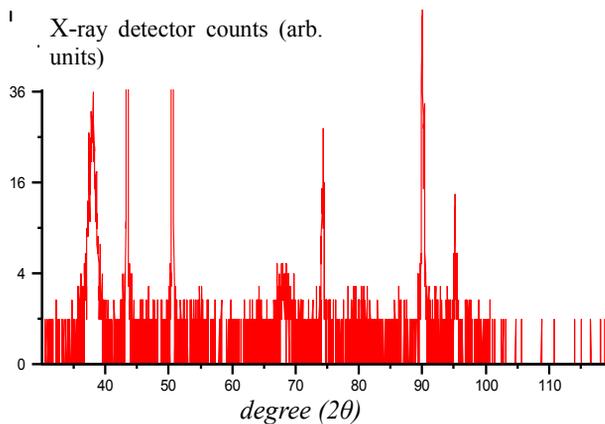
Figure 24: XRD in Bragg-Brentano mode ($\theta/2\theta$ scan) on coupon small sample, “LSF1-1.2.4”.

XRD measurement was conducted at Norfolk State University. The same coupon small sample, “LSF1-1.2.4” was surveyed. The X-ray survey area was on a non-welding zone, which plateau is very flat and suitable for XRD reflection geometry. A survey in Bragg-Brentano mode ($\theta/2\theta$) proved that the Nb film has a classic polycrystalline structure. There are a variety of $\{hkl\}$ crystal planes (grain orientations) parallel to the sample surface (Figure 24).

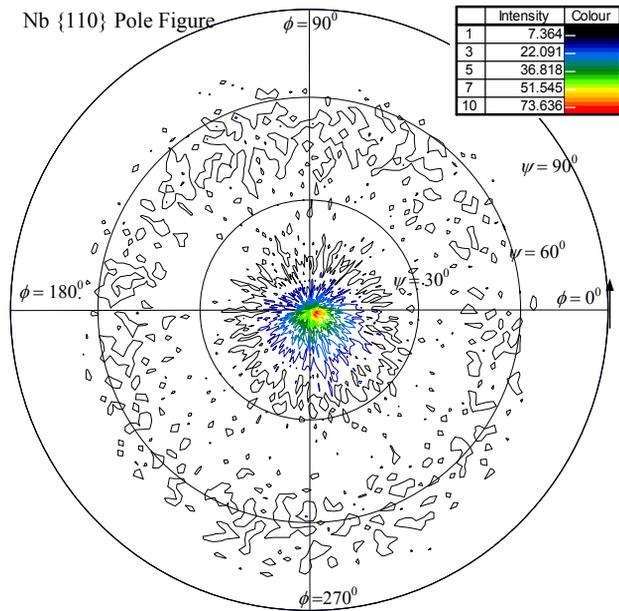
Figure 25: Experimental XRD pole figure of the coupon small sample, “LSF1-1.2.4”. The Nb{110} pole figure shows an obvious broad centre peak, and a diffusive “ring” at orbital $\psi = 60^\circ$. This ring pattern implies the Nb film has a fibrous grain microstructure.

The XRD pole figure of Nb{110} planes (Figure 25), shows an obvious broad centre peak, and a diffusive “ring” at orbital $\psi = 60^\circ$. This ring pattern indicates the Nb film has a preferential orientation: a Nb{110} *in-plane* fibrous texture. This means, a majority of the Nb grains expose one {110} plane parallel to the cavity wall surface, while the grains have different azimuthal orientations *off-plane*. The off-plane orientations have a uniform distribution; therefore, the ring texture pattern is quite even. Such texture implies that the Nb film was growing in a fibrous mode or fibrous microstructure, rather than the Nb-Cu epitaxial mode. This is one preliminary evidence of success in implementing a multi-layer structure by our coating procedure.
