# OPERATING EXPERIENCE IN SRF ELECTRON LINACS

## JOSEPH PREBLE\*

Continuous Electron Beam Accelerator Facility
12000 Jefferson Avenue, Newport News, VA 23606-1909 USA

The operating experience of SRF linacs is reported. Accelerators included are HEPL, MACSE, S-DALINAC, and CEBAF.

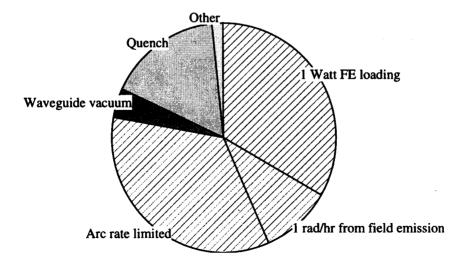
Currently CEBAF has 320 cavities in operation. During the last two years 16 cavities have been commissioned and the main linacs have been optimized for support of 4 GeV beam operations and currents up to 20  $\mu$ A. The cavity operating limitations were determined during commissioning<sup>5</sup> for each cavity in the accelerator. Since that time some cavities have had these limits lowered. The primary reason for these reductions in operating field level is excessive arcing in the waveguide coupler. At this time 108 cavities have had their operating field levels reduced to lower arc rates to an acceptable level (< 0.25/day). Figure 1 shows the distribution of cavity limitations.

FIGURE 1: Distribution of CEBAF cavity limitations.

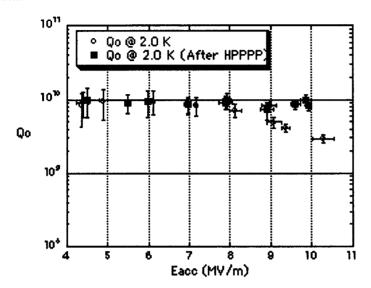
Recently, additional testing of 15 cavities was performed after 2-3 years of operations. There has been no performance degradation in any of the cavities tested. Of the 15 cavities tested, 8 had been rf pulse processed using a 5 kWatt klystron, just prior to the testing. In one of these 8 cavities the performance was measurably improved. Figure 2 shows the  $Q_0$  vs. gradient curves for the initial commissioning and the recent test results.

FIGURE 2: Qo comparison before and after RF processing SL03-8.

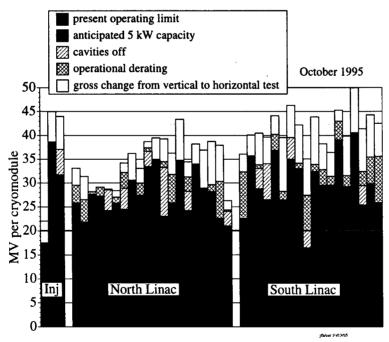
An additional limit imposed on current operations is a reduction from 5 kWatts to 1.7 kWatts of available rf power for each cavity as a cost savings measure. Figure 3 shows the summed gradient for each cryomodule installed for the current operating limits, the projected limits for 5 kWatt operations, and the limits defined during vertical testing. The values for the current operational and projected 5 kWatt operational limits are continually being updated with operating experience.

FIGURE 3: CEBAF cryomodule performance limits.

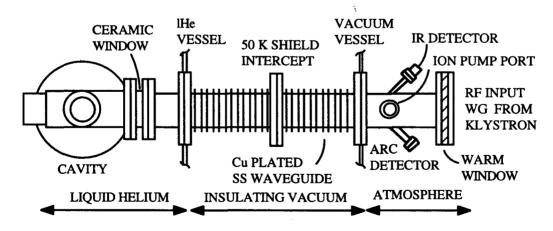
There have been three failures of rf input couplers during operations at CEBAF. On each occasion the warm polyethylene window has failed resulting in an air leak into the waveguide transition vacuum space. The input coupler configuration utilizes one vacuum manifold for two waveguide regions resulting in the loss of two cavities from operations when a single window fails. A single coupler is shown in Figure 4. Investigations of two of these failures identified procedures that effectively bypassed the interlocks intended to prevent this kind of failure. Without interlock protection, sustained arcing in the waveguide transition region coupled rf power into the polyethylene window and melted them. Procedures have been reviewed and modified to eliminate a possible repeat of these failures. The recovery from these required the warm up of the cryomodule to allow for the replacement of the polyethylene windows and the clean up of the vacuum space. This effort requires 1–2 weeks to accomplish and returns the cryomodule to a fully operational state.

FIGURE 4: CEBAF waveguide transitions (not to scale).

The third failure of the input coupler occurred in August 1995. This failure also included the melting of the polyethylene window but was not the result of sustained arcing in the waveguide region. A smaller vacuum leak developed which allowed enough time to stabilize the waveguide vacuum before we suffered a

complete loss of cryogenic support. The cryomodule is still in operation without the two effected cavities. Continued operations precludes a complete investigation of the failure.
