DATA ACQUISITION AND STUDIES OF VIBRATION MOTION IN TLS BEAMLINES

P.C. Chiu, C.H. Kuo, K. H. Hu, Jenny Chen, Y. S. Cheng, Y. K. Chen, K.T. Hsu
 NSRRC, Hsinchu 30076, Taiwan

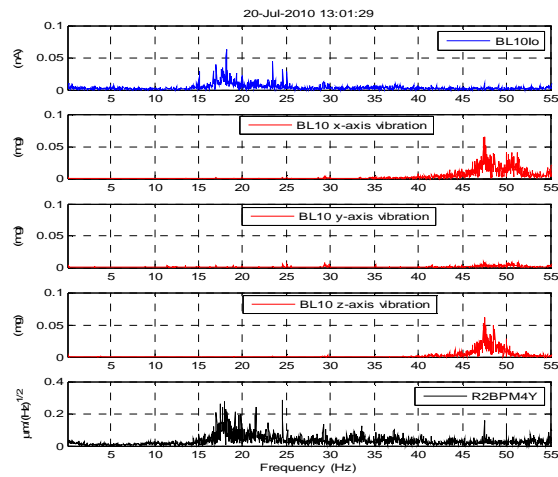
Figure 3: (a) Spectrum of BL 10 I_o , three-axis vibration and electron BPM: R2BPM4Y. (a) Spectrum of BL 11 I_o , three-axis vibration and electron BPM: R2BPM1Y.

Fig. 2 shows the normal status of the beam stability in quiet: the stability of beamline intensity ($\Delta I_0/I_0$) is usually under 0.1%, the spectrum amplitude of electron beam stability is also less than 0.5 μm below 50 Hz. The overall RMS stability of electron beam can achieve submicron level from DC to 50 Hz in normal operation [1][2]. The mechanic design of BL11 looks better than BL10's where the vibrations of three-axis at BL11 are all

less than 0.01 mg and are less 0.1 mg at BL10 as Fig. 3. It is required further studied to seek for causes of these differences. It is clear from Fig. 3 that the spectrums of two electron BPM are very similar while they are not consistent with the spectrum of photon intensity I_o between BL10 and BL11. Furthermore, even these two I_o cannot agree with each other. The vibration characteristics of two beamlines are not consistent so much. The fact that 47.5Hz noise is observed in both of the electron beam and accelerometers but is invisible in photon beam. It seems very necessary with more sensors for detection and analysis.
