# OPTIMIZATION OF CLEAN ROOM INFRASTRUCTURE AND PROCEDURE DURING LCLS-II CRYOMODULE PRODUCTION AT FERMILAB\*

## Abstract

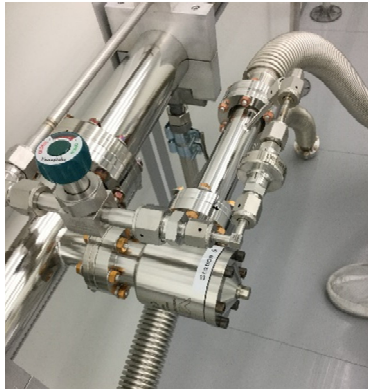
The Fermilab string assembly procedure or coupler assembly required the cavity to be purged at a mass flow rate of 1 liter per minute. In a previous configuration, Nitrogen purging, and cavity evacuation was merged at the one end of a long-corrugated vacuum hose. The other end of the vacuum hose joins the cavity end. This was adopted to simplify the connection of the cavity side as shown in Figure 1.

Figure 1: Nitrogen purging and evacuation merges at the beginning of the corrugated vacuum hose.

Unfortunately, this configuration underestimated the particulates that could potentially be generated in the corrugated hose. In the event of purging mass flow, higher mass flow would increase the particulates movement.

In a simple measurement, it was found there are non-negligible particle counts that come from the corrugated vacuum hose as the nitrogen purge was at nominal 1 liter per minute. When the corrugated hose was disturbed, the particle count flared up. This was not a surprise since a corrugated vacuum hose is notoriously hard to be cleaned and remove the particulates.

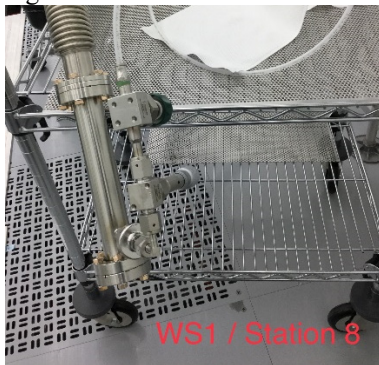
It was concluded it would benefit to relocate the nitrogen purging to the cavity side of the corrugated vacuum hose as shown in Figure 2.

Figure 2: Nitrogen purging is relocated at the cavity side of corrugated vacuum hose.

In this configuration, nitrogen purging does not go through long corrugated vacuum hose. The section after the nitrogen filter is considered much easier to clean. The downside is the parts that are connected to cavity were

more complex. The particulates in this configuration was tested and no particulates were recorded even at higher mass flow of nitrogen purging.

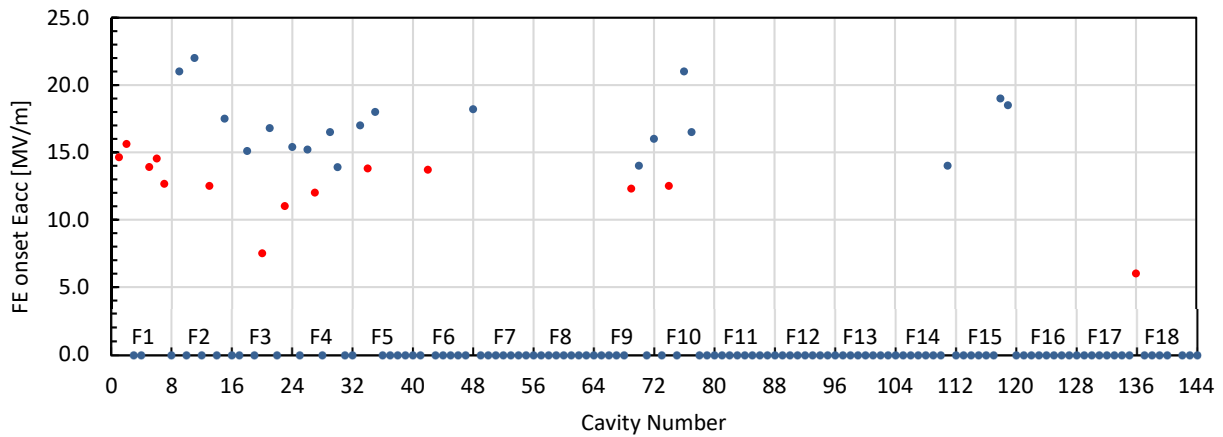
Fermilab has completed the testing of 18 cryomodules. Field emission for all these cavities were plotted in Figure 3. All cavities were tested and field emission free unless indicated otherwise.

Figure 3: Field emission onset gradients for all 18 Fermilab built cryomodules. The blue dots on the axis indicated no x-ray was detected for that cavity. Red dots indicated the field emission for that cavity reduced the cavity performance.

For LCLS-II cryomodules, 50 mR/h x-ray from any detectors is considered the safe operation specification. Any cavities that generated 50 mR/h would be considered performance limited at its measured gradient up to the administrative limit of 21 MV/m. To simplify the discussion, all Fermilab cryomodules were simplified by F and followed by cryomodule numbers such as F1 represents F1.3-01.

The first internal audit was conducted during F7 assembly. Procedural improvement was implemented in F7 assembly and the benefit was immediate. F7 was the first cryomodule that there was no x-ray detected throughout up to administrative limit. The second audit was conducted during F9 assembly. Most of the audit recommendation was implemented starting at F11 assembly.

These are recorded events for all the cryomodules. F2 experienced uncontrolled beam line pressure change due to unfamiliarity with the gate valves that resulted gate valves not being fully closed. F5 had a cavity high order mode feedthrough replaced at cavity location one at work station 3 with non-ideal clean room setup. F9 experienced a minor leak that resulted two extra cycles of evacuation and back-fill. F10 coupler #6 cannot achieve leak tightness and the cavity had to be extracted from the completed string assembly and replaced with a new cavity.
