## SRF ACCELERATING MODULES REPAIR AT DESY

D. Kostin†, J. Eschke, B.v.d. Horst, K. Jensch, N. Krupka, L. Lilje, A. Muhs, D. Reschke, S. Saegbarth, J. Schaffran, M. Schawat, P. Schilling, M. Schmoekel, S. Sievers, N. Steinhau-Kuehl, E. Vogel, H. Weise, M. Wiencek, Deutsches Elektronen-Synchrotron, Hamburg, Germany

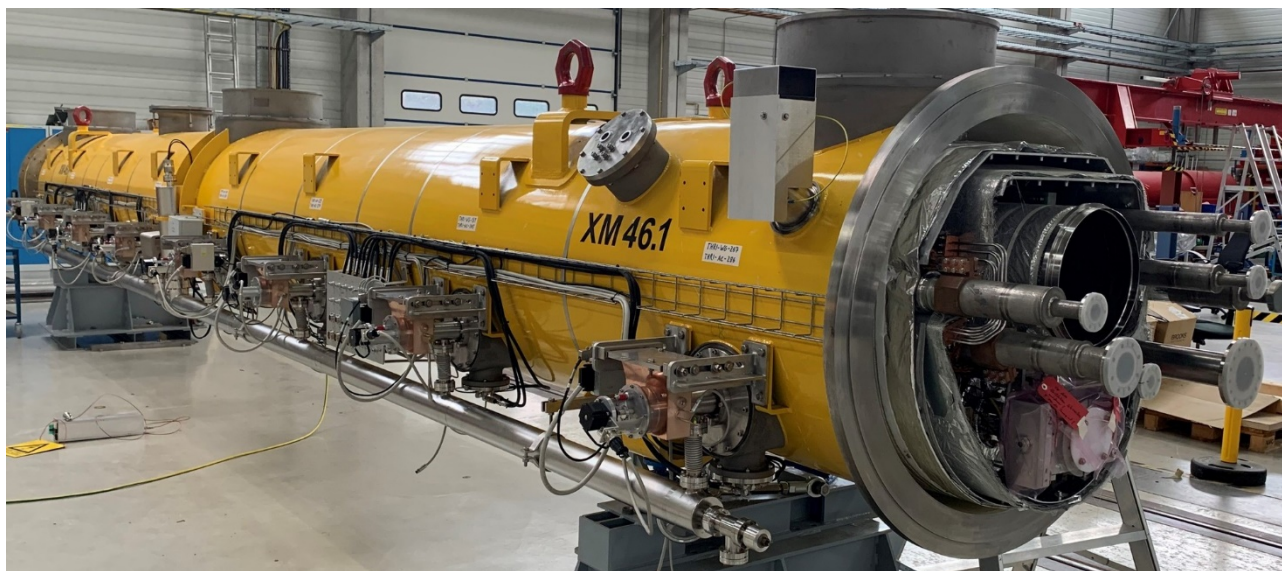
Figure 1: Module XM46.1 in AMTF.

After reassembly CM XM46.1 (Fig.1) was tested on both module test-stands at DESY: AMTF (Sep. 2020, Table 3 and Fig. 3) and CMTB (May 2021), a successful CM repair is confirmed on both with a very close test results. Currently a CW CM test on CMTB is ongoing [10, 11].

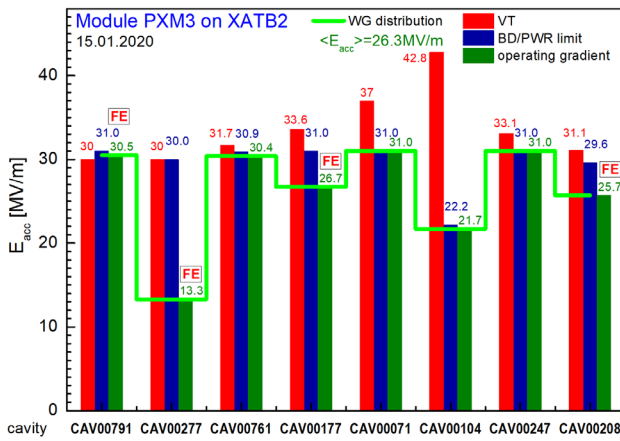
Figure 5: PXM3 cavities VT (max) and CM tests.

Also for PXM3 (Fig. 5) three cavities degraded in their performance compared to their VT. At cavities 1 and 2 Fundamental Power Coupler (FPC) antennae did touch the cavity inner surface caused by an incident during FPC cold parts bellows adjustment. While cavity 1 showed a higher radiation level, but the gradient is unchanged, cavity 2 degraded significantly limited by a very high FE. The corresponding DC measurement ( $\sim 9 \mu\text{A}$ ) is shown in Figure 6. Also the gradient of cavity 6 degraded to 22 MV/m limited by breakdown after it FPC cold part had to be exchanged in the clean room because of pre-cleaning water penetration under the cold part protecting cap.

It was decided to re-assemble both modules after re-treatment (HPR) [8] and partial exchange of their cavities.

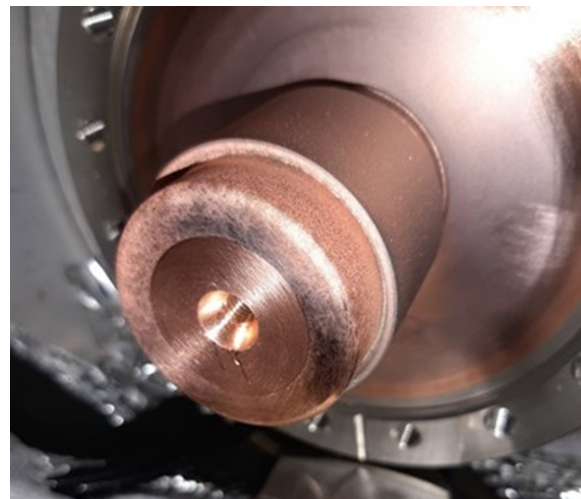
After retreatment of the PXM3 cavities two cavities had to be replaced before the assembly of PXM3.1. As shown in Figure 7 the test of all cavities in the CM was successful, especially no cavity was limited by FE. Unexpectedly the cold part of the FPC of cavity 6 (CAV00791) degraded during the CM test showing strong RF discharges. An optical inspection showed copper sputtered on the ceramic window, see Fig. 8. The reason is unclear, but as no reliable FPC operation can be assured, it was decided to exchange the cold part. Afterwards the defective cold part will be investigated

Figure 8: PXM3.1 FPC6 cold part.

- Module PXM3.1 cavities re-treatment and re-assembly was successful: cavities did not degrade anymore. But the new cold part of FPC, cavity 6, showed a degraded performance in the module test in AMTF with strong RF discharge. Faulty FPC cold part must be exchanged, new module test will follow.
