Results of an RF Pulsed Heating Experiment at SLAC[*]

D. P. Pritzkau and R. H. Siemann, Stanford Linear Accelerator Center, Stanford, CA, 94309, USA

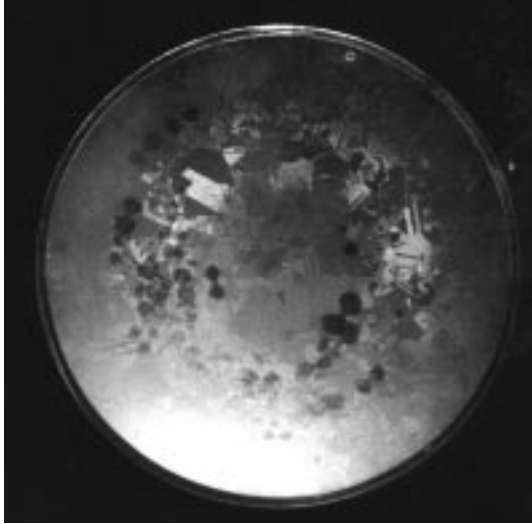
In Figure 1, one can see a visible change in the crystal grains in the region approximately 10.4 mm to 11.0 mm from the center with an average width of approximately 4 mm to 5 mm. From GdifdL [8] simulations, the fields in the region closer to the coupling iris is 5% higher than the fields diametrically opposite of this region. This simulation would then explain why there is more damage in the region closer to the aperture, since the region farther away has a temperature rise approximately 10% lower.

Figure 1: One of the copper endcaps. The other endcaps are similar in appearance.

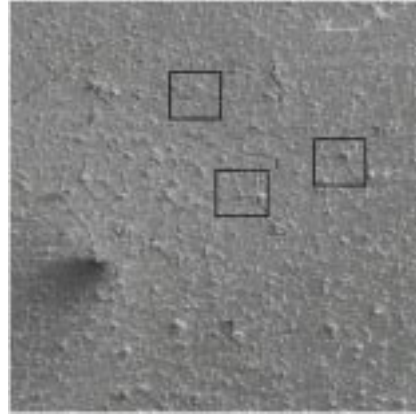
Figure 2: Region (0.9 mm × 0.9 mm) where maximum damage is expected. The scale in the upper right-hand corner is 100.7 μm. Figure 4 has higher magnification images of the indicated regions.

The endcaps were examined with a scanning electron microscope using secondary emission and a 5 keV electron beam. Figure 2 shows a region where maximum damage is expected. Note that this endcap pictured is different from the one shown in Figure 1; however, all four endcaps are similar in appearance. The little bumps along the surface are the copper globules sputtered from breakdown at the coupling iris. More importantly, one can easily see the numerous cracks that have occured on the surface. For comparison, a region at the center where the temperature rise is close to zero is shown in Figure 3. This picture was taken at the same magnification. There are no cracks in this region. The copper globules are also noticeable here. Because of the sputtering, we cannot isolate the unloaded Q degradation shown in Table 1 due to sputtering from that due to the presence of the cracks.

agnification images of the regions of cracks were taken. For the endcap shown in Figure 2, the average location of all higher-magnification images of cracks is approximately 10.4 mm from the center with a standard deviation of 1.3 mm. Close-up shots of a few of these cracks are shown in Figure 4.

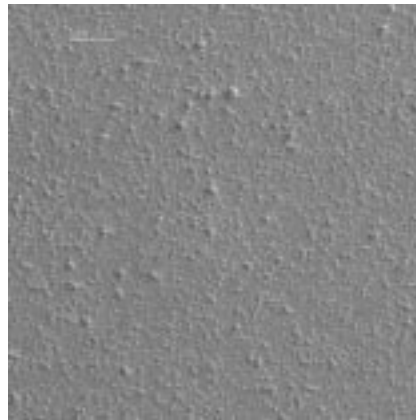
Figure 3: Center of endcap. The scale in the upper left-hand corner is 100.7 μm.
