VISUAL INSPECTION OF A COPPER COLLIMATOR IRRADIATED BY 590 MeV PROTONS AT PSI

Å Strinning*, P. Baumann, M. Gandel, D. Kiselev, Y.J. Lee, S. Adam,
Paul Scherrer Institut, 5232 Villigen PSI, Switzerland

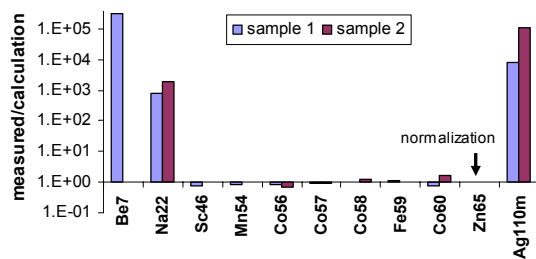
Figure 9: Ratio of the measured to calculated activities in the samples 1 and 2. Zn65 is used for normalisation of the measured nuclide inventory.

Figure 9 shows the ratio of the measured to calculated activities. For the isotopes from Sc46 to Co60, both activities are in very good agreement. These isotopes are produced mainly from Cu. However, large deviations are observed for Be7 in sample 1. Be7 is produced in large quantities in the graphite of Target E. It is likely that the grey cover of the last teeth is a layer of graphite evaporated from Target E. The measured activity of both samples show a large excess of Ag110m. It is obvious that it comes from the silver solder used to fabricate the collimator; in particular, the sample from the back side contains even more Ag110. The golden shiny stripe at the back side (Figure 7) is probably due to the diffusion of Ag into Cu. The reason for the large amount of Na22 is not clear yet. It might come from surrounding materials.

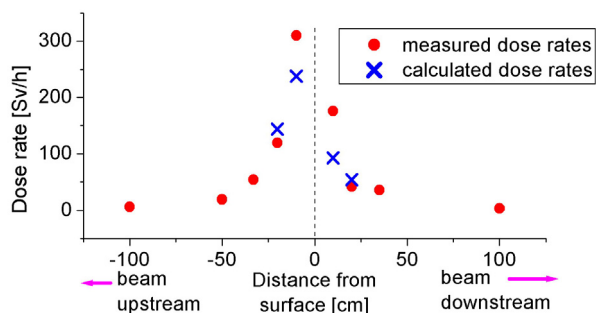
Figure 10: Comparison of calculated and measured dose rates at the collimator, measured along the beam axis.

shielding for the camera and electronics in the hot cell. Later the dose rates were measured in the hot cell. Figure 10 shows the calculated and measured values. The agreement is better for larger distances from the collimator, because the calculated dose rate is an average over a larger region and cannot reproduce hot spots at the inner surface. The dose rate in 10 cm from the beam entry was 310 Sv/h.
