THE DATA ACQUISITION SYSTEM AND INSPECTION EQUIPMENT ON VIBRATION EVALUATION FOR DEIONIZED AND COOLING WATER PUMPS IN TPS *

Yung-Hui Liu[†], Yen-Ching Chung, Chien-Kuang Kuan, Zong-Da Tsai
National Synchrotron Radiation Research Center, Hsinchu, Taiwan.

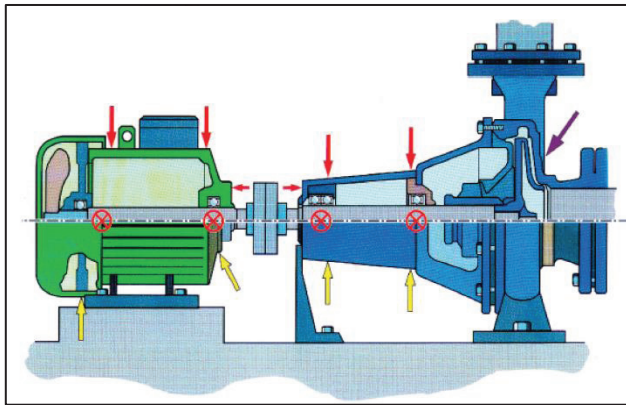
Figure 1: Vibration test locations.

The BO and CU DIW pump systems used horizontal split-coupled end suction pumps and the power energy supplied from motor to pump by coupling. The alignment and accuracy of coupling between motor and pump could affect the status of the system. In order to verify the detail of pump system vibration status, the vibration test for each system in 4 different section in three directions is specified in Fig. 1.

Base on over one year inspection, the positions of the vibration measurement were 45° direction in non-drive end and vertical, horizontal and axial directions in drive-end of motor. It could demonstrate the motor whether stable, coupling abrasion and status of coupling alignment. In addition, the positions of pump vibration measurement are vertical, horizontal and axial directions in drive-end of pump. For maintain temperature fixed, the non-drive end of pumps was covered insulation materials, the non-drive end of pumps could not be measured.
