PERFORMANCE OF THE CERN HIGH-INTENSITY RFQ

E. Tanke, M. Vretenar and M. Weiss
 PS Division, CERN, CH-1211 Geneva 23, Switzerland

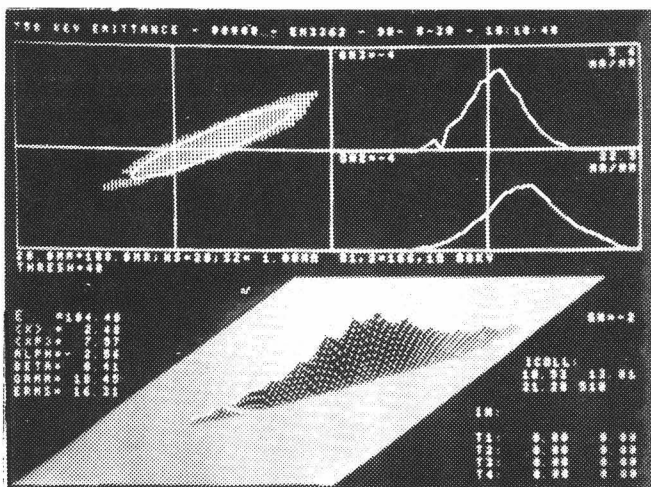
Output beam emittances: the measured output emittances are shown in Figs. 4 and 5. The normalized r.m.s. value, $\epsilon_{\text{rms},n}$, is about 0.6π mm-mrad. For comparison, we also show emittances measured before the accident, see Figs. 6 and 7. Their $\epsilon_{\text{rms},n}$ value is about 0.5π mm-mrad. The corresponding input emittance values are $\epsilon_{\text{rms},n} \approx 0.4\pi$ mm-mrad.

Figure 6: Horizontal output beam emittance, before accident

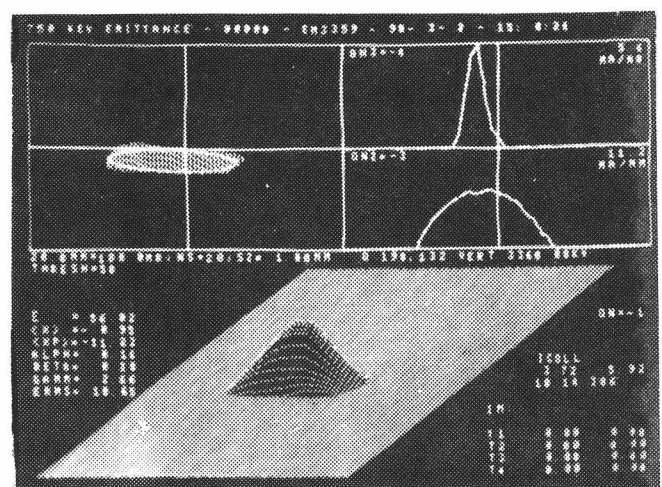
Figure 7: Vertical output beam emittance, before accident
