Solving the USB Communication Problem of the High-Voltage Modulator Control System in the European XFEL

M. Bousonville*, S. Choroba, S. Göller, T. Grevsmühl, A. Hauberg, T. Weinhausen, DESY, Hamburg, Germany

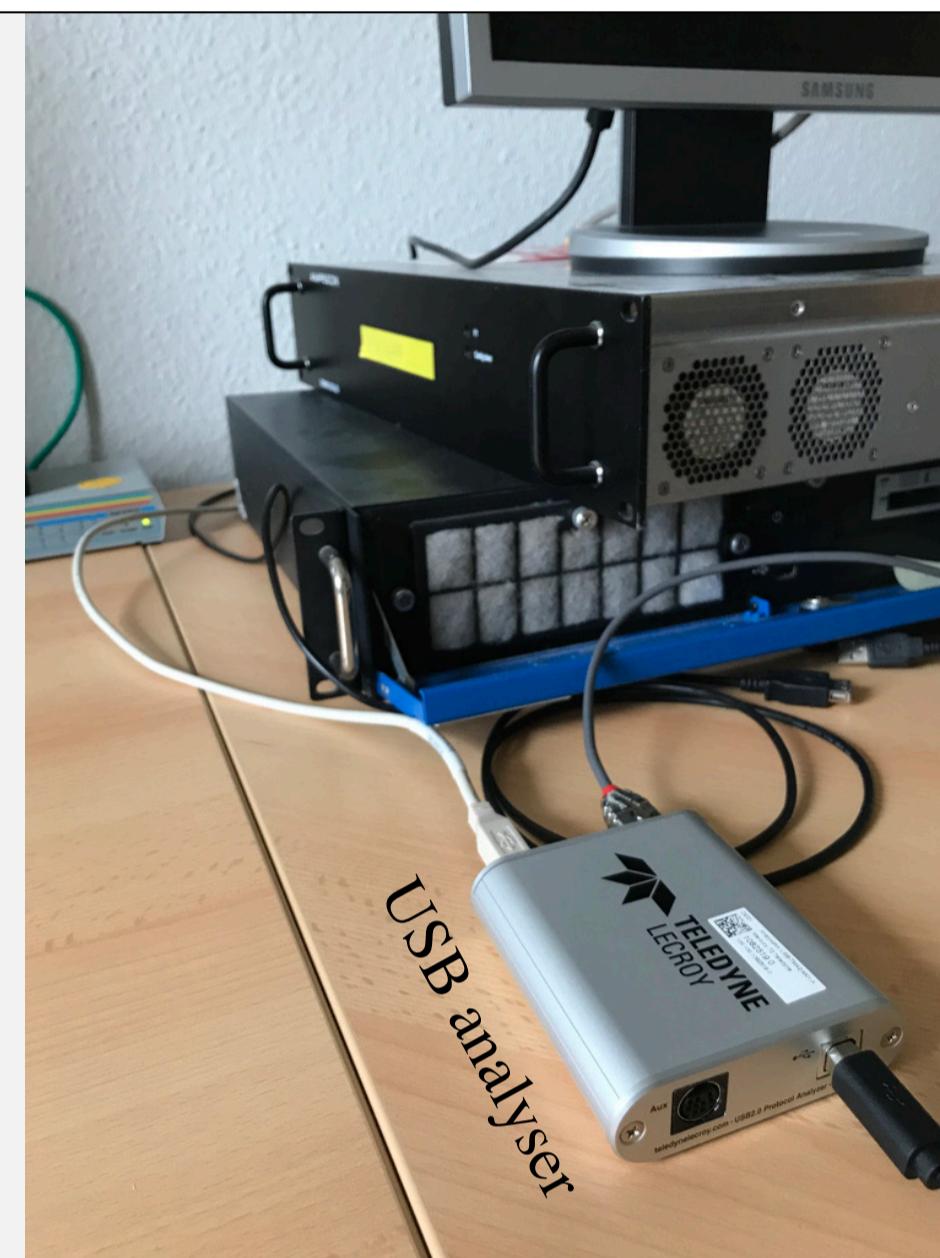
- We tried to find out if there was a difference between the 17 modulators that were affected and the 9 that were not.
 - ⇒ **But no difference could be found**, in age, software status, cable connections, etc.
- It was investigated whether an electromagnetic disturbance had become larger.
 - ⇒ **There were no indications and EMC measurements did not reveal any unusual stress in the vicinity** of the modulators.
- It was decided to use a USB analyser to analyse the data traffic between the electronic boards and the server in the hope of detecting communication problems.
 - ⇒ **Surprisingly, the error no longer occurred.**
