# STATUS OF THE RF SYSTEM FOR THE 6.5 GEV SYNCHROTRON LIGHT SOURCE PF-AR

S. Sakanaka, K. Ebihara, S. Isagawa, M. Izawa, T. Kageyama, T. Kasuga, H. Nakanishi, M. Ono, H. Sakai, T. Takahashi, K. Umemori, and S. Yoshimoto, High Energy Accelerator Research Organization (KEK), 1-1 Oho, Tsukuba, Ibaraki 305-0801, Japan

In this paper, we report the operations, troubles, and modifications of an rf system for the 6.5 GeV synchrotron light source PF-AR for the past two years. It includes a strange trouble in one of the cavities, our efforts to recover this cavity, and the work of transferring two cavities from the west to the east rf section.

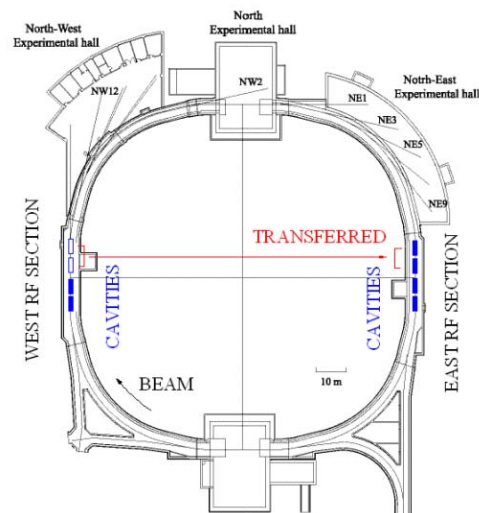
In order to leave a space for installing new undulators in the latter half of the west rf section, we transferred two cavities from the west to the east rf section during a summer shutdown in 2004. The change in the arrangement of the cavities is shown in Fig. 4. We transported the cavities along the ring tunnel with rollers, as shown in Fig. 5. At the same time, we replaced the wrong cavity (W-3) with a spare one. In addition, we adjusted coupling coefficients of input couplers from 1.2 to 1.6 in order to fit them for high beam currents.

Figure 4: Change in the arrangement of the cavities.

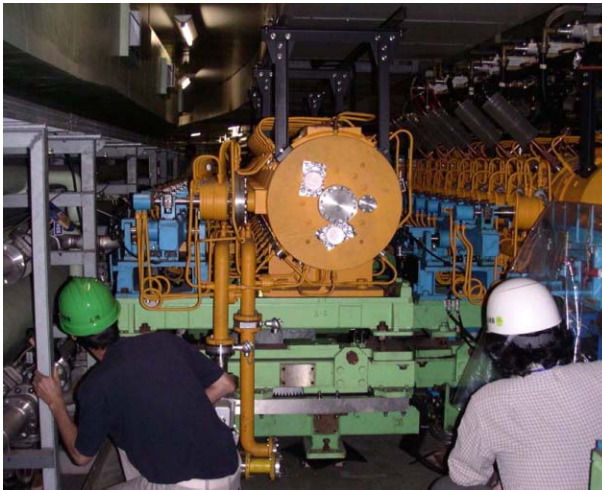
Figure 5: Transporting the cavity in the PF-AR tunnel.
