THE FACILITY FOR RARE ISOTOPE BEAMS SUPERCONDUCTING CAVITY PRODUCTION STATUS AND FINDINGS CONCERNING SURFACE DEFECTS*

C. Compton[†], H. Ao, J. Asciutto, J. Craft, K. Elliott, W. Hartung, S. Kim, E. Metzgar, S. Miller, E. Oswald, J. Popielarski, L. Popielarski, K. Saito, T. Xu
Facility for Rare Isotope Beams, Michigan State University, East Lansing, MI, 48824, U.S.A.

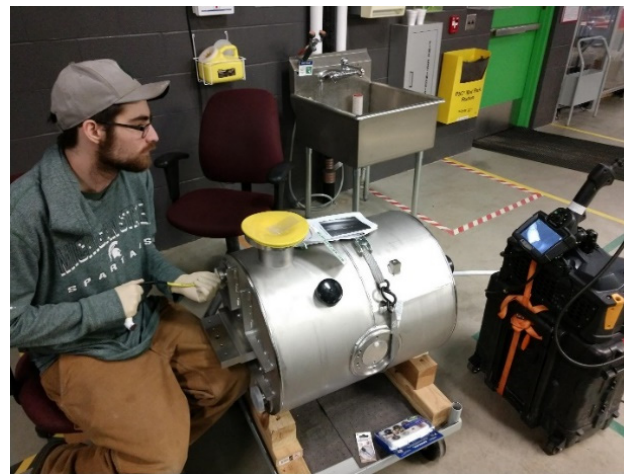
Figure 2: HWR polishing using the borescope (right) and a manual polishing tool (left).

Access to the inside surface is difficult for HWRs, which have no large openings. HWRs have 4 rinse ports (one of which is used for the RF pickup coupler), 2 beam ports, and one RF input port. When polishing an HWR, the borescope camera is inserted through a bushing fixture secured to a nearby port and focused on the target area. The operator then inserts the polishing tool through a different port that allows adequate movement to abrade the surface, as shown in Figure 2. The real-time borescope view of the polishing region improves the final results by helping to localize the polishing to only the desired area; additionally, the condition of the defect can be monitored while polishing it.

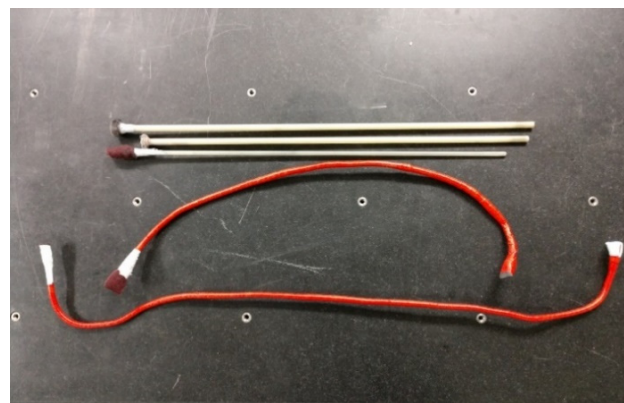
Figure 3: Examples of cavity polishing tools. The tools are bent as needed to reach features via the available access ports.

Polishing tools are made by bending ¼ inch (6.4 mm) stainless tubing, which is wrapped in protective tape, into a shape that avoids inadvertent contact with the soft niobium interior, as shown in Figure 3. If the target feature is within line-of-sight through a cavity port, a power tool is used in lieu of manual polishing: a rotary flapper wheel or abrasive pad is fixed to a composite rod, which is driven by a cordless drill/driver.
